Project: Greenacres Elementary School	Date: 01-17-20
Address: 41 Huntington Ave, Scarsdale, NY 10583	Job ID / MU #:
Client: Scarsdale CSD	Weather: Clear~25deg F

Inspection Type: Noise and Dust Monitoring	Contractor: Park East Construction
Present At Site: Don Herlihy	Sub-Contractor:
General Area: North Side of School	CM/Designer:
Specific Location: North side of School in the basement, 1st and 2nd Floor	
Last Inspection:	Building Code Section:
Reviewed Approved	Drawings:
	Submittals
	Other:

REPORT #
SD11720

INSPECTION REPORT

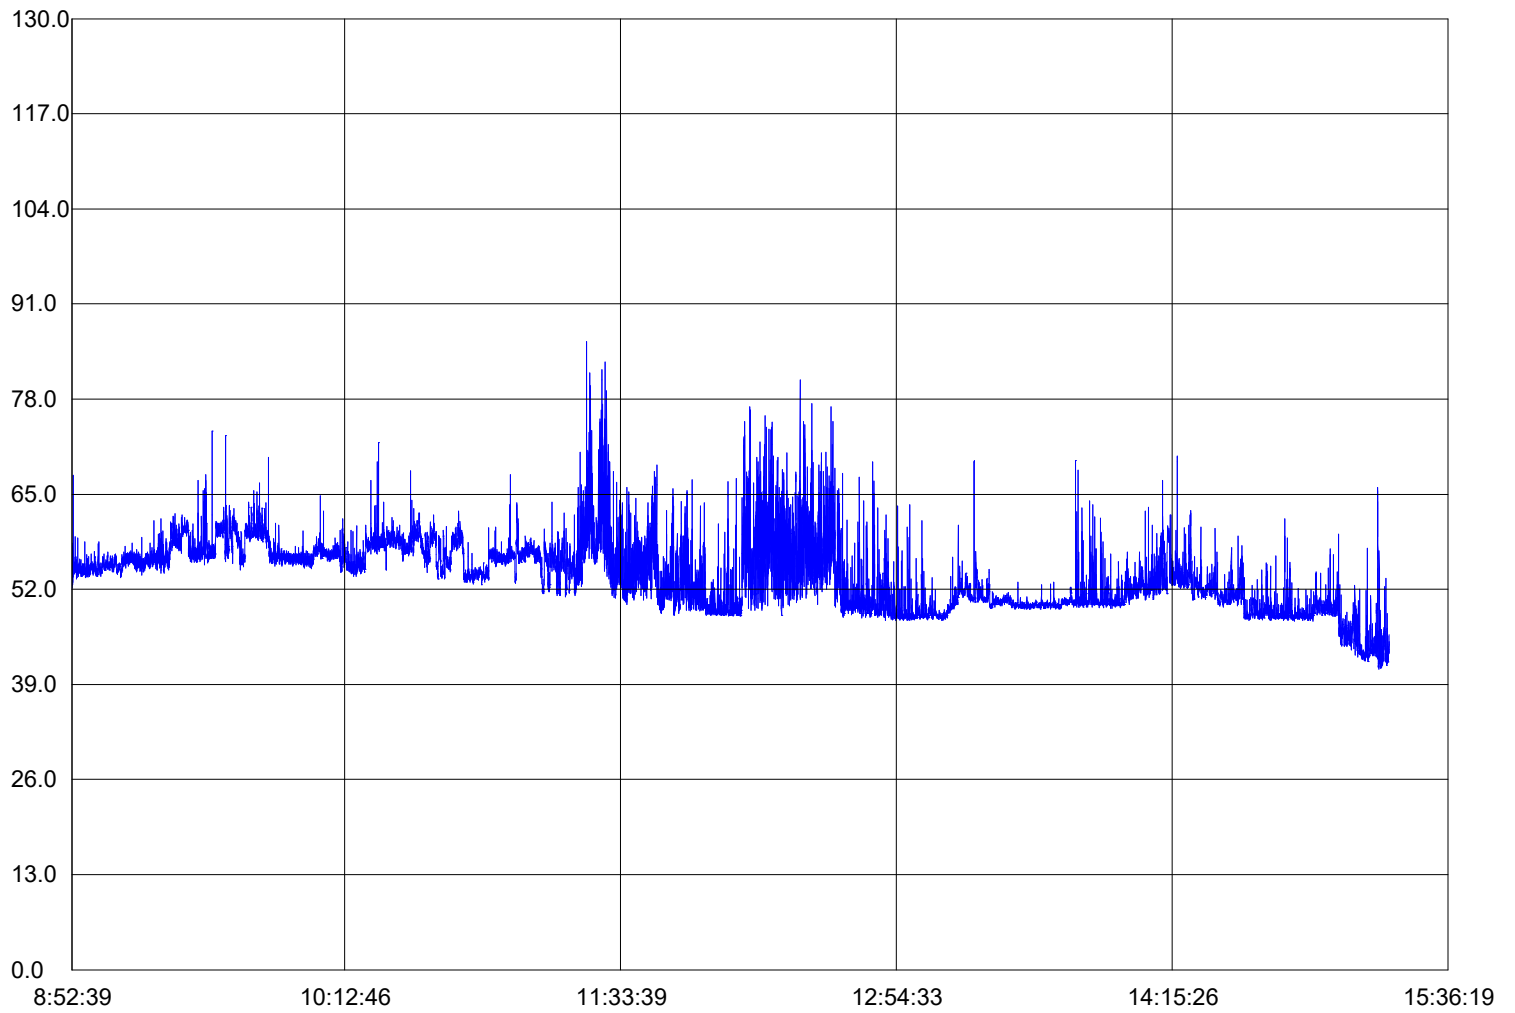
Meter 1 in library

Noise Monitoring- Readings were taken in the Art room and Library (Basement and 1st Floor) which is closest to the construction zone. Average readings were 53.87 dBA. Readings from 730a to 930a were also taken in the 1st floor hallway by closed off corridor, meter moved after showing no indication of high noise levels. Moved to basement next to art room at 930a.

Start Time: 17-01-2020,8:52:39
Maxnum: 85.90 17-01-2020,11:23:38
Minnum: 41.10 17-01-2020,15:16:05
Sample Rate: 1.00
Average: 53.82

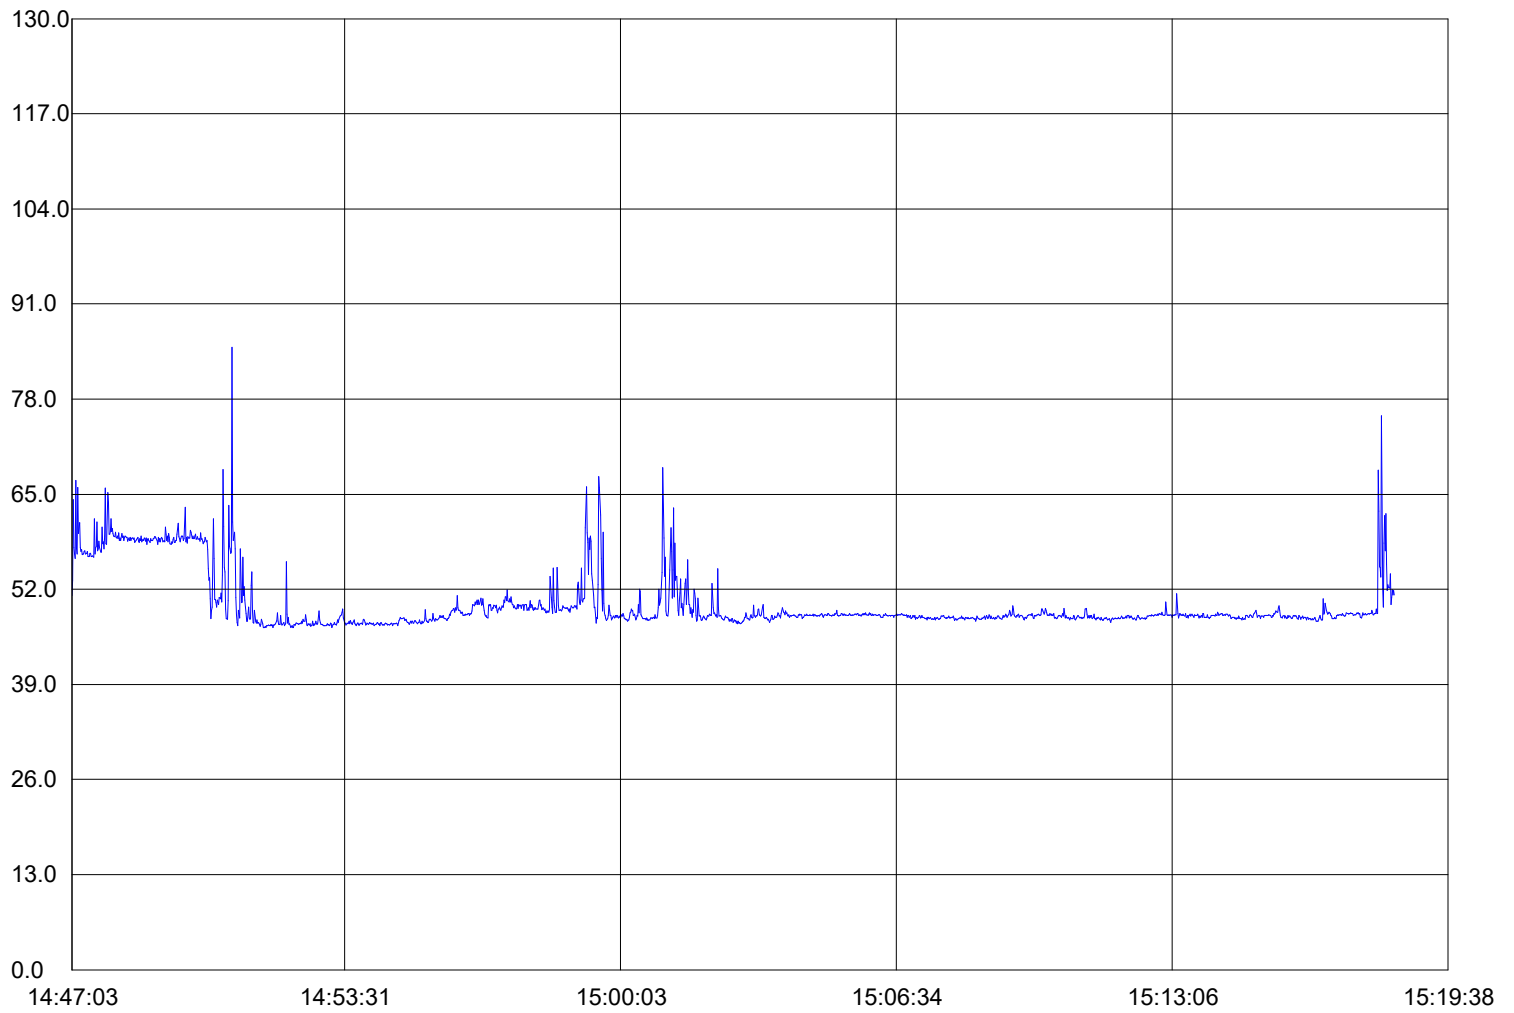
Meter 2 - reading taken in basement

Start Time: 17-01-2020,14:47:03
Maxnum: 85.10 17-01-2020,14:50:51
Minnum: 46.80 17-01-2020,14:51:35
Sample Rate: 1.00
Average: 49.89
