| Project: Greenacres Elementary School | Date: 01-21-20 |

| Inspection Type: Noise and Dust Monitoring | Contractor: Park East Construction |

REPORT #
SD12120

INSPECTION REPORT

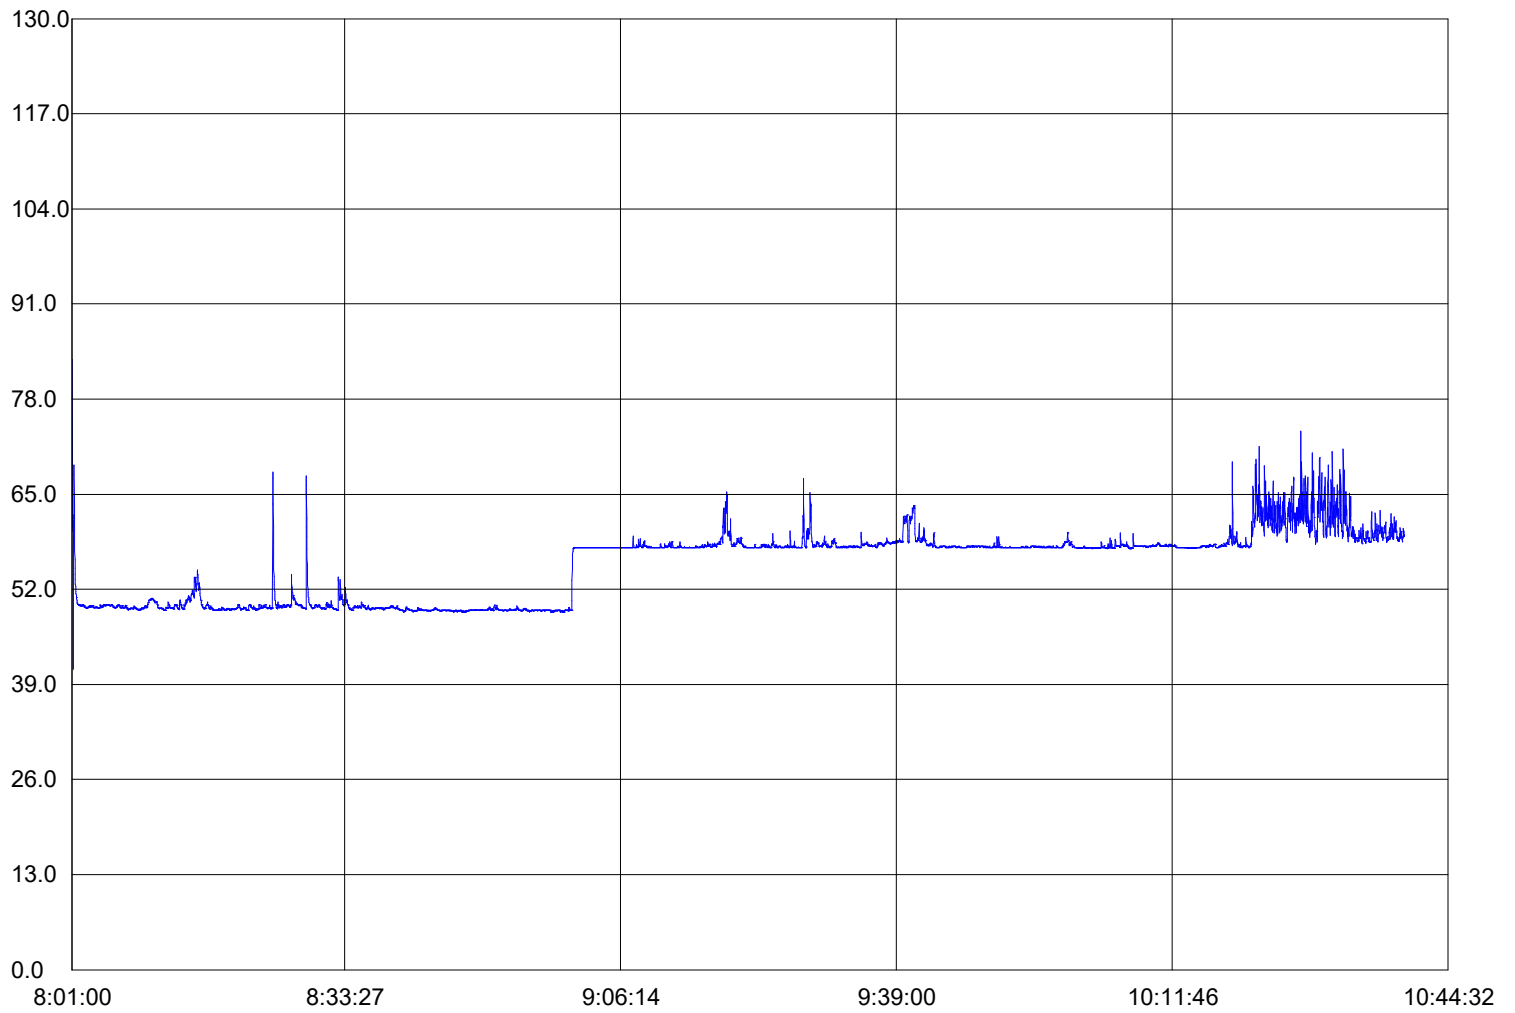
Meter 1 Library readings

| Noise Monitoring- Readings were taken in the Library (meter 1) and 1st floor hallway near vacant corridor(meter 2). Average readings were 55 dBA in the library. Meter 2 was removed to due local noise affecting readings in both the 1st floor hallway and basement near art/music rooms. At 930am, noise levels of 70dBA were observed due to chopping of concrete curbs outside the vacant corridor. Park East and Contractor were notified. Operations ceased till after school hours. |

Start Time: 21-01-2020,8:01:00
Maxnum: 83.40 21-01-2020,8:01:04
Minnum: 41.10 21-01-2020,8:01:11
Sample Rate: 1.00
Average: 55.29

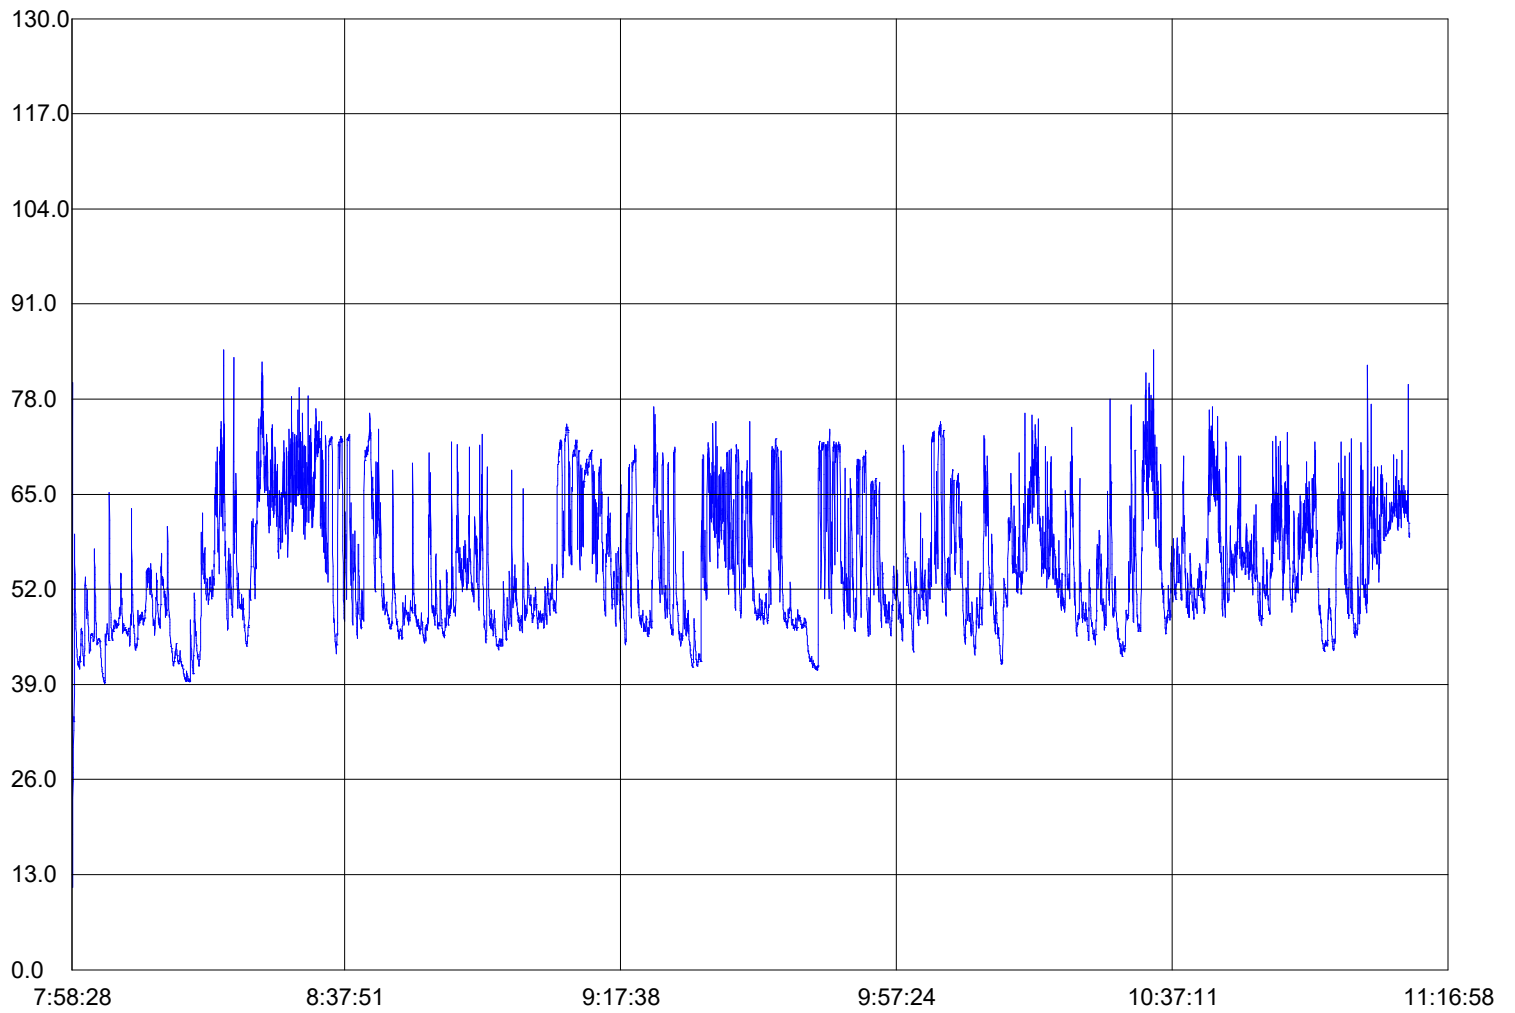
Meter 2 1st floor Hallway

Start Time: 21-01-2020,7:58:28
Maxnum: 84.70 21-01-2020,8:20:24
Minnum: 11.20 21-01-2020,7:58:37
Sample Rate: 1.00
Average: 55.08
