Project: Greenacres Elementary School	Date: 01-22-20
Address: 41 Huntington Ave, Scarsdale, NY 10583	Job ID / MU #:
Client: Scarsdale CSD	Weather: Clear~25deg F

Inspection Type: Noise and Dust Monitoring	Contractor: Park East Construction
Present At Site: Don Herlihy	Sub-Contractor:
General Area: North Side of School	CM/Designer:
Specific Location: North side of School in the basement, 1st and 2nd Floor	
Last Inspection:	Building Code Section:
Reviewed Approved	Drawings:
	Submittals
	Other:

REPORT #
SD12220

INSPECTION REPORT

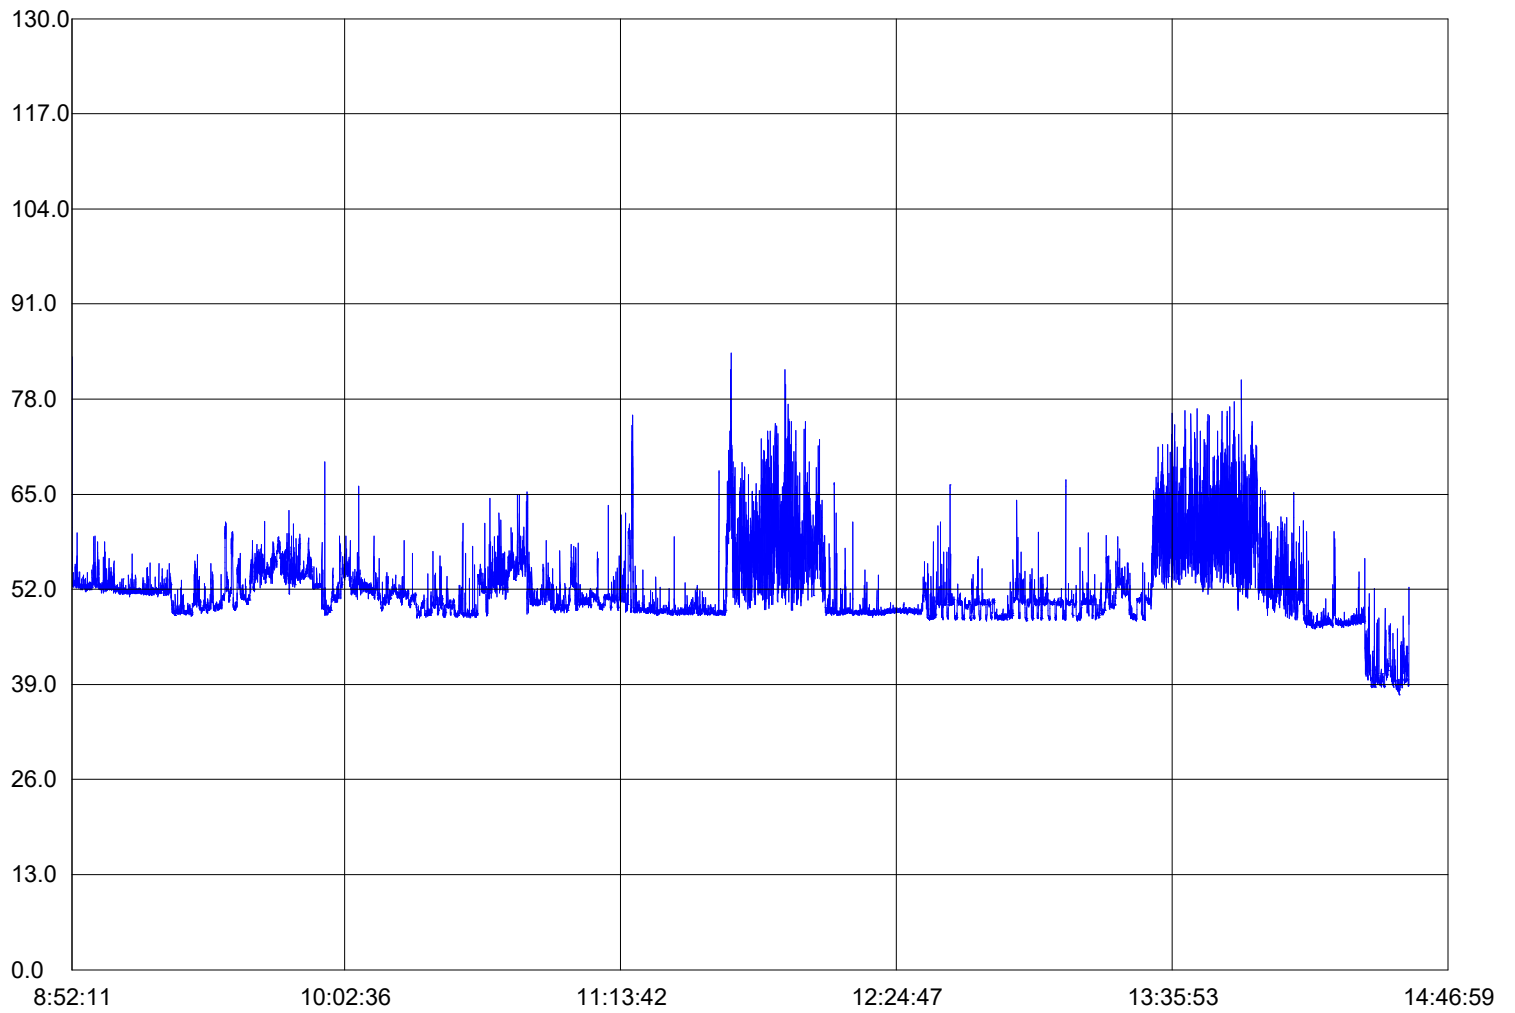
Meter 1 in Library

Standard Sound Level Meter RealTime Graph
Time: 2020-1-22 14:54:48

Start Time: 22-01-2020,8:52:11
Maxnum: 84.30 22-01-2020,11:42:12
Minnum: 37.60 22-01-2020,14:34:27
Sample Rate: 1.00
Average: 51.82

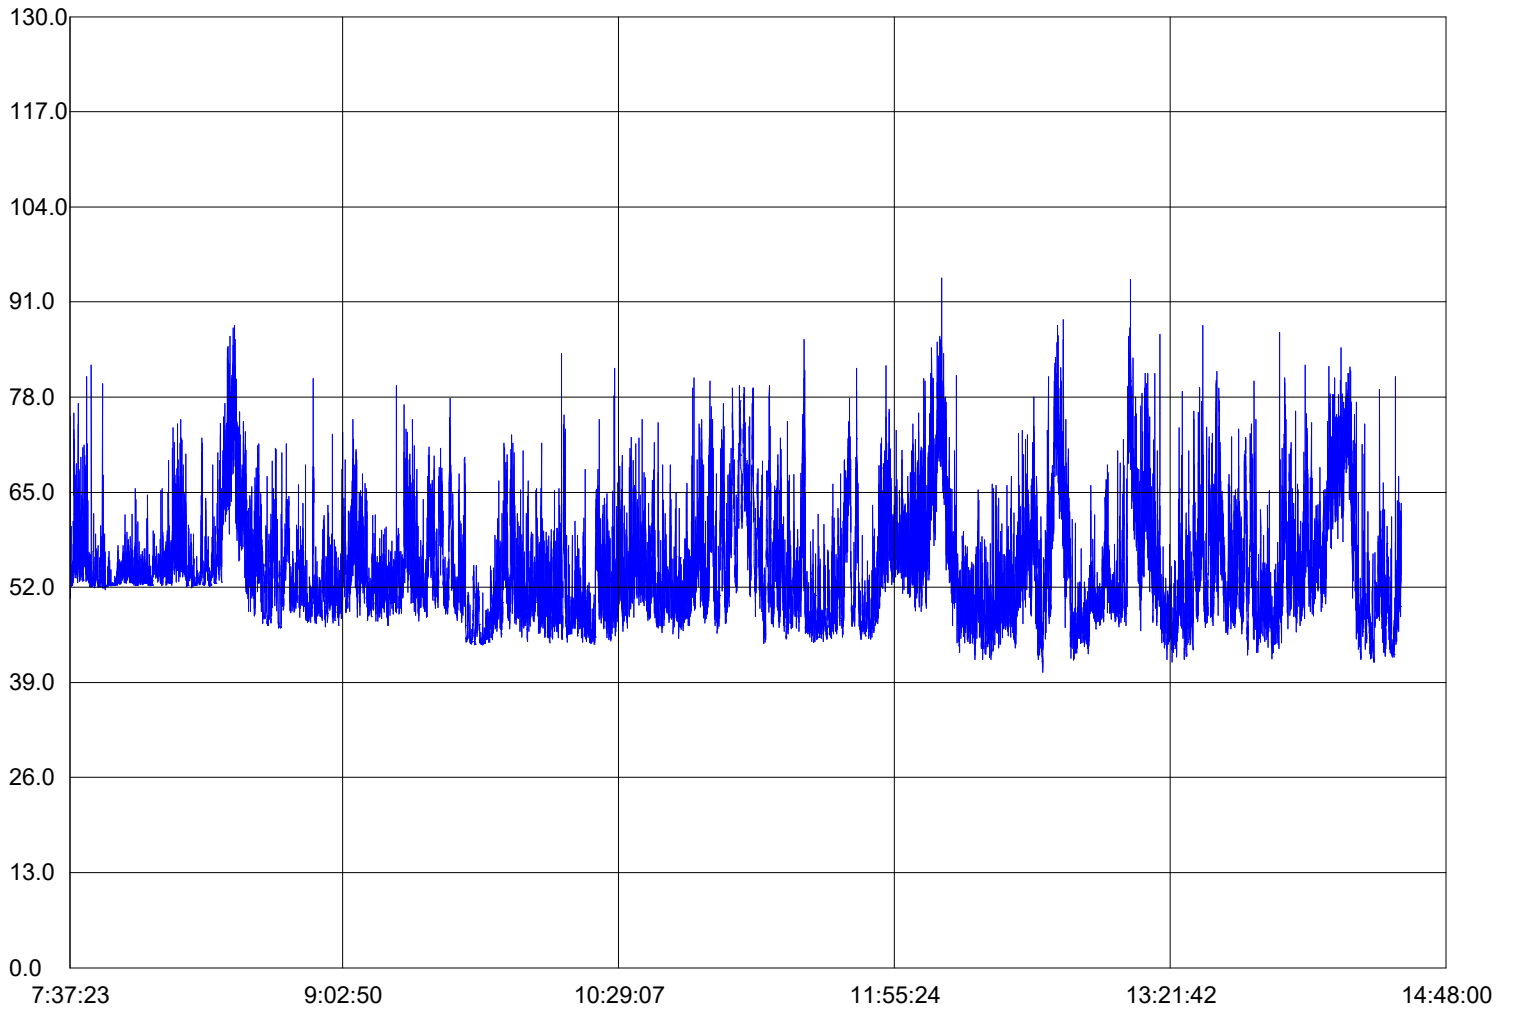
Meter 2 in 1st Floor Hallway

Standard Sound Level Meter RealTime Graph
Time: 2020-1-22 14:58:0

Start Time: 22-01-2020,7:37:23
Maxnum: 94.30 22-01-2020,12:10:17
Minnum: 40.40 22-01-2020,12:41:50
Sample Rate: 1.00
Average: 54.68
