Project: <b>Greenacres Elementary School</b>	Date: <b>01-23-20</b>
Address: <b>41 Huntington Ave, Scarsdale, NY 10583</b>	Job ID / MU #:
Client: <b>Scarsdale UFSD</b>	Weather: <b>Clear~25deg F</b>

Inspection Type: <b>Noise and Dust Monitoring</b>	Contractor: <b>Park East Construction</b>
Present At Site: <b>Don Herlihy</b>	Sub-Contractor:
General Area: <b>North Side of School</b>	CM/Designer:
Specific Location: <b>North side of School in the basement, 1st and 2nd Floor</b>	
Last Inspection:	Building Code Section:
Reviewed Approved	Drawings:
	Submittals
	Other:

REPORT #  
**SD12320**

## INSPECTION REPORT

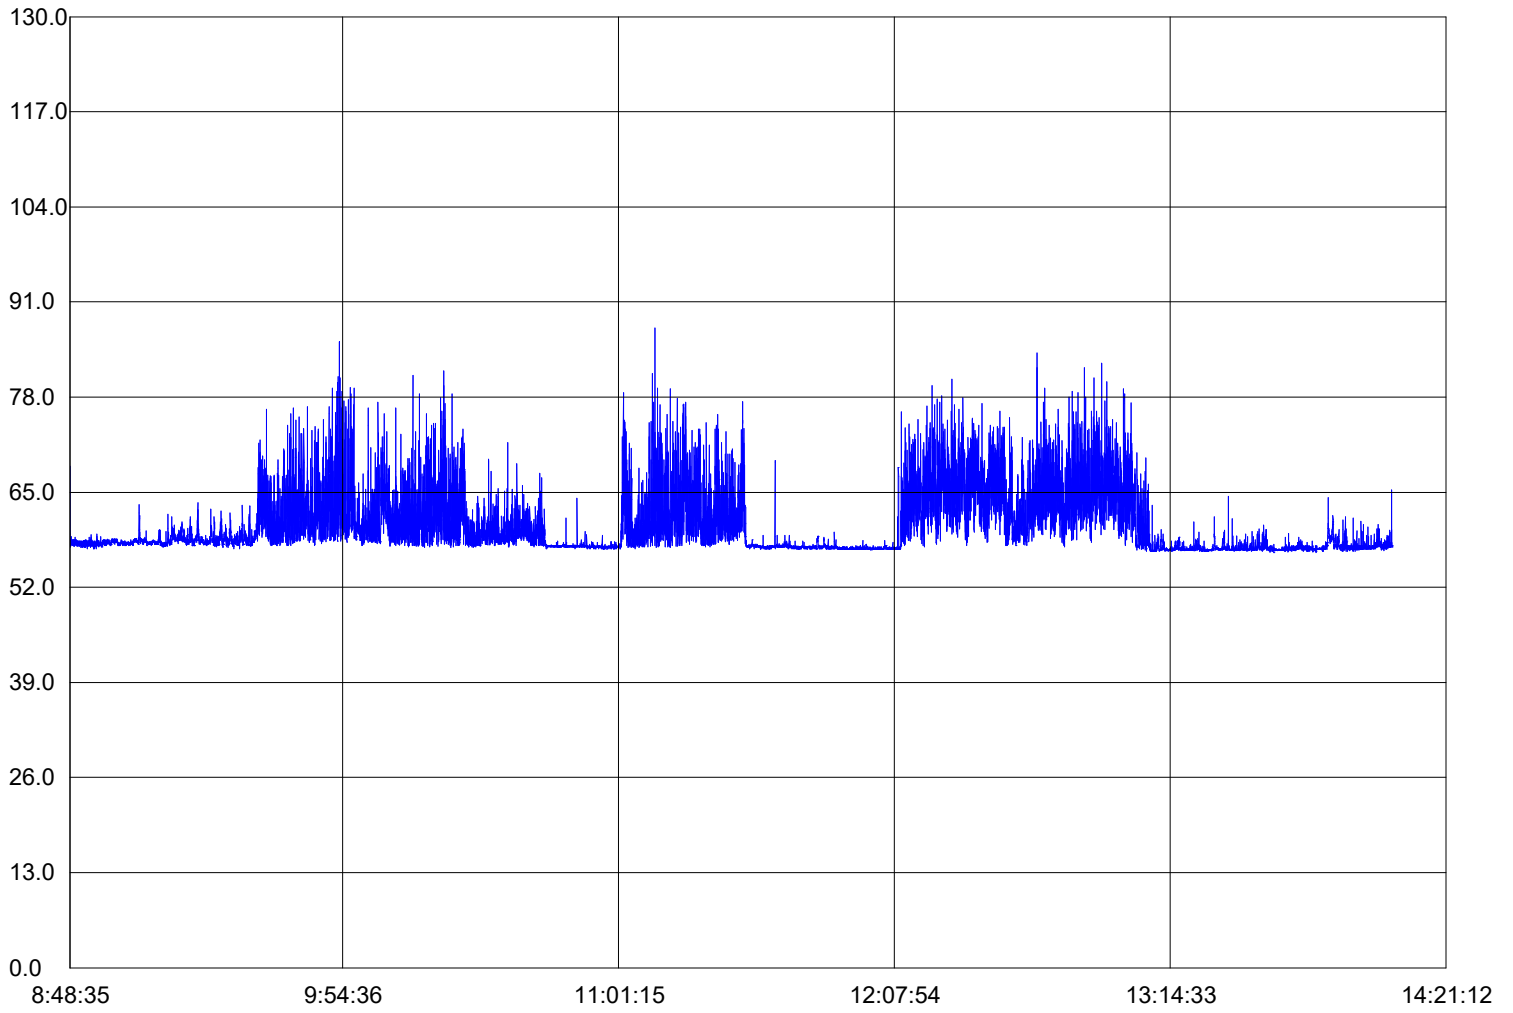
Meter 1 in Library

Noise Monitoring- Readings were taken in the Library (meter 1) and basement hallway between music and art rooms(meter 2). Average reading was 60.35 dBA in the library. Average reading was 46 and 48dBA in the basement. High levels observed in meter 1 and 2 were local noise from students passing through the hallway, class in library and music being played. No observations of construction noise was noticed during rounds.

Start Time: 23-01-2020,8:48:35  
Maxnum: 87.40 23-01-2020,11:10:03  
Minnum: 56.70 23-01-2020,13:39:38  
Sample Rate: 1.00  
Average: 60.35

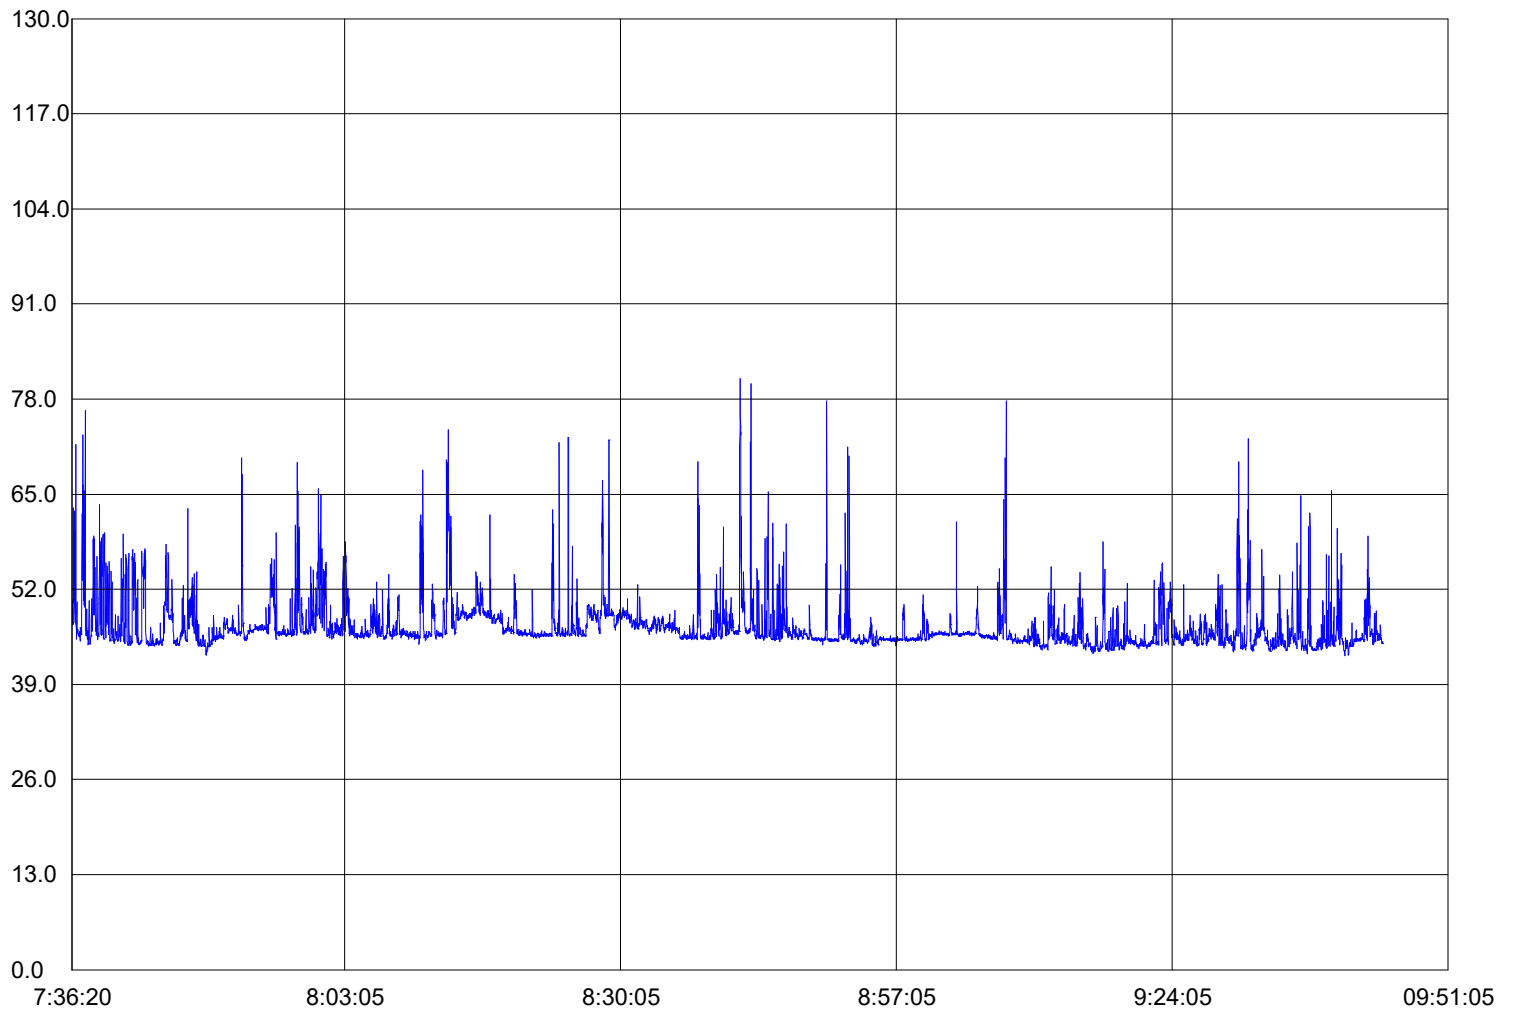
Meter 2 part 1 in Basement hallway next to artroom

Start Time: 23-01-2020,7:36:20  
Maxnum: 80.80 23-01-2020,8:41:48  
Minnum: 42.90 23-01-2020,9:41:01  
Sample Rate: 1.00  
Average: 46.85

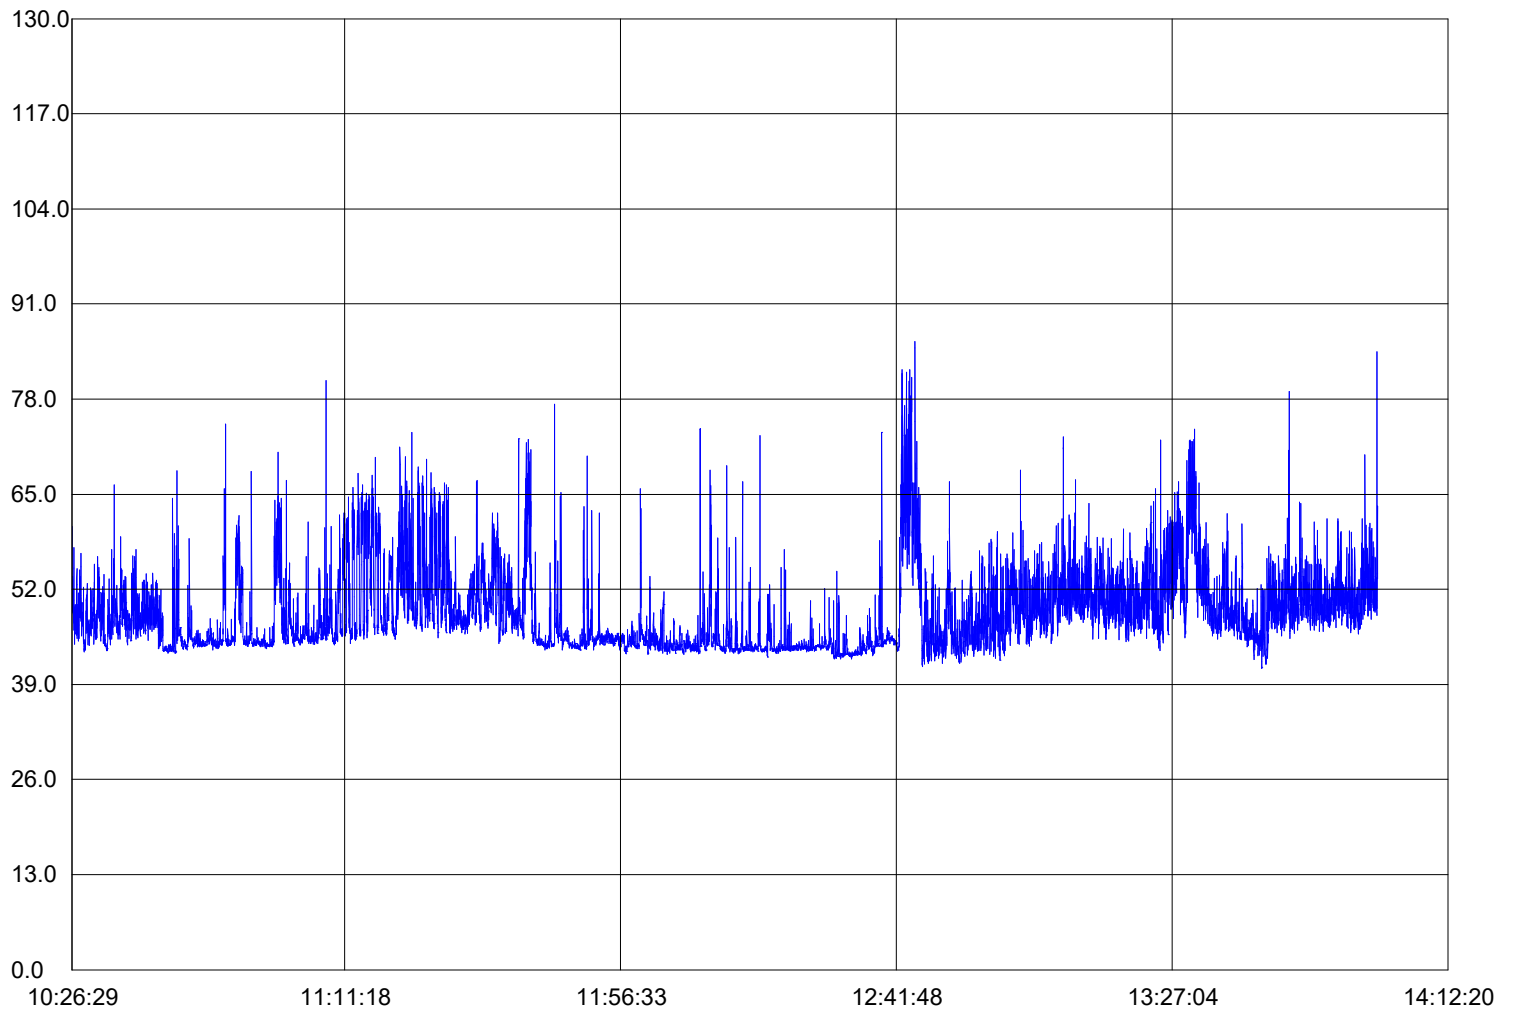
Meter 2 part 2 in hallway next to art room

Start Time: 23-01-2020,10:26:29  
Maxnum: 85.90 23-01-2020,12:44:55  
Minnum: 41.20 23-01-2020,13:41:48  
Sample Rate: 1.00  
Average: 48.69
