REPORT # **SD12420**

## **INSPECTION REPORT** Page 1 of 6

Project: Greenacres Elementary School		Date: 01-24-20			
Address: 41 Huntington Ave, Scarsdale, NY 10583			Job ID / MU #:		
	arsdale UFSD		Weather: Clear~40deg F		
Inspection '	Type: Noise and Dust Monitoring	Contractor:	Park East Construction		
	Site: Don Herlihy	Sub-Contractor:	Tank East Constitution		
	ea: Existing School	CM/Designer:			
	3	in the basement	. 1st and 2nd Floor		
Reviewed					
	Submittals				
Approved	Other:				
Deficiency:		Resolution:			
Request Fo	r Information:	<u> </u>			
Non-Confor	mance Report:				
RFI#:	Issued RFI # : Answered NCR # :	Issued NCR # :	Resolved NCR # : Open		
Observation	ns/Notes:		•		
On site for	the on going monitoring of construction Noi	se and Dust for Gre	enacres Elementary School.		
and art roo 48dBa in t through the noticed du	oms(meter 2). Average reading was 60.35 dl he basement. High levels observed in meter e hallway, class in library and music being p ring rounds.	Ba in the library. Av 1 and 2 were local layed. No observati	verage reading was 46 and noise from students passing

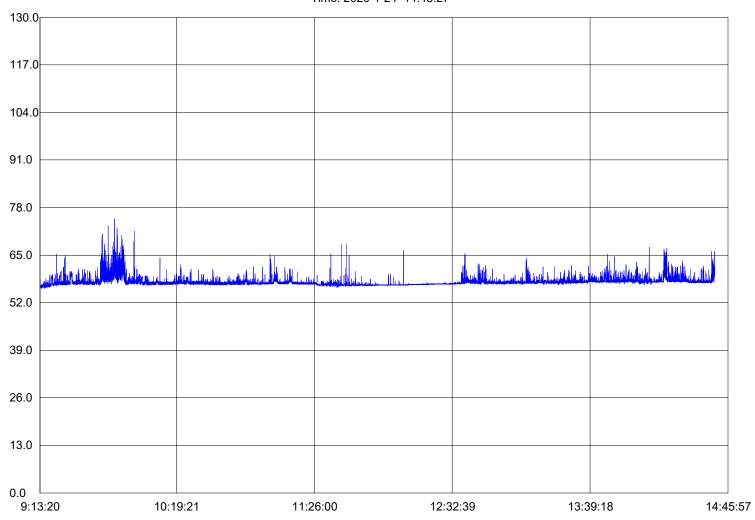
### Standard Sound Level Meter RealTime Graph Time: 2020-1-24 14:48:27

Maxnum:
 74.90
 24-01-2020,9:49:23

Minnum:
 55.90
 24-01-2020,9:14:11

Sample Rate: 1.00 Average: 57.69 Meter 1 Library

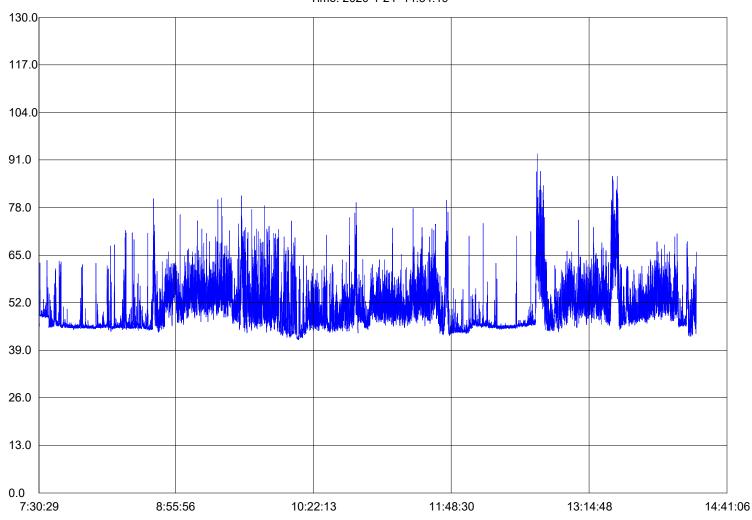
### Standard Sound Level Meter RealTime Graph Time: 2020-1-24 14:34:19

Maxnum: 92.70 24-01-2020,12:42:27 Minnum: 41.90 24-01-2020,10:12:46

Sample Rate: 1.00 Average: 50.45 Meter 2 outside artroom
