MUNICIPAL
TESTING LABORATORY, INC.

INSPECTION REPORT

| Project: Greenacres School | Date: 09/06/19 |

| Inspection Type: Noise and Dust Monitoring | Contractor: Park East |

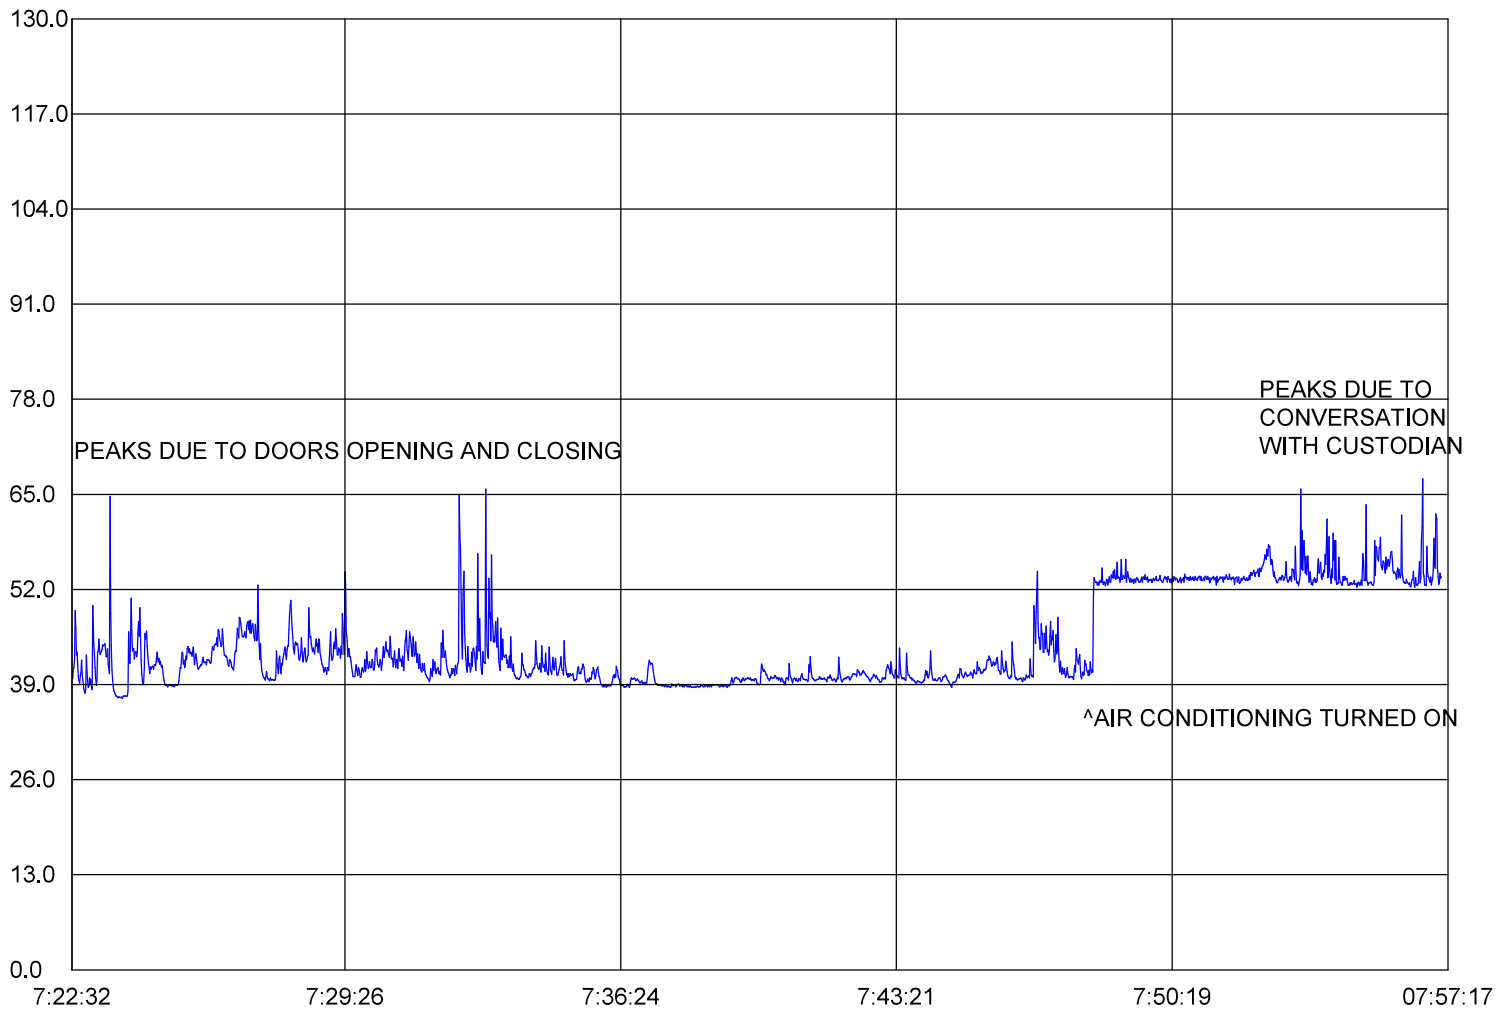
GYMNASIUM NOISE LEVELS

Start Time: 06-09-2019,7:22:32
Maxnum: 67.10 06-09-2019,7:56:39
Minnum: 37.10 06-09-2019,7:23:49
Sample Rate: 1.00
Average: 44.62

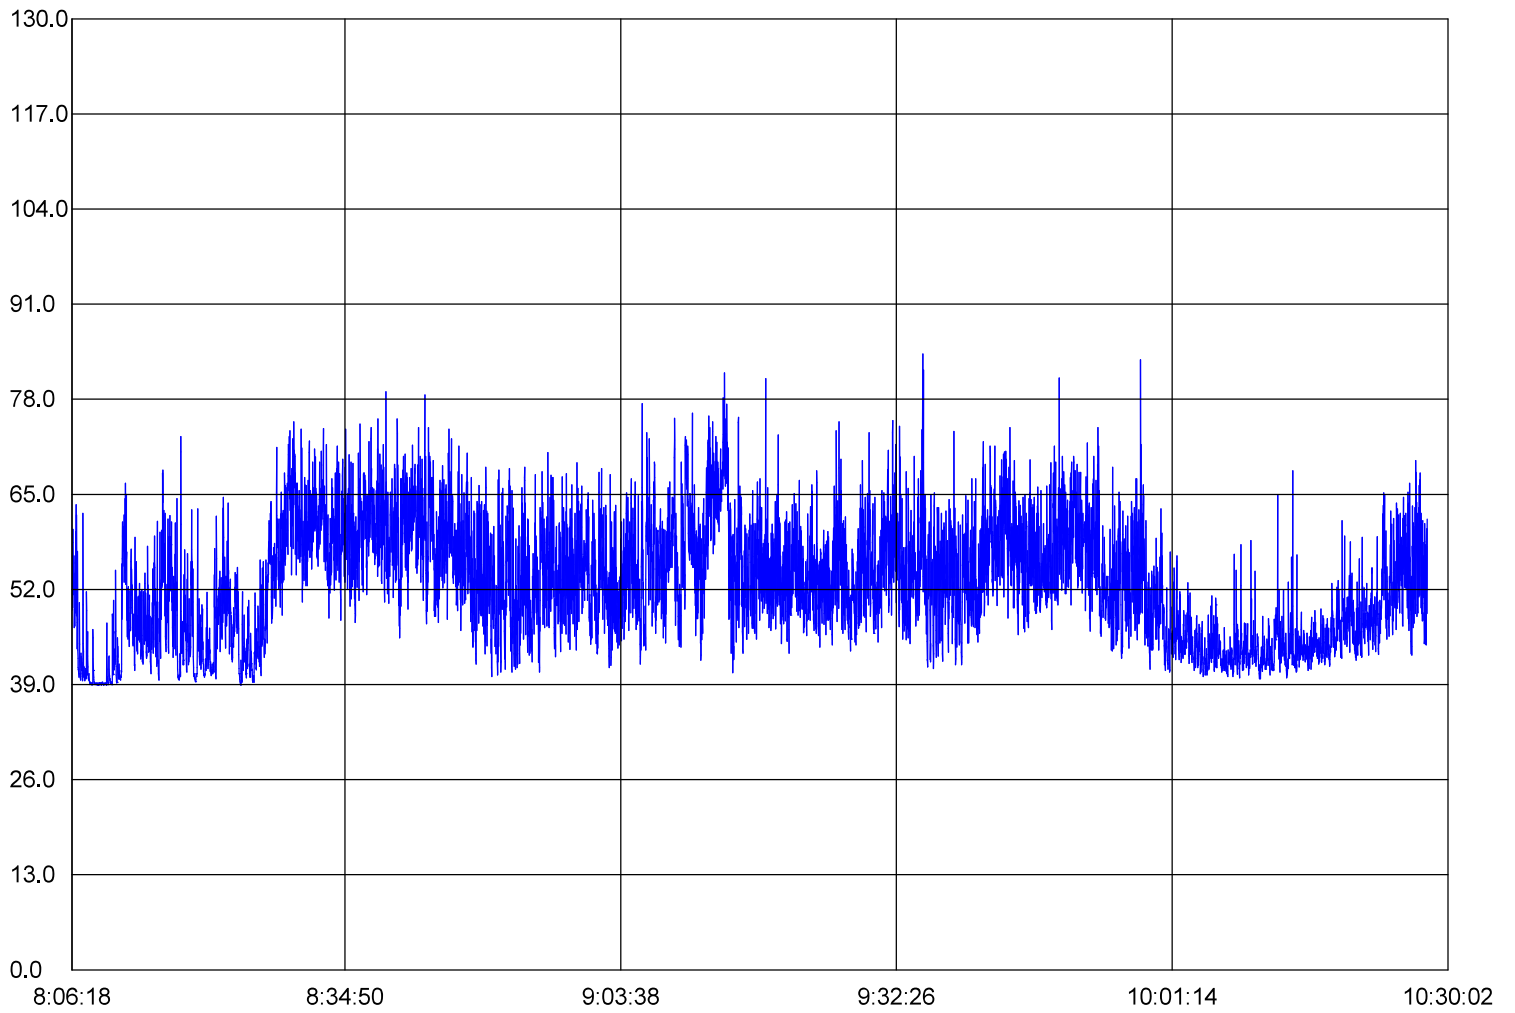
KINDERGARTEN ART CLASS WITH STUDENTS

Start Time: 06-09-2019,8:06:18
Maxnum: 84.20 06-09-2019,9:35:12
Minnum: 38.90 06-09-2019,8:09:02
Sample Rate: 1.00
Average: 52.80

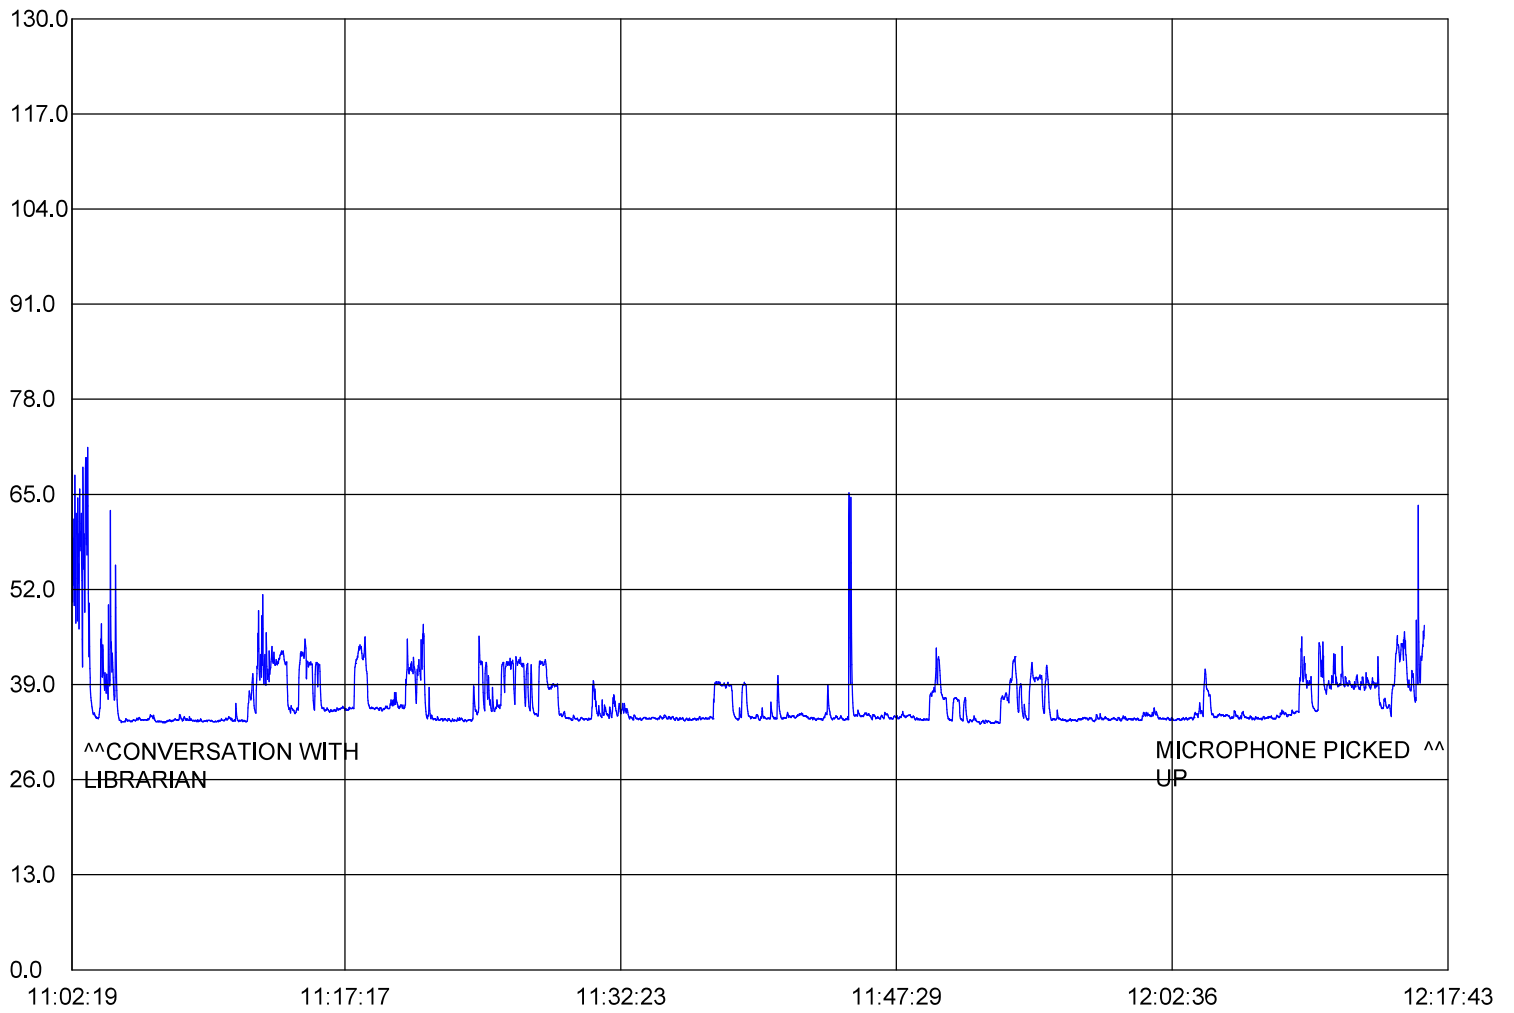
LIBRARY NOISE LEVELS

Start Time: 06-09-2019,11:02:19
Maxnum: 71.40 06-09-2019,11:03:11
Minnum: 33.60 06-09-2019,11:52:04
Sample Rate: 1.00
Average: 36.57

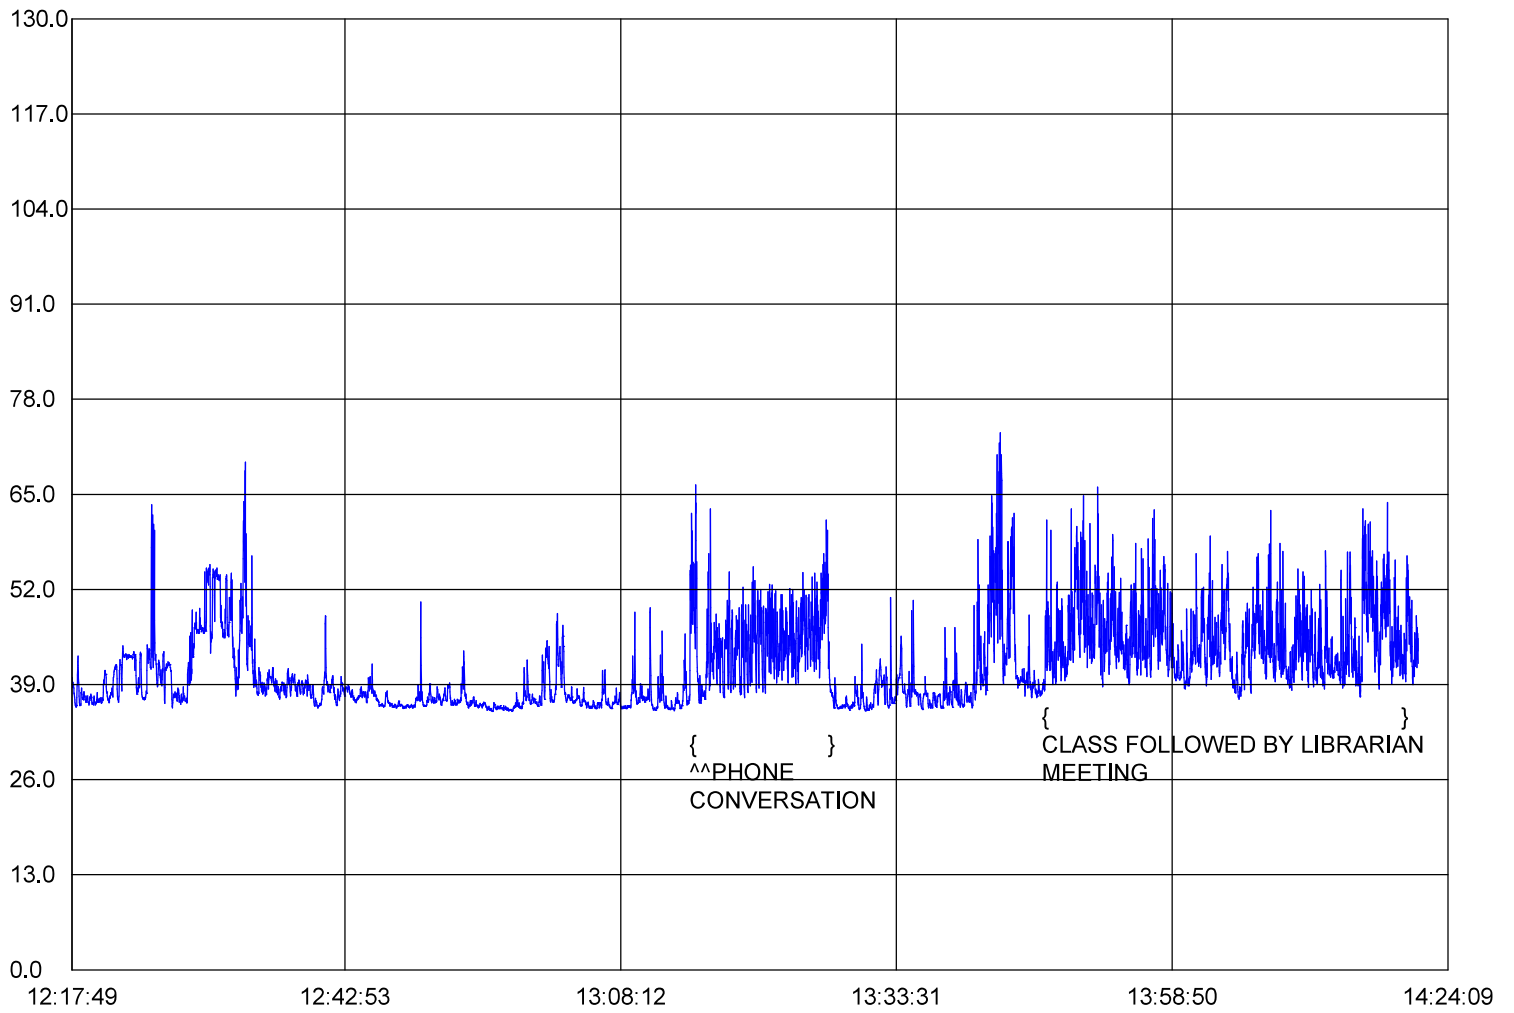
LIBRARY NOISE LEVELS

Start Time: 06-09-2019,12:17:49
Maxnum: 73.40 06-09-2019,13:43:03
Minnum: 35.30 06-09-2019,12:56:27
Sample Rate: 1.00
Average: 41.44
