375 Rabro Drive, Hauppauge, NY 11788 • Tele: 631-761-5555 • www.mtllab.net NYC DoB Special Inspection Agency #0230

| bob opecial inspection rigericy wo200 | |
|---|---|
| INSPECTION REPORT | |

| Date: 09/09/19 | | | | | |
|--|--|--|--|--|--|
| ess: 41 Huntington Avenue, Scarsdale NY 10583 Job ID / MU #: t: Park East Construction Weather: Sunny Sub-Contractor: Park East | | | | | |

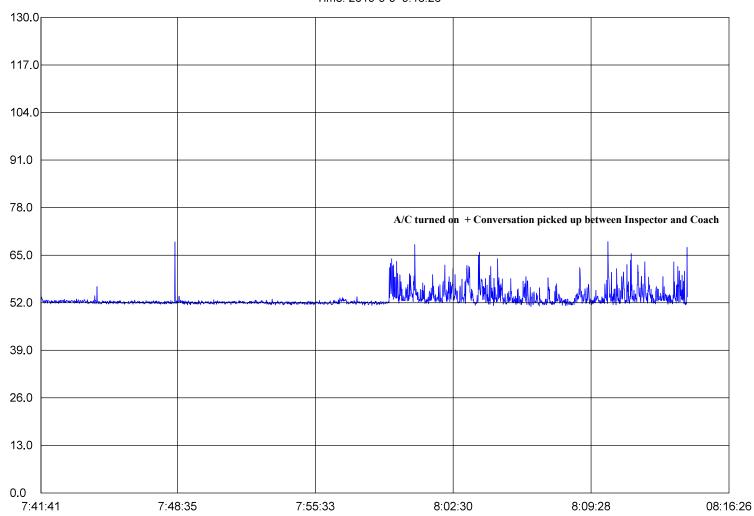
Gymnasium AM

Start Time:
 09-09-2019,7:41:41

Maxnum:
 68.70
 09-09-2019,8:10:19

Minnum:
 51.00
 09-09-2019,8:06:26

Sample Rate: 1.00 Average: 53.05

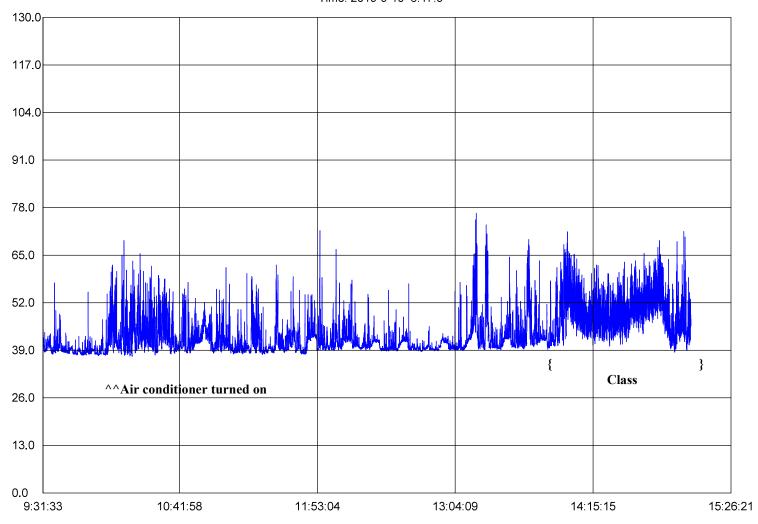
Library

Start Time: 09-09-2019,9:31:33

Maxnum: 76.50 09-09-2019,13:15:01 Minnum: 37.40 09-09-2019,10:16:25

Sample Rate: 1.00 Average: 43.44
