Project: Greenacres School	Date: 09/18/19
Address: 41 Huntington Avenue, Scarsdale NY 10583	Job ID / MU #:
Client: Park East Construction	Weather: Sunny (AM)

Inspection Type: Noise and Dust Monitoring	Contractor: Park East
Present At Site: 7:00AM	Sub-Contractor:
General Area: Northern Yard of School	CM/Designer:
Specific Location: Northern Side of school 1st, 2nd floor, Basement	
Last Inspection:	Building Code Section:
Reviewed	Drawings:
Approved	Submittals
	Other:

INSPECTION REPORT

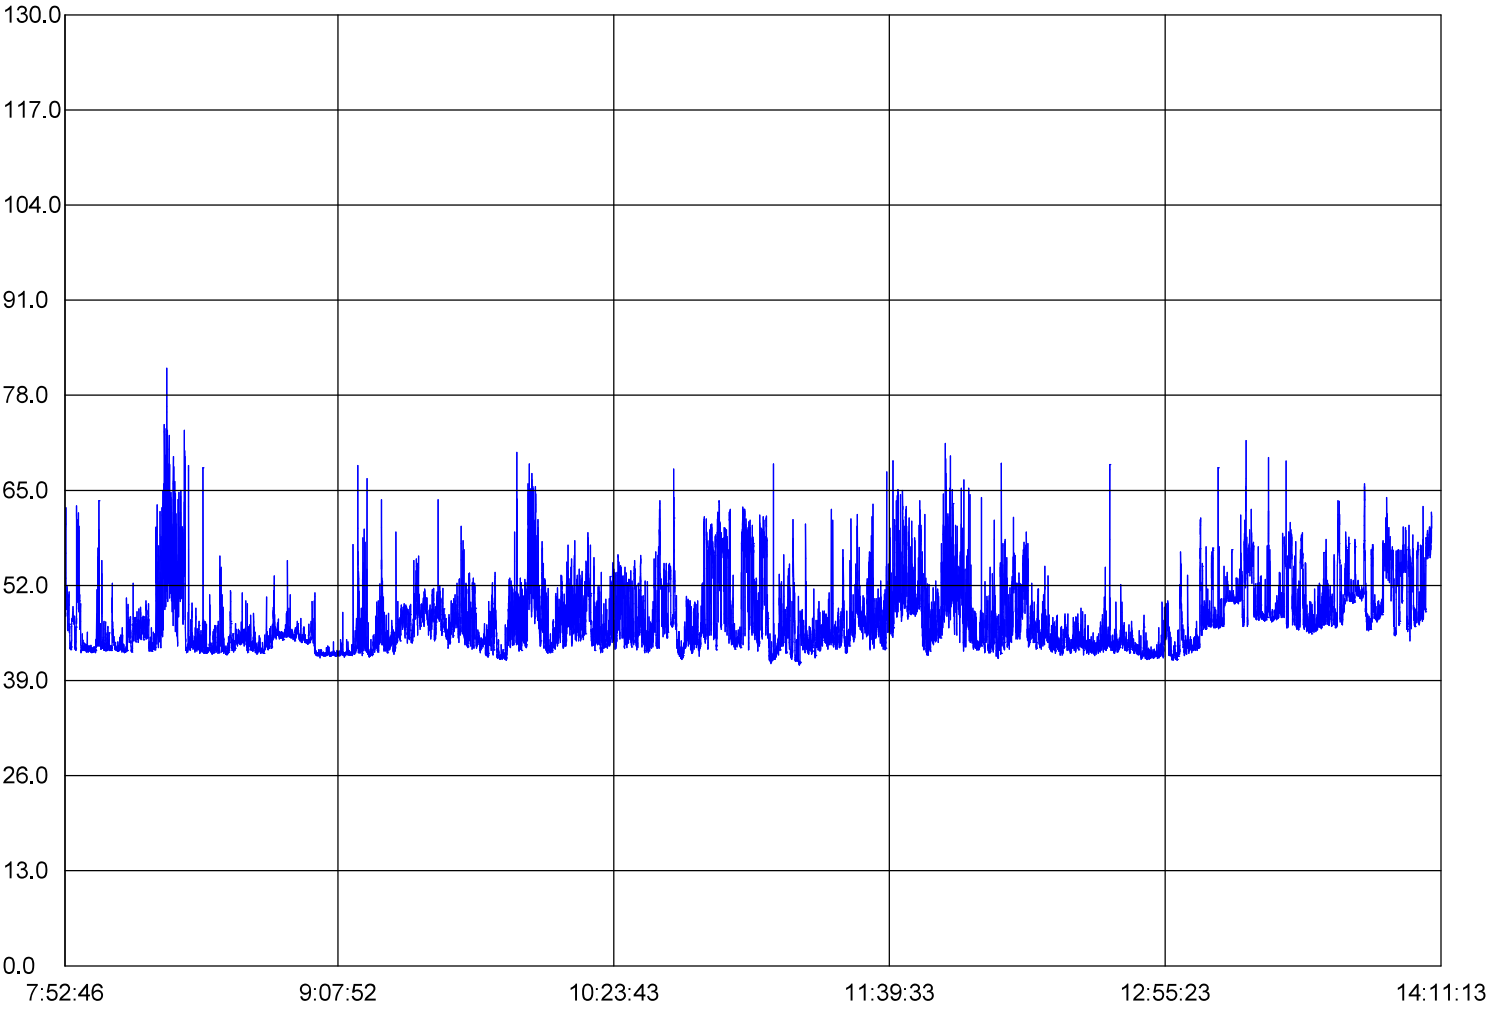
Library

Start Time: 18-09-2019,7:52:46
Maxnum: 81.70 18-09-2019,8:20:49
Minnum: 41.10 18-09-2019,11:14:49
Sample Rate: 1.00
Average: 47.40

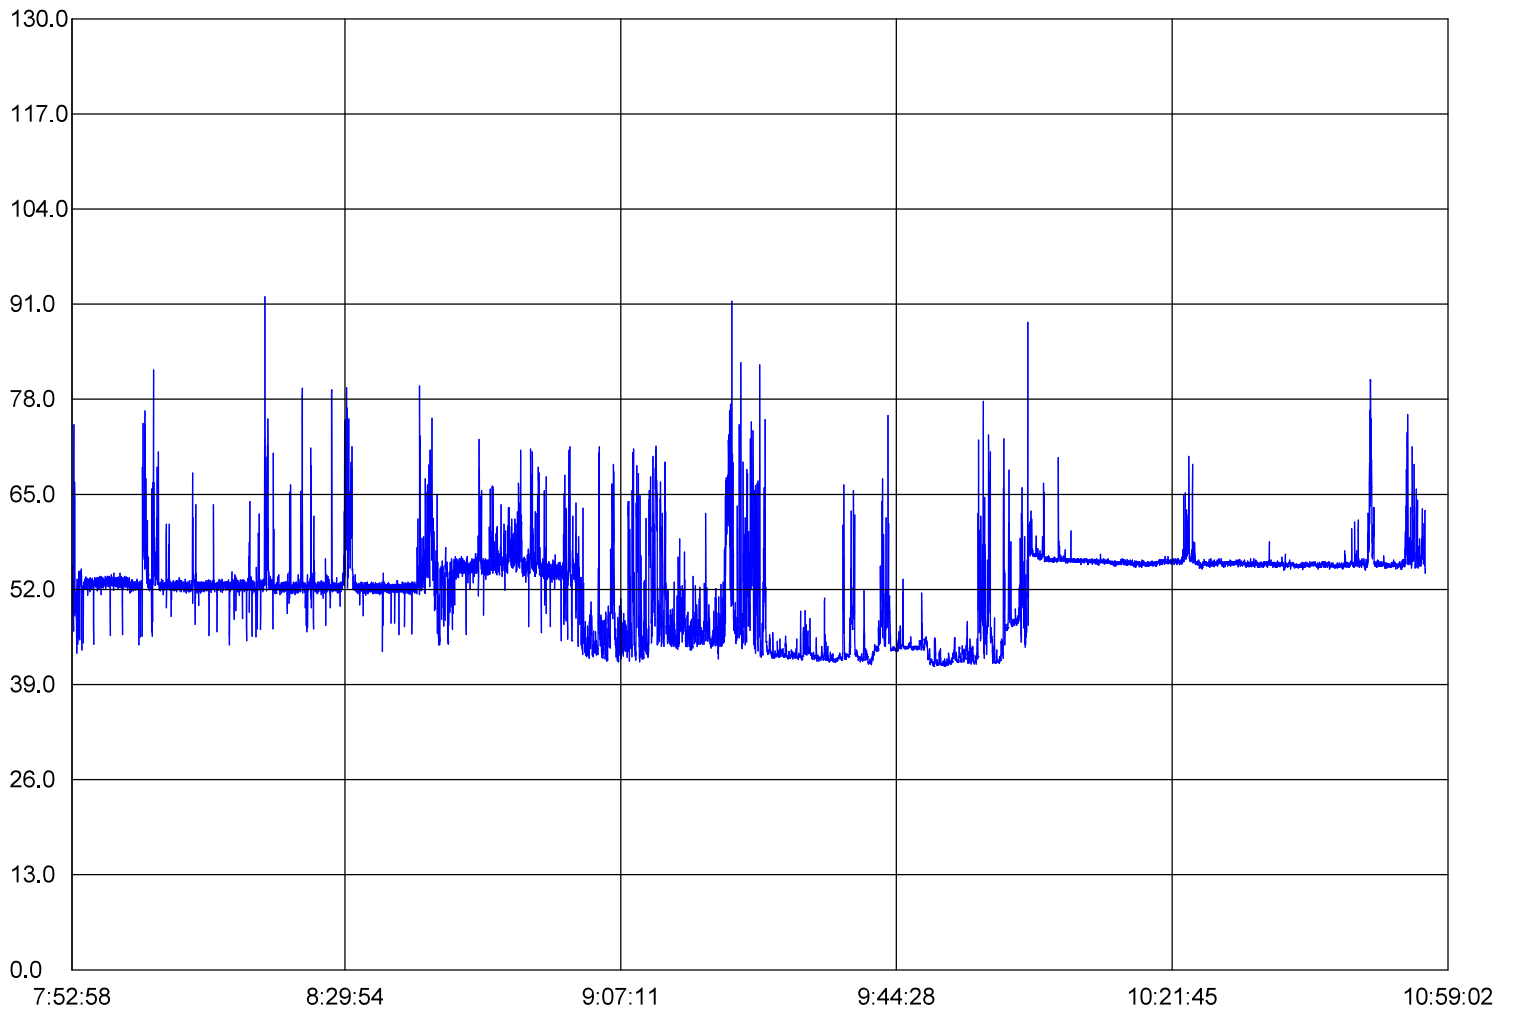
Basement Hallway

Start Time: 18-09-2019,7:52:58
Maxnum: 92.00 18-09-2019,8:19:05
Minnum: 41.50 18-09-2019,9:49:31
Sample Rate: 1.00
Average: 52.10

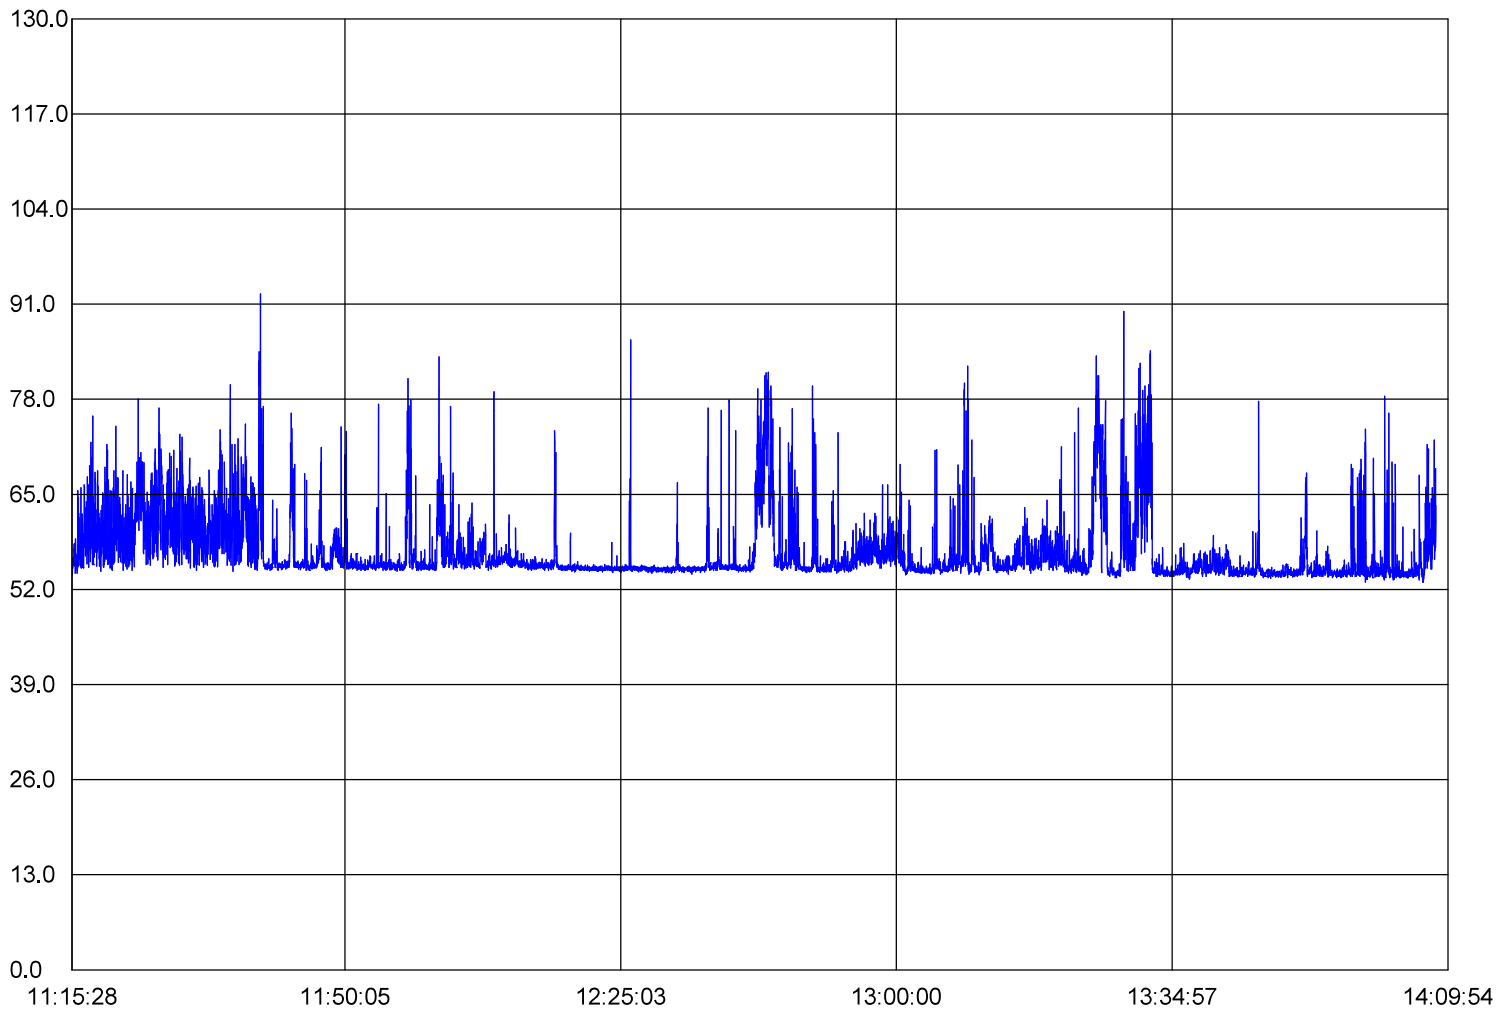
Basement Hallway PM

Start Time: 18-09-2019,11:15:28
Maxnum: 92.40 18-09-2019,11:39:23
Minnum: 53.00 18-09-2019,13:59:28
Sample Rate: 1.00
Average: 57.11
