## INSPECTION REPORT

Project: <b>Greenacres School</b>	Date: <b>09/19/19</b>
Address: <b>41 Huntington Avenue, Scarsdale NY 10583</b>	Job ID / MU #:
Client: <b>Park East Construction</b>	Weather: <b>Sunny(AM)</b>

Inspection Type: <b>Noise and Dust Monitoring</b>	Contractor: <b>Park East</b>
Present At Site: <b>7:00AM</b>	Sub-Contractor:
General Area: <b>Northern Yard of School</b>	CM/Designer:
Specific Location: <b>Northern Side of school 1st, 2nd floor, Basement</b>	
Last Inspection:	Building Code Section:
Reviewed	Drawings:
Approved	Submittals
	Other:

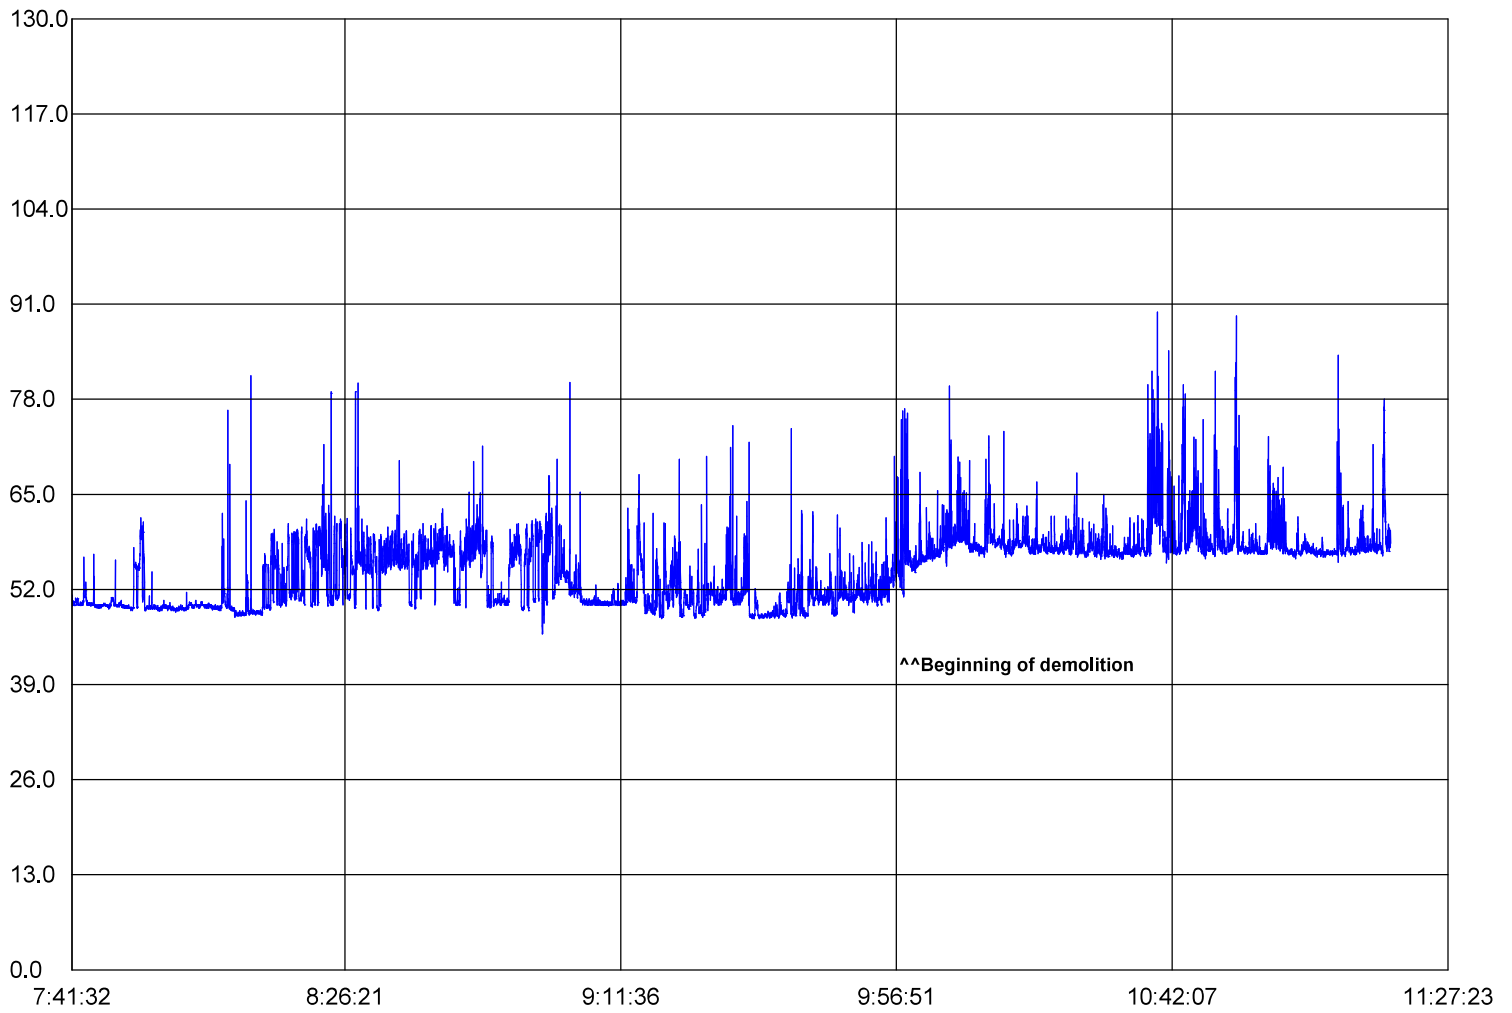
## Basement Hallway AM

Start Time: 19-09-2019,7:41:32  
Maxnum: 89.90 19-09-2019,10:39:42  
Minnum: 45.90 19-09-2019,8:58:46  
Sample Rate: 1.00  
Average: 54.78

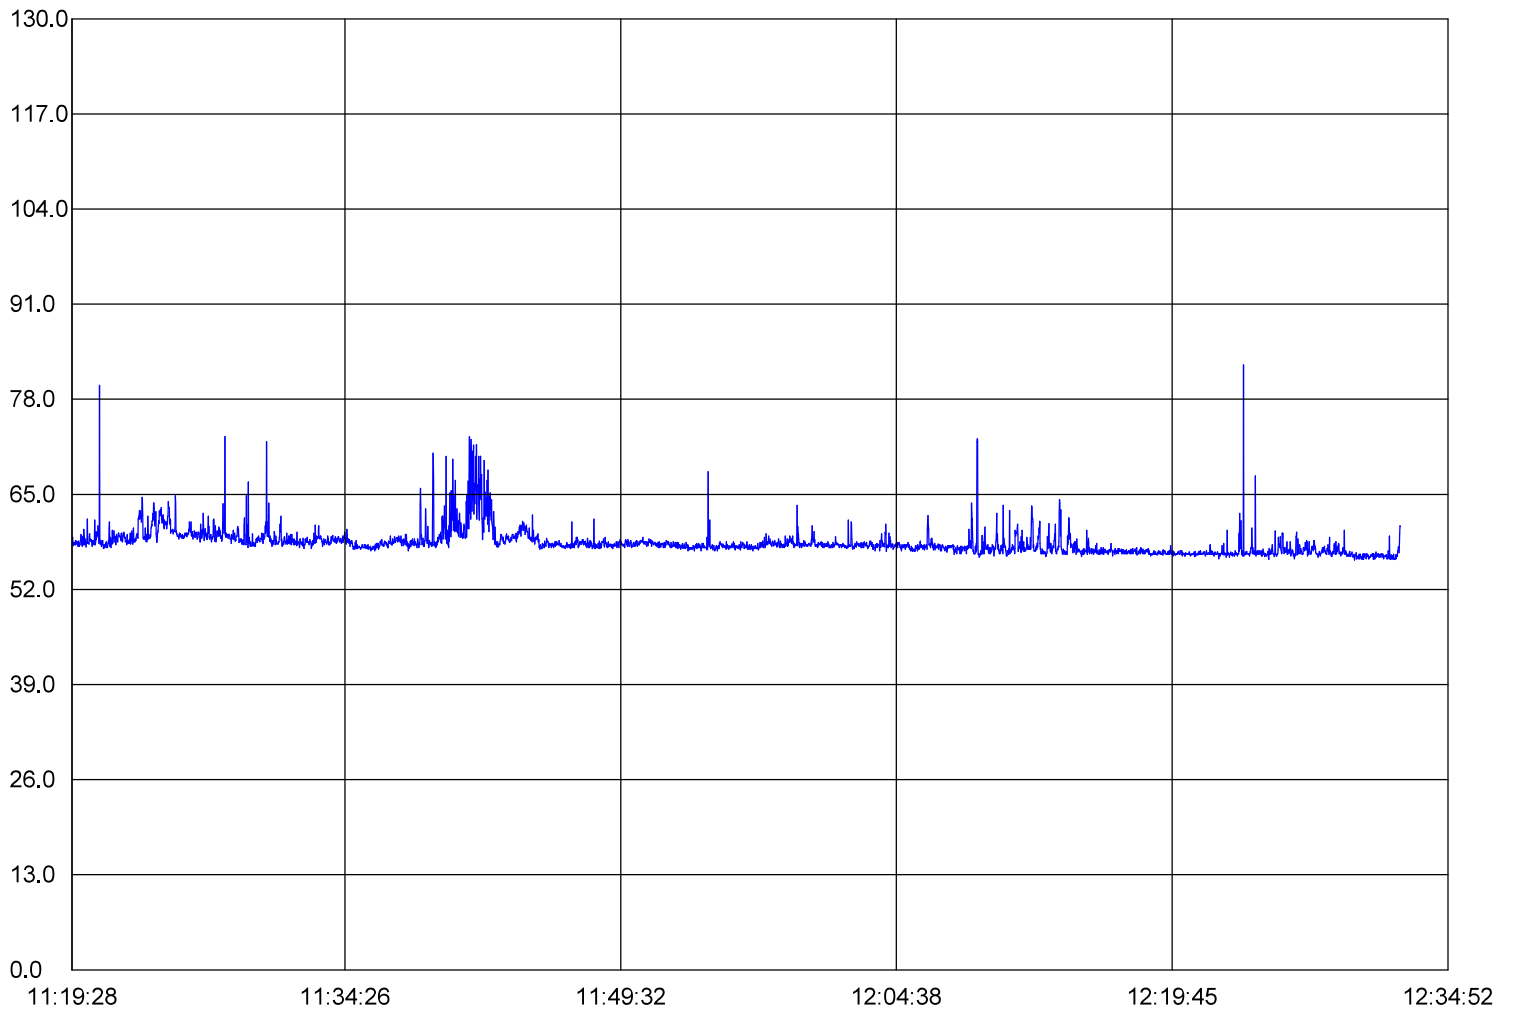
**Basement Hallway AM 2**

Start Time: 19-09-2019,11:19:28  
Maxnum: 82.70 19-09-2019,12:23:40  
Minnum: 56.00 19-09-2019,12:29:45  
Sample Rate: 1.00  
Average: 58.36

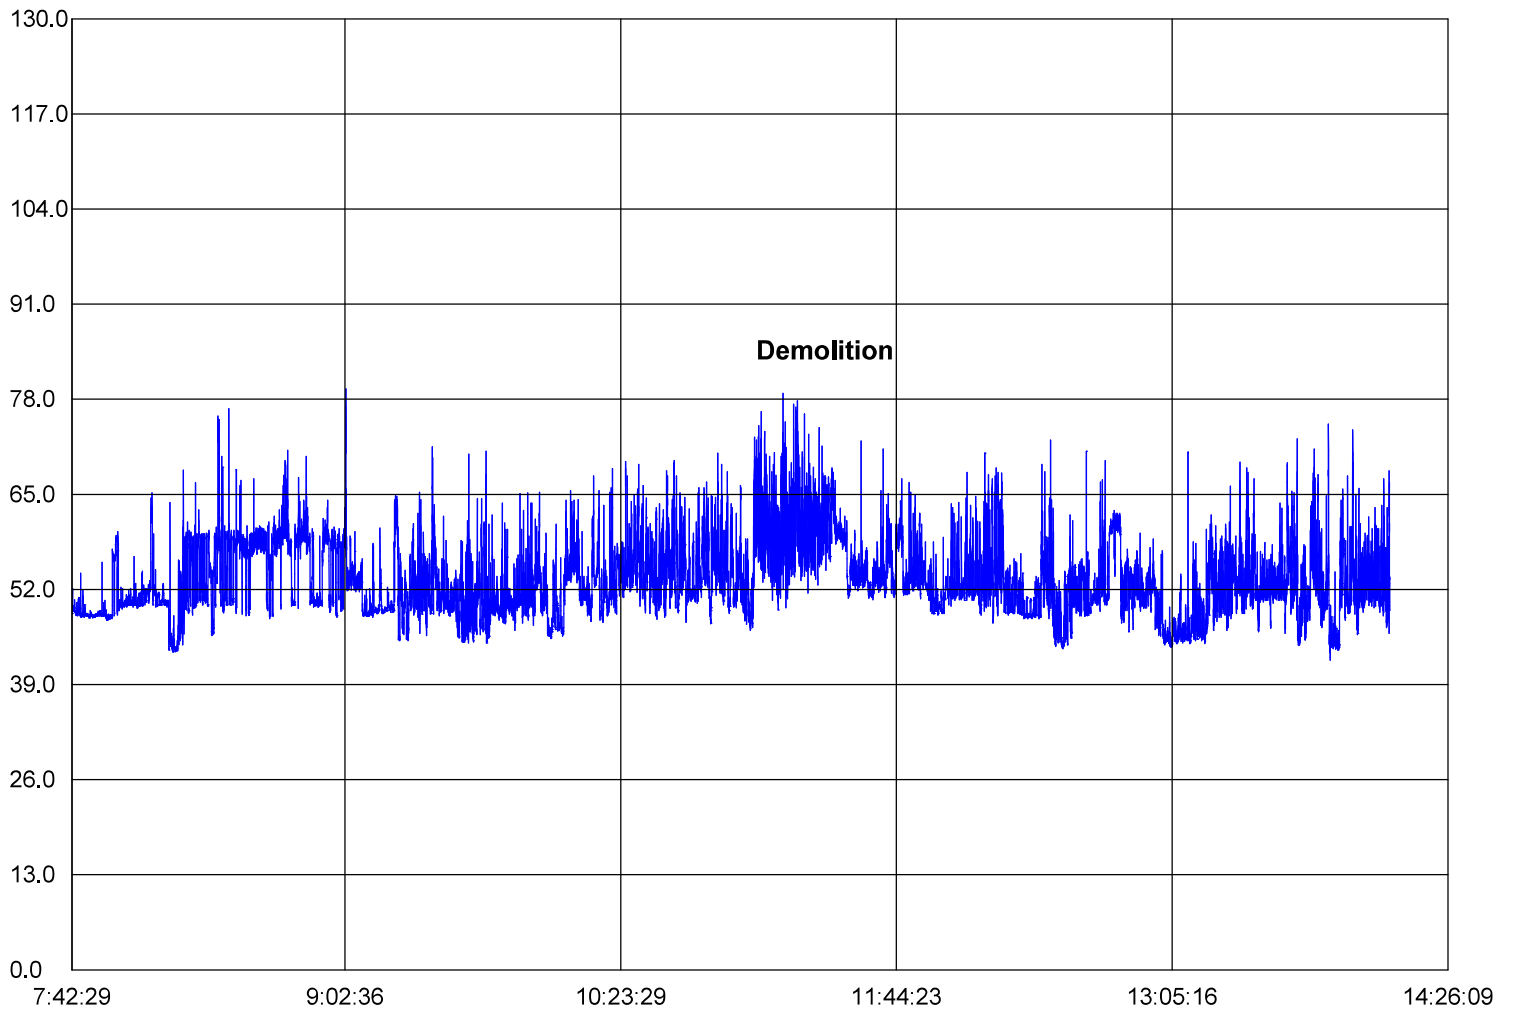
Library

Start Time: 19-09-2019,7:42:29  
Maxnum: 79.40 19-09-2019,9:02:54  
Minnum: 42.30 19-09-2019,13:51:40  
Sample Rate: 1.00  
Average: 53.19

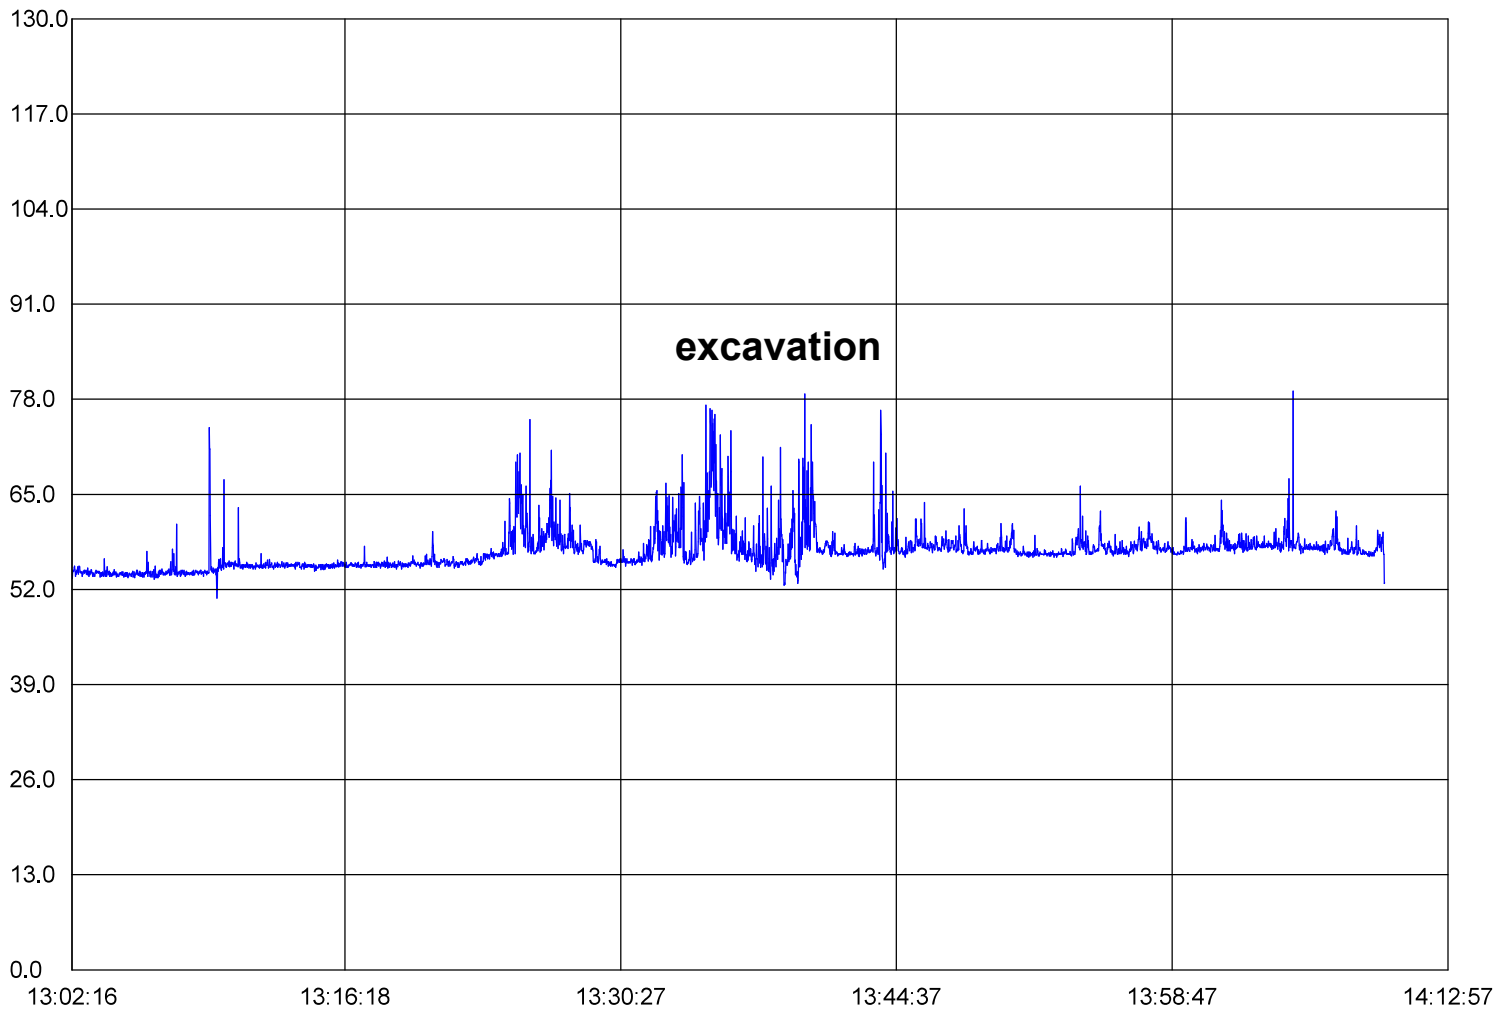
**Basement Hallway PM**

Start Time: 19-09-2019,13:02:16  
Maxnum: 79.10 19-09-2019,14:05:00  
Minnum: 50.80 19-09-2019,13:09:43  
Sample Rate: 1.00  
Average: 57.18
