DoB Special Inspection Agency #0230	REPORT #
INSPECTION REPORT	CAMDIES TAVEN

Project: (Greenacres School		Date: 09/20/19	
Address: 41 Huntington Avenue, Scarsdale NY 10583		Job ID / MU #:		
Client: Park East Construction		Weather: Sunny(AM)		
Inspection '	Tune at the late to	Contractor: Park F	Foot	
Present At S	Type: Noise and Dust Monitoring Site: 7:00AM	Sub-Contractor:	zast

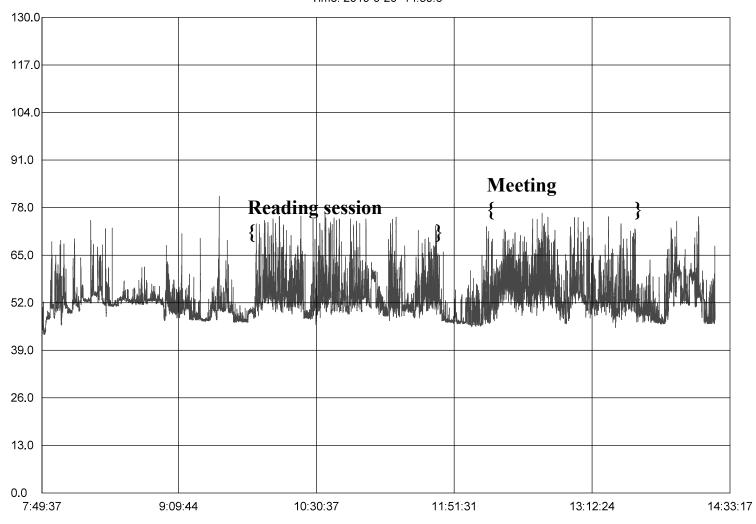
Sample Rate: 1.00 Average: 53.26 Library

Standard Sound Level Meter RealTime Graph Time: 2019-9-20 14:39:6

Start Time:
 20-09-2019,7:49:37

Maxnum:
 81.10
 20-09-2019,9:33:39

Minnum:
 43.30
 20-09-2019,7:50:45

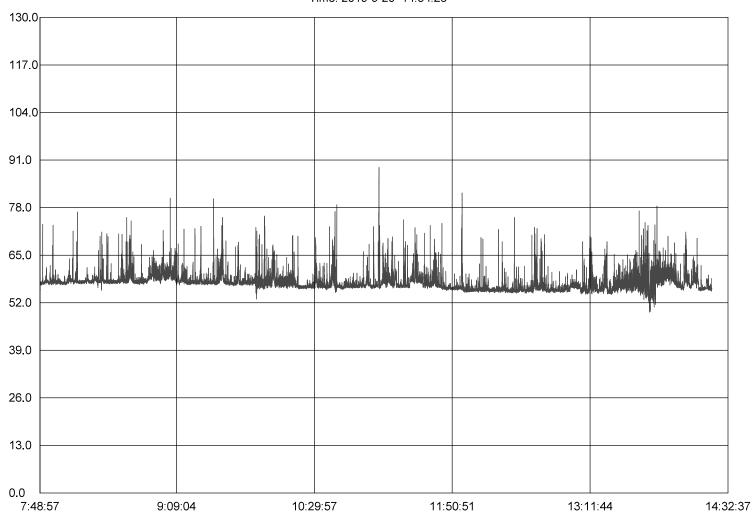
Basement Hallway

Standard Sound Level Meter RealTime Graph Time: 2019-9-20 14:34:28

Start Time: 20-09-2019,7:48:57

Maxnum: 89.00 20-09-2019,11:07:54 Minnum: 49.40 20-09-2019,13:46:41

Sample Rate: 1.00 Average: 57.56
