INSPECTION REPORT

Project: Greenacres School	Date: 09/23/19
Address: 41 Huntington Avenue, Scarsdale NY 10583	Job ID / MU #:
Client: Park East Construction	Weather: Sunny(AM)

Inspection Type: Noise and Dust Monitoring	Contractor: Park East
Present At Site: 7:00AM	Sub-Contractor:
General Area: Northern Yard of School	CM/Designer:
Specific Location: Northern Side of school 1st, 2nd floor, Basement	
Last Inspection:	Building Code Section:
Reviewed	Drawings:
Approved	Submittals
	Other:

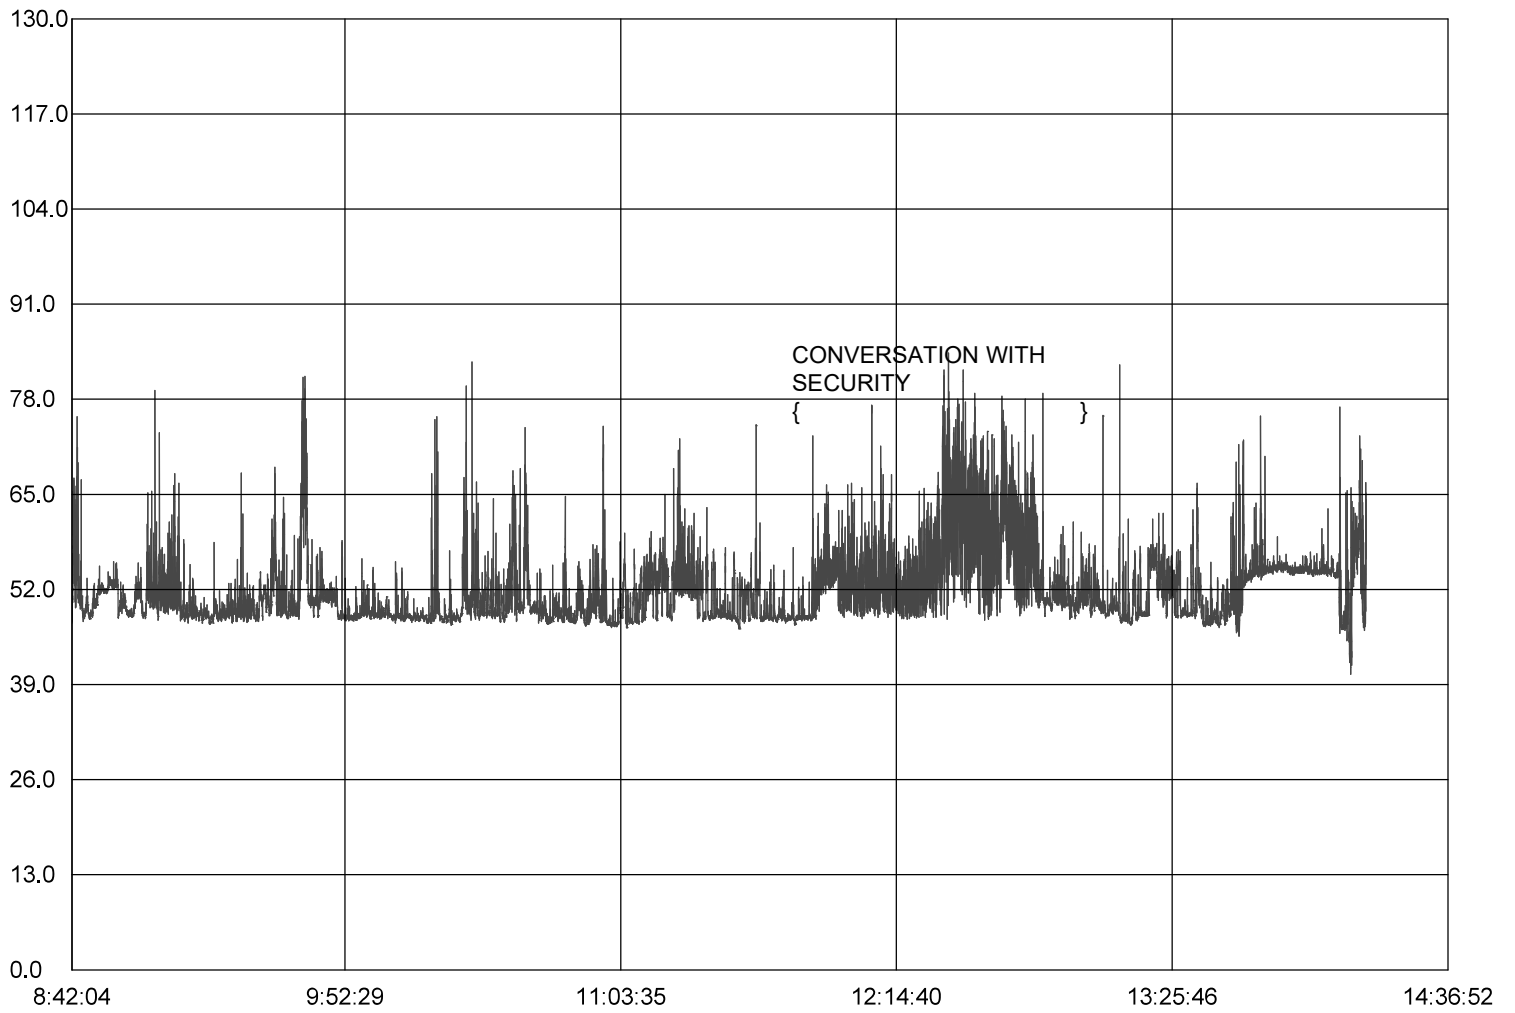
BASEMENT HALLWAY

Standard Sound Level Meter RealTime Graph
Time: 2019-9-23 14:38:56

Start Time: 23-09-2019,8:42:04
Maxnum: 84.30 23-09-2019,12:28:05
Minnum: 40.40 23-09-2019,14:11:49
Sample Rate: 1.00
Average: 51.83

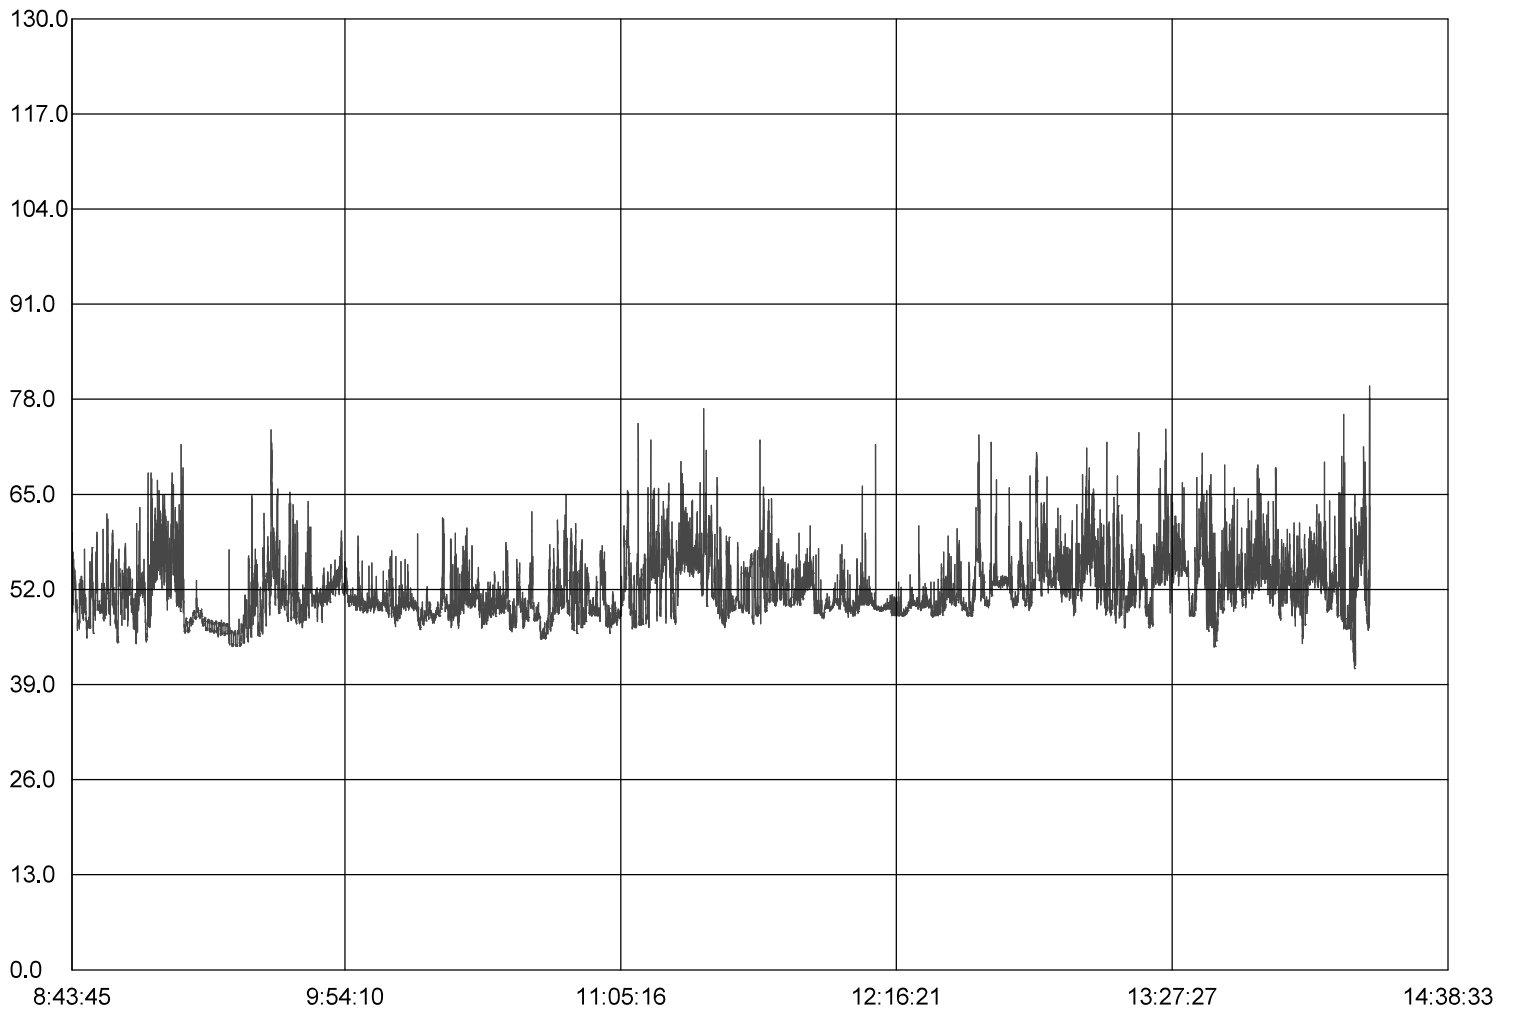
LIRBARY

Standard Sound Level Meter RealTime Graph
Time: 2019-9-23 14:36:40

Start Time: 23-09-2019,8:43:45
Maxnum: 79.80 23-09-2019,14:18:20
Minnum: 41.20 23-09-2019,14:14:28
Sample Rate: 1.00
Average: 51.90
