## **IPAL** INSPECTION REPORT

Project: (	Greenac	res Schoo	ol				Date: 09/24	4/19	
Address: 41 Huntington Avenue, Scarsdale NY 10583					Job ID / MU #	<b>#</b> :			
Client: Park East Construction					Weather: Sunny(AM)				
Inspection '	Type: NL	aise and I	Dust Monito		Contract	or: Park F	last		
Present At S	Site: $7 \cdot$	00AM	Just Monito	oring	Sub-Cont		asi		
General Are			d of School		CM/Desig				
	1101		Side of scho						
Last Inspec				01 130, 2110		Code Sectio			
Dents and	Drawing	S:							
Reviewed	Submittals								
Approved Other:									
Deficiency:					Resolutio	00.			
Denerency.					Resolution				
Request For									
Non-Confor	-			NCD	1				
RFI # :	Issued	RFI # :	Answered	NCR # :	Issued	NCR # :	Resolved	NCR # : Open	
Observation

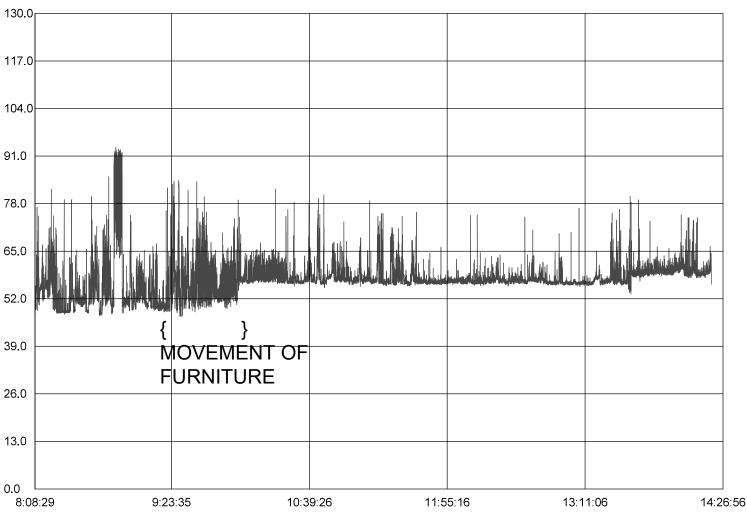
## **BASEMENT HALLWAY**

Standard Sound Level Meter RealTime Graph Time: 2019-9-24 14:36:56

Start Time:
 24-09-2019,8:08:29

Maxnum:
 93.40
 24-09-2019,8:52:59

Minnum:
 47.00
 24-09-2019,8:08:30

Average:
 57.20

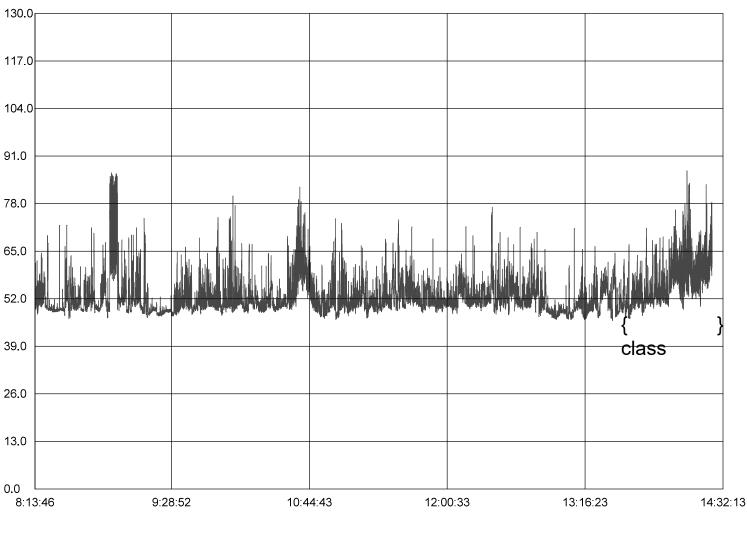
LIBRARY

Standard Sound Level Meter RealTime Graph Time: 2019-9-24 14:32:56

Start Time:
 24-09-2019,8:13:46

Maxnum:
 87.00
 24-09-2019,14:12:30

Minnum:
 46.00
 24-09-2019,13:31:27

Average:
 52.66
