INSPECTION REPORT

Project: Greenacres School Date: 09/27/19						7/19					
Address: 41 Huntington Avenue, Scarsdale NY 10583						Job ID / MU #	‡ :				
Client: Park East Construction							Weather: Suny	(AM)			
Inspection Type: Noise and Dust Monitoring						Contractor: Park East					
Present At Site: 7:00AM					Sub-Contractor:						
General Are			rd of Schoo		CM/Designer:						
Specific Location: Northern Side of school 1st, 2nd floor, Basement											
Last Inspection:					Building Code Section:						
Reviewed	Drawings										
	Submitta	ils									
Approved	Other:	Other:									
Deficiency:					Resoluti	on:					
Request Fo	r Informa	tion		-							
Non-Confor											
RFI # :	Issued	RFI# :	Answered	NCR # :	Issued	NCR # :	Resolved	NCR # : Open			
RF1 # Issued NCR # Issued NCR # Resolved NCR # Open Observations/Notes:											
			construction in	the perime	er offhe	school was	monitored 1	ising a sound			
			taken in the li					using a sound

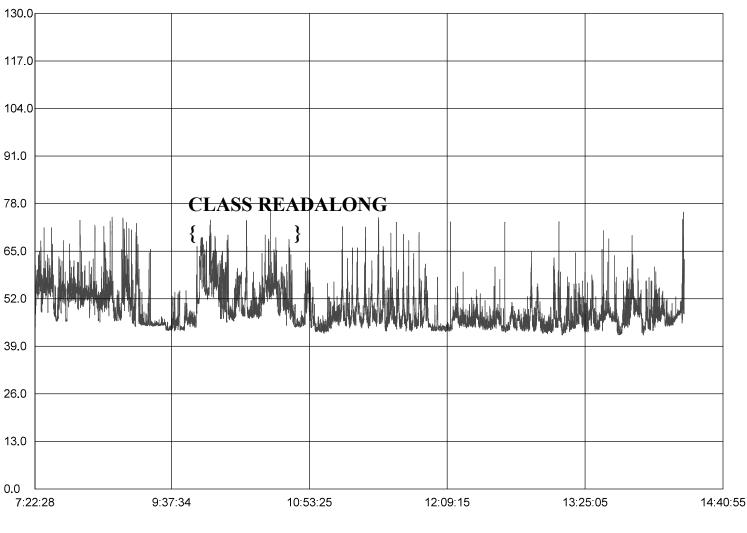
LIBRARY DATA

Maxnum:
 76.40
 27-09-2019,10:32:08

Minnum:
 42.10
 27-09-2019,13:12:29

Average:
 48.86

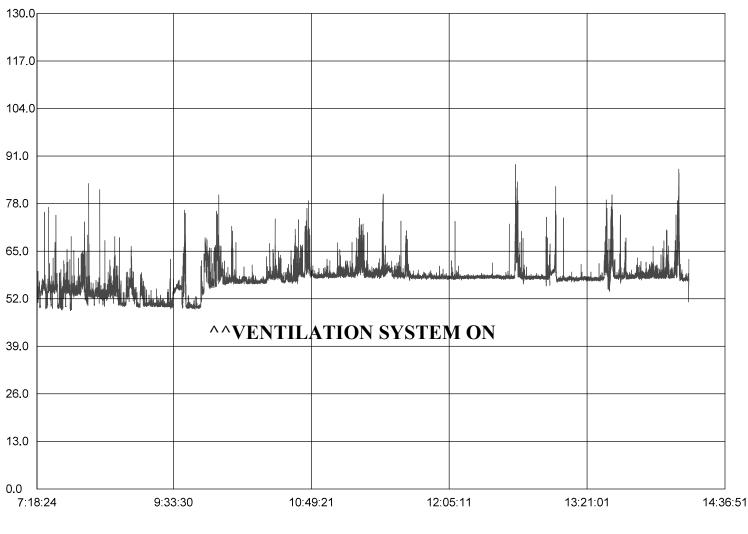
BASEMENT HALLWAY

*all spikes due to classroom noise

Maxnum:
 88.70
 27-09-2019,12:41:42

Minnum:
 48.00
 27-09-2019,8:18:25

Average:
 57.22
