INSPECTION REPORT

Project: GREENACRES ELEMENTARY SCHOOL						Date: 01/14/2020					
Address: 41 HUNTINGTON AVENUE, SCAR				SDALE	ENY	Job ID / MU #:					
Client: PARK EAST CONSTRUCTION						Weather: CLOUDY					
Inspection '	Type: 3 to	NOT AND		ONTEOD	Contract	or					
Inspection Type: NOISE AND DUST MONITOR Present At Site: 7:00AM					Sub-Contractor:						
		JAWI			CM/Designer:						
General Area: Specific Location:						CM/Designer:					
Last Inspec					Building Code Section:						
Last Hispec		c.		<u></u>	Building Code Section.						
Reviewed		Drawings:									
Approved	Other:	Submittals									
	ouler:	Other:									
Deficiency:					Resoluti	on:					
					÷						
Request For	r Informat	ion:		- 99	0.5						
Non-Confor	mance Re	port:						n			
RFI#:	RFI # : Issued RFI # : Answered NCR # : Issued NCR # : Resolved NCR # : Open										
Observation	ns/Notes:										
Noise caused by ongoing construction in the perimeter of the school was monitored using a sound level meter. Readings were taken in the basement hallway (20 feet from construction) next to the work performed today.

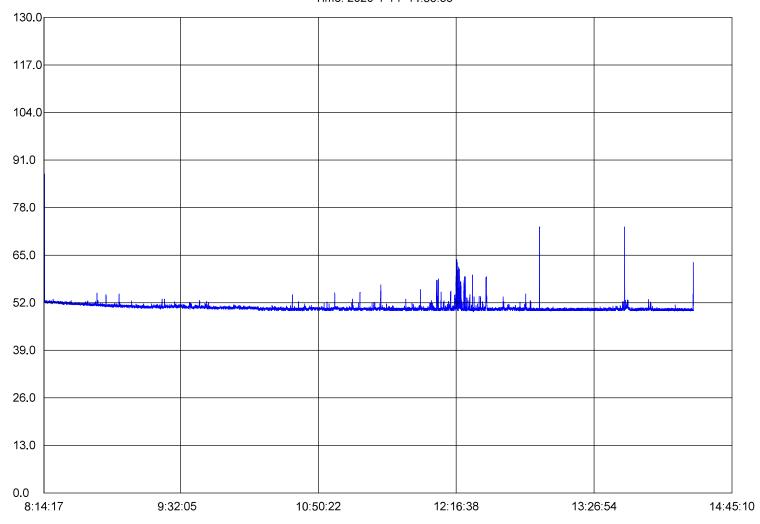
Standard Sound Level Meter RealTime Graph Time: 2020-1-14 14:56:33

Start Time: 14-01-2020,8:14:17 Maxnum: 87.20 14-01-2020,9:54:30 Minnum: 49.50 14-01-2020,12:24:43

Sample Rate: 1.00 Average: 50.64 2nd floor storage

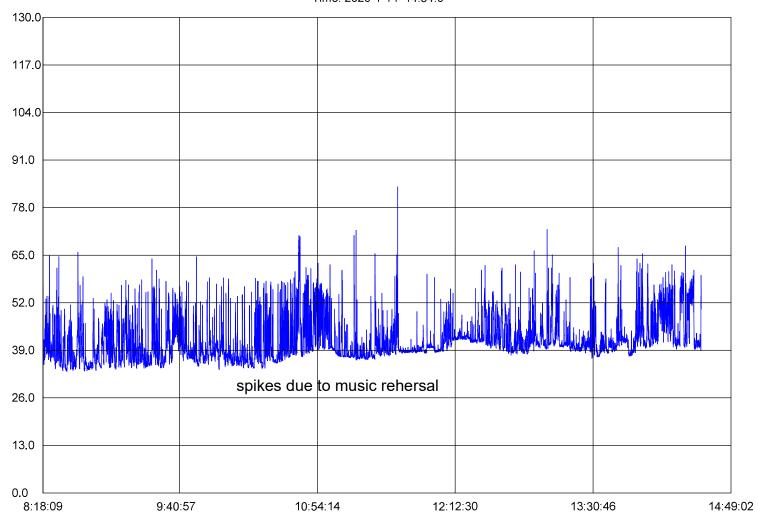
Standard Sound Level Meter RealTime Graph Time: 2020-1-14 14:54:0

Start Time: 14-01-2020,8:18:09

Maxnum: 83.70 14-01-2020,11:52:22 Minnum: 33.20 14-01-2020,9:56:32

Sample Rate: 1.00 Average: 41.50 basement hallway
