Project: GREENACRES ELEMENTARY SCHOOL	Date: 01/27/2020
Address: 41 HUNTINGTON AVENUE, SCARSDALE NY	Job ID / MU #:
Client: PARK EAST CONSTRUCTION	Weather: CLOUDY

Inspection Type: NOISE AND DUST MONITOR	Contractor:
Present At Site: 7:00AM	Sub-Contractor:
General Area:	CM/Designer:
Specific Location: N and S side of school basement, 1st floor, 2nd floor	
Last Inspection:	Building Code Section:
Reviewed	Drawings:
Approved	Submittals
	Other:

INSPECTION REPORT

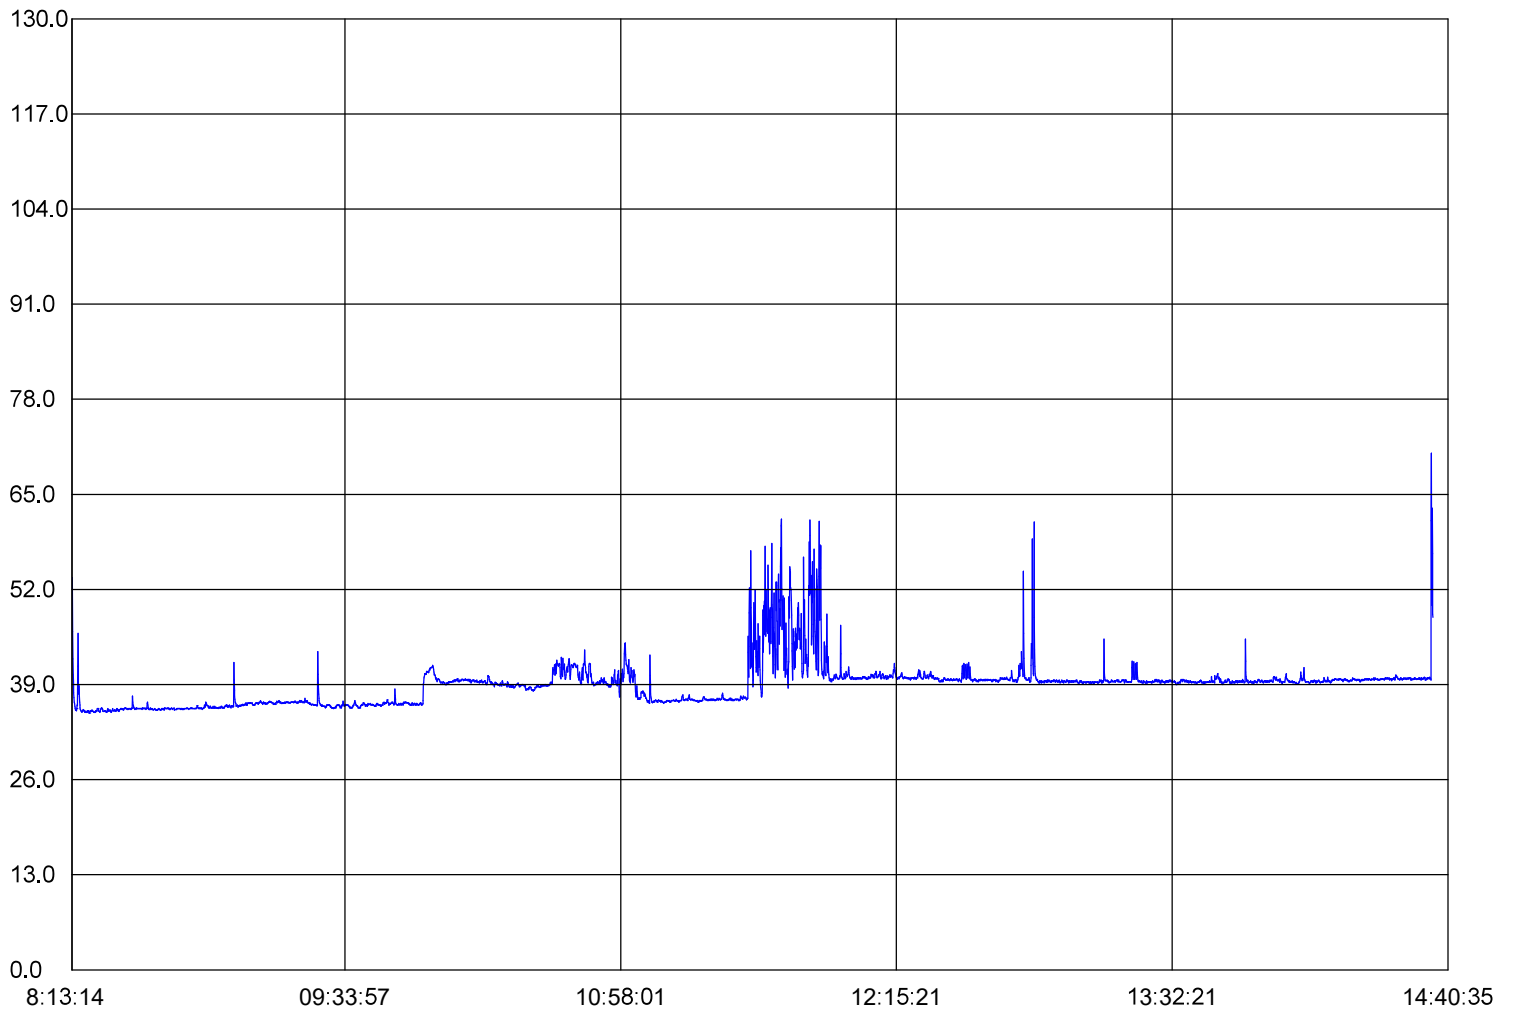
BASEMENT HALLWAY

Standard Sound Level Meter RealTime Graph
Time: 2020-01-27 14:53:16

Start Time: 27-01-2020,8:13:49
Maxnum: 71.23 27-01-2020,11:48:34
Minnum: 36.45 27-01-2020,08:14:52
Sample Rate: 1.00
Average: 42.89
