INSPECTION RI	EPORT
---------------	-------

Project:	GREENACRES ELEMENTARY SCHO	OOL	Date: 01/06/2019				
Address:	41 HUNTINGTON AVENUE, SCARSDA	ALE NY	Job ID / MU #:				
Client:	PARK EAST CONSTRUCTION		Weather:				
ai.	Inspection Type: NOISE AND DUST MONITORING Contractor:						
Present At		Sub-Contractor:					
General Are	500 c 2 m 2	CM/Designer:					
Specific Loc	cation: NORTHERN SIDE OF THE SCHO	OL BASEMENT, 1	ST FLOOR, 2ND FLOOR				
Last Inspec	ction:	Building Code Section	n:				
Reviewed	Drawings:						
Approved	Submittals						
Approved	Other:						
Deficiency:		Resolution:					
Deficiency:		Resolution:					
Request Fo	r Information:						
Non-Confor	rmance Report:						
RFI # :	Issued RFI#: Answered NCR#:	Issued NCR # :	Resolved NCR # : Open				
Observation	ns/Notes:	•					
Noise caused by ongoing construction in the perimeter of the school was monitored using a sound level meter. Readings were taken in the basement hallway (20 feet from construction) next to the work performed today.  An average noise level of 50.81 db was measured for the day.  Dust levels within the perimeter of the school were measured. These readings can be found in the chart on the next page. Daily PM

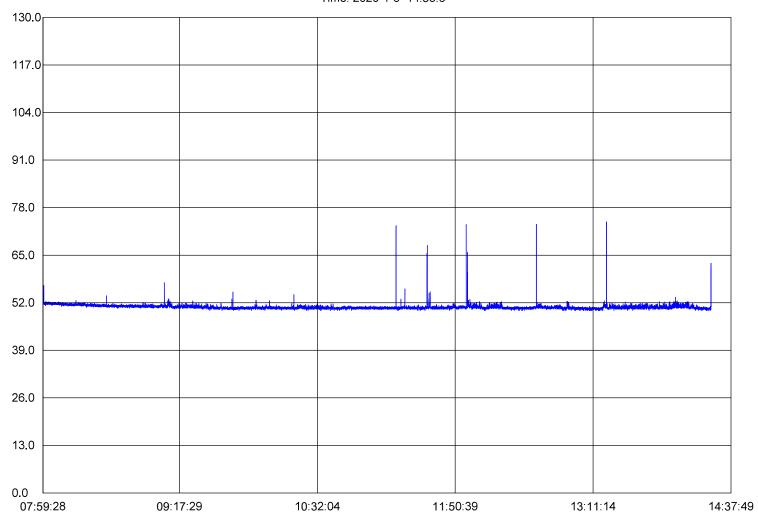
### Standard Sound Level Meter RealTime Graph Time: 2020-1-6 14:53:8

Start Time:
 06-01-2020,07:59:28

Maxnum:
 74.10
 06-01-2020,14:14:58

Minnum:
 49.90
 06-01-2020,11:26:25

Sample Rate: 1.00 Average: 50.81 **BASEMENT HALLWAY**
