INSPECTION REPORT

REPORT #
78

Project:	GREENACRES ELEMENTARY SCHOOL					Date: 01/08/2020			
Address:	41 HUNTINGTON AVENUE, SCARSDAL				ENY	Job ID / N	MU #:		
1 6360	PARK EAST CONSTRUCTION						Weather:	SUNNY	
Inspection'	Inspection Type: NOISE AND DUST MONITORING Contractor:								
Present At S				11010110	Sub-Cont				
General Are	(24) (20)(1)				CM/Desig				
	PHE P. 2003	ORTHERN S	SIDE OF T			**CONTENT	ST FLOO	OR, 2ND FLOOR	
Last Inspec						Code Section			
Reviewed	Drawing	s:		-					
Approved	Submitta	als							
Approved	Other:								
Deficiency:					Resolutio	nn:			
Deficiency.					resolution	ו••			
D	. T. C.								
Request For									
Non-Confor	_			NGD #	, ,	NGD "		NOD#	
RFI # :	Issued		Answered	NCR # :	Issued	NCR # :	Resolve	red NCR # : Open	
Observation	ns/Notes:								
Noise caus	sed by or	ngoing const	ruction in t	he perimete	r of the s	chool was	monitore	ed using a sound	
		ngs were take	en in the ba	sement hall	way (20	feet from	construct	tion) next to the work

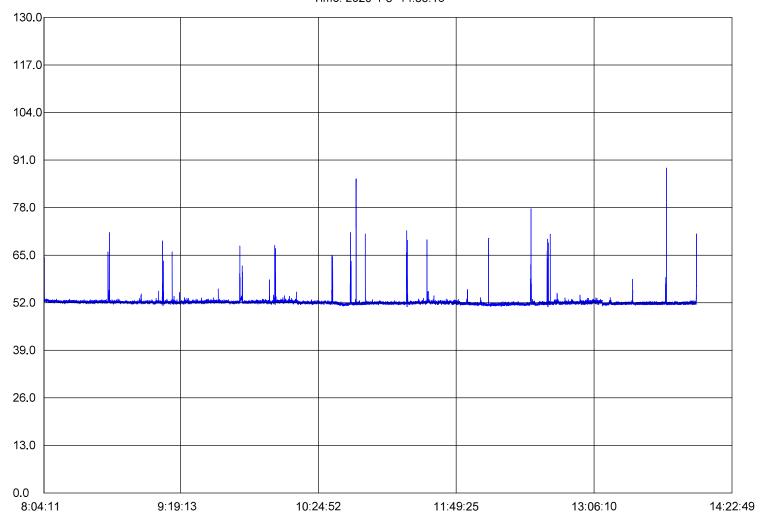
Sample Rate: 1.00 Average: 51.28 **BASEMENT HALLWAY**

Maxnum: 88.80 08-01-2020,12:31:09 Minnum: 50.90 08-01-2020,09:15:42

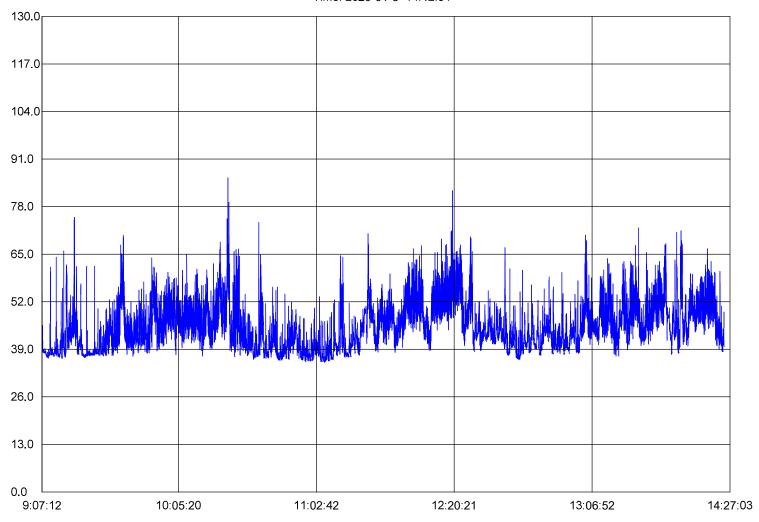
2ND FLOOR STORAGE

Maxnum: 81.20 08-01-2020,10:22:03 Minnum: 32.40 08-01-2020,11:13:21

Sample Rate: 1.00 Average: 43.49
