INSPECTION REPORT

Project: GREENACRES ELEMENTARY SCHOOL					Date: 01/09/2019			
Address: 41 HUNTINGTON AVENUE, SCARS					Job ID / MU #:			
Client: PARK EAST CONSTRUCTION					Weather: SUNNY			
Increation '	Timera			Contractory				
Inspection Descent At (UST REPORT	Contractor:				
Present At S	1.0	DOAM		Sub-Contractor:				
General Area: CM/Designer:								
Specific Location: NORTHERN SIDE OF THE SCHOOL BASEMENT, 1ST FLOOR, 2ND FLOOR								
Last Inspec				Building Code Section:				
Reviewed	-	Drawings:						
Approved	2.505	Submittals						
. Fr	Other:							
Deficiency:				Resolution:				
Request For	r Informa	ation:						
Non-Confor								
RFI # :	Issued		swered NCR # :	Issued NCR # :	Resolved NCR # : Open			
Observations/Notes:								
00000114400								
Noigo ag	ugod bu	ongoing constr	nation in the norim	ator of the school w	was monitored using a sound

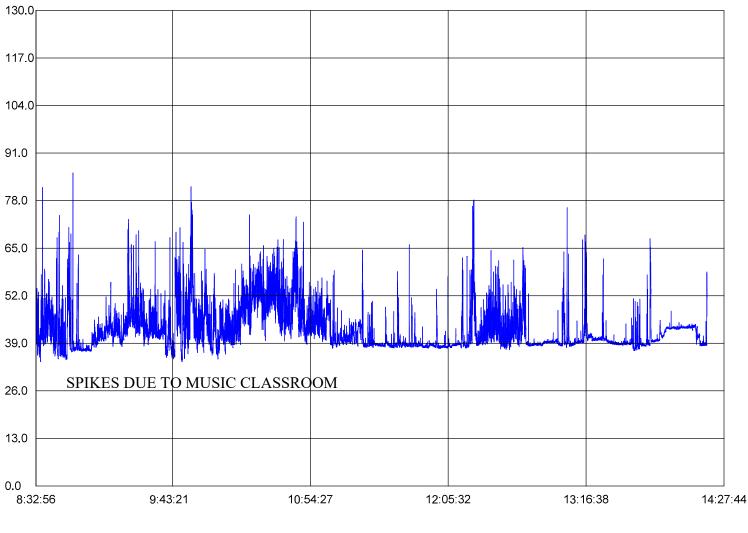
BASEMENT HALLWAY

Maxnum:
 85.60
 09-01-2020,9:52:00

Minnum:
 34.00
 09-01-2020,9:35:16

Average:
 42.57

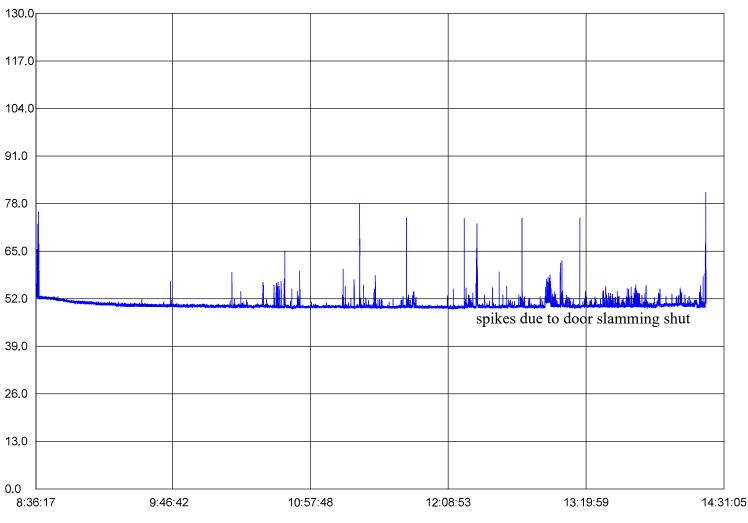
2nd floor storage closet

Maxnum:
 81.10
 09-01-2020,15:21:45

Minnum:
 49.10
 09-01-2020,13:11:22

Average:
 50.30
