## INSPECTION REPORT

| Project: <b>Greenacres School</b> | Date <b>10/07/19</b> |

| Inspection Type: <b>Noise and Dust Monitoring</b> | Contractor: <b>Park East</b> |

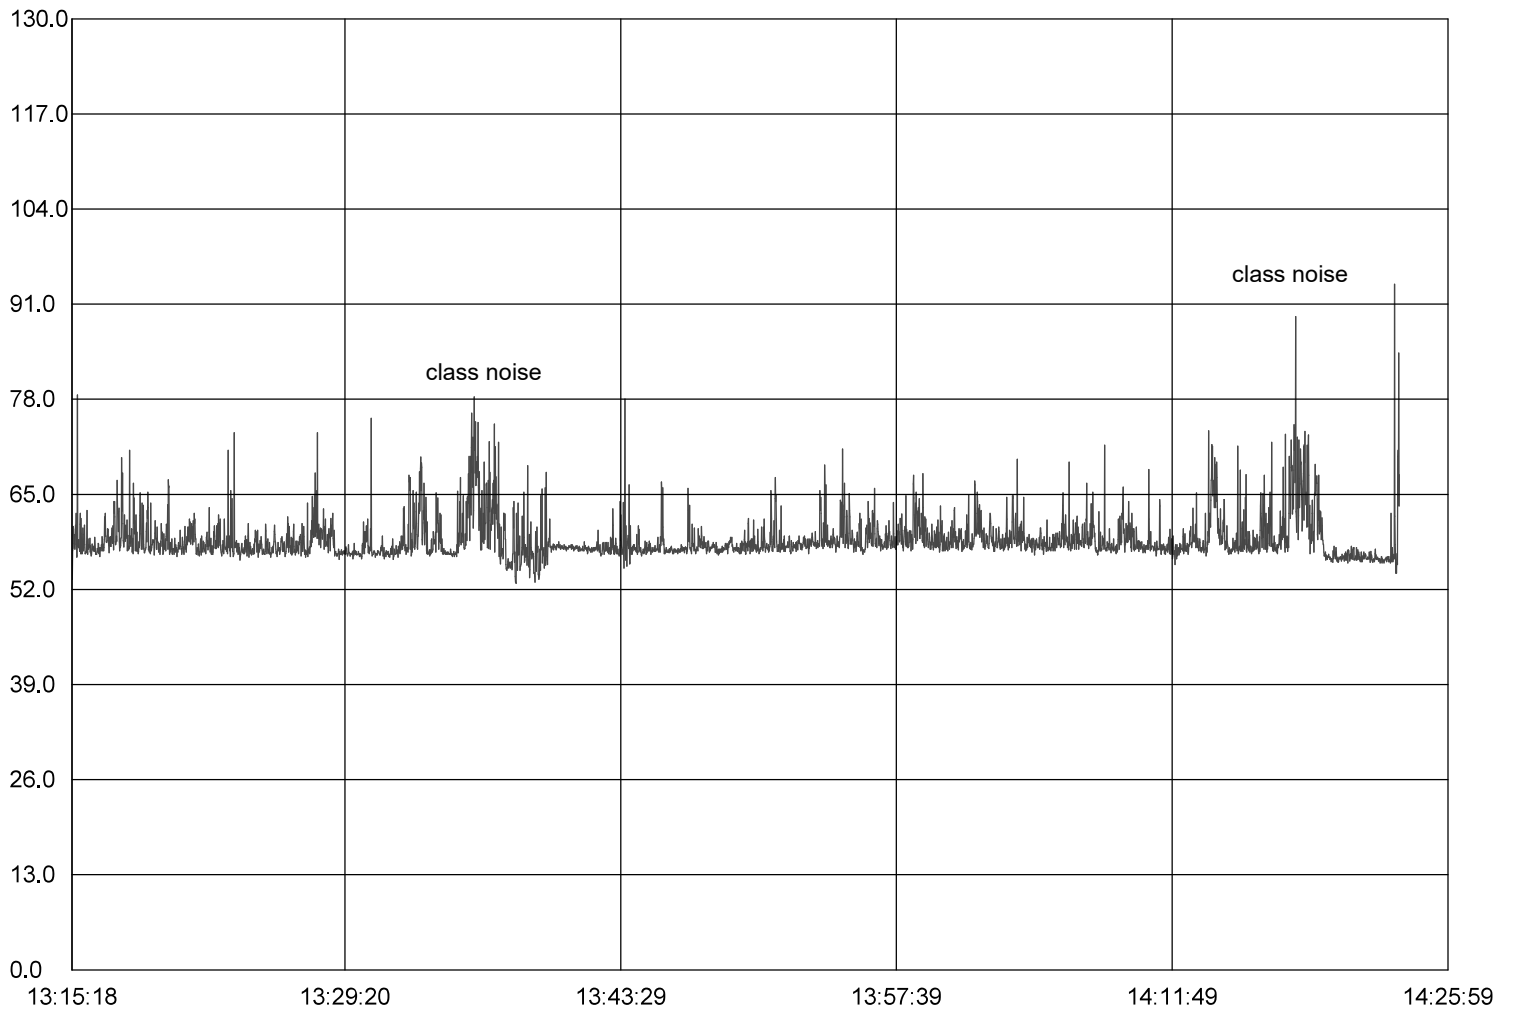
basement hallway

Start Time: 07-10-2019,13:15:18  
Maxnum: 93.70 07-10-2019,14:23:14  
Minnum: 52.80 07-10-2019,13:38:07  
Sample Rate: 1.00  
Average: 58.80

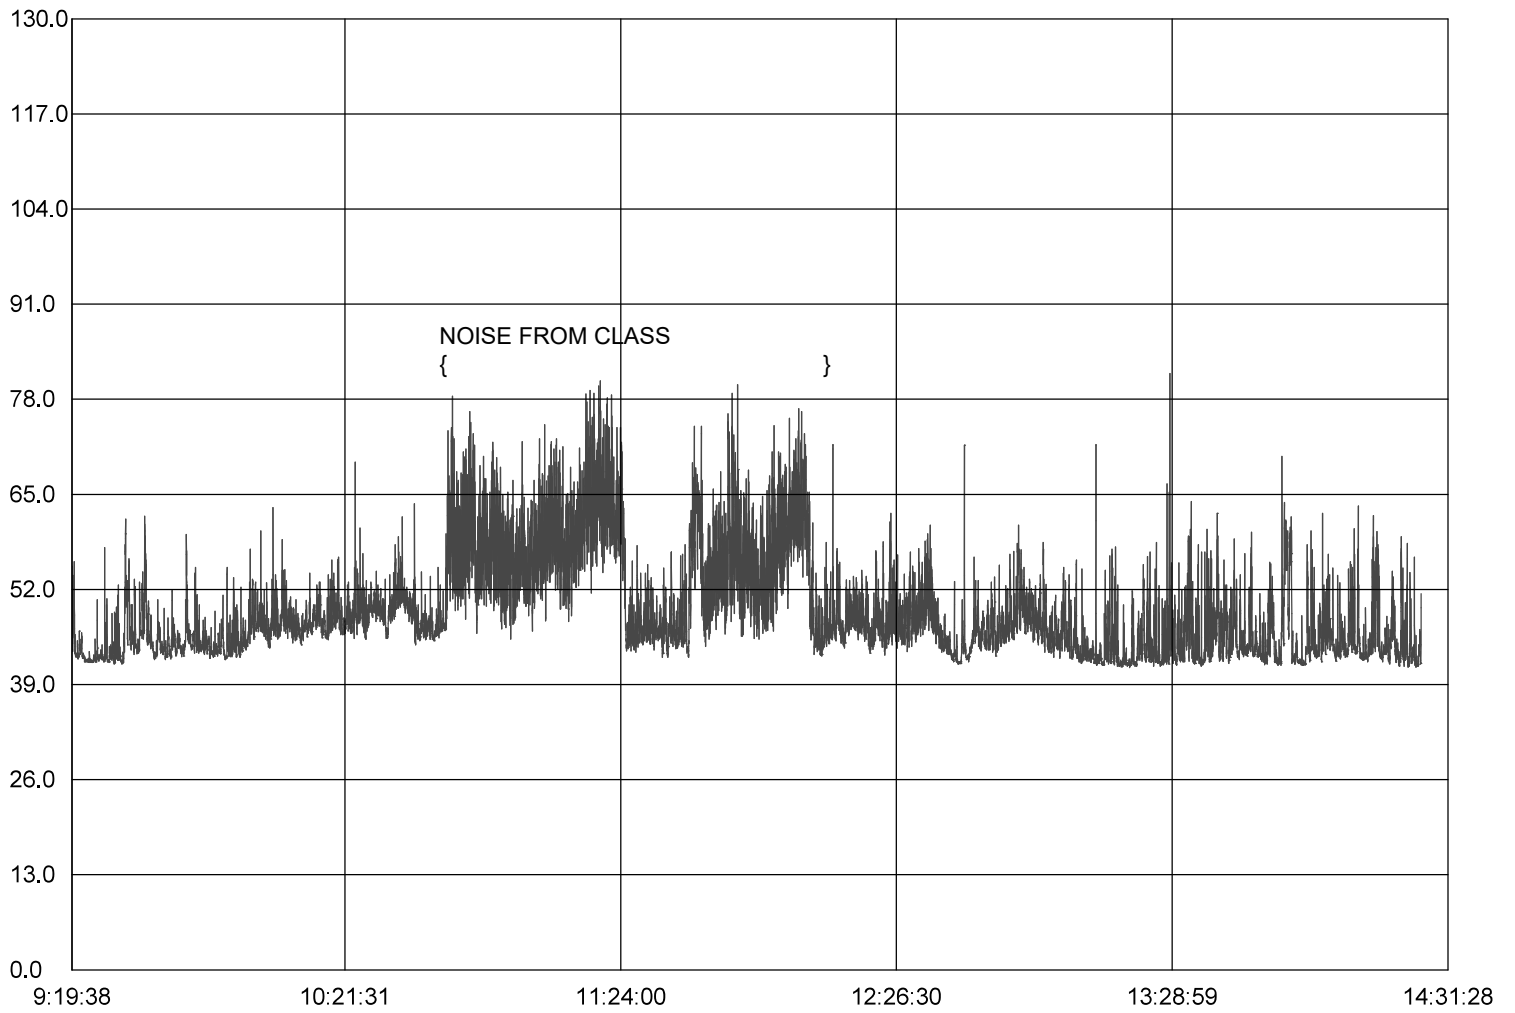
LIBRARY

Start Time: 07-10-2019,9:19:38  
Maxnum: 81.50 07-10-2019,13:28:30  
Minnum: 41.30 07-10-2019,13:19:22  
Sample Rate: 1.00  
Average: 48.91
