**Greenacres School**

Project: Greenacres School							DATE: 10/25/19		
Address: 41 Huntington Avenue, Scarsdale NY 10583						JOB ID: #39			
Client: Park East Construction					WEATHER: SUNNY				
Inspection '	Type: NL	siaa and D	ust Monito		Contract	or: Park E	act .		
Present At S	Site: 7:	oise and D	ust Monne	ring	Sub-Con		asi		
General Are			d of School		CM/Desig				
	1101		de of scho						
Last Inspec		ormem S	ide of scho	01 1St, ZHC		Code Sectio		=

**INSPECTION REPORT**

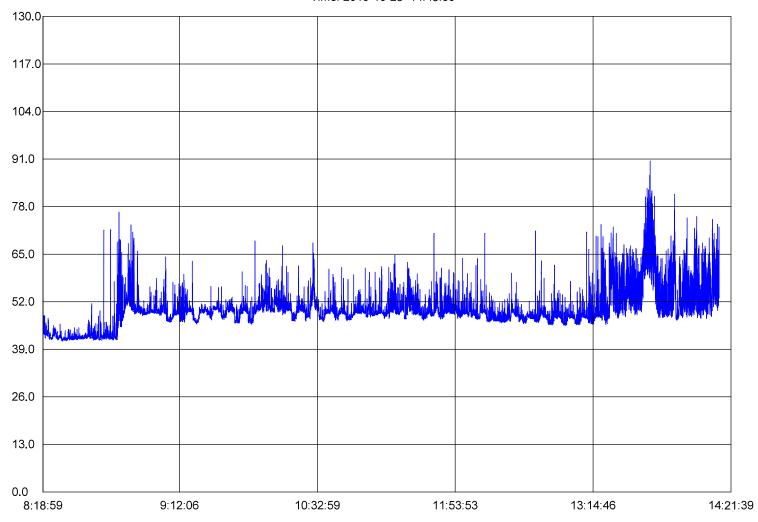
## Standard Sound Level Meter RealTime Graph Time: 2019-10-25 14:48:39

Start Time: 02-10-2019,8:18:59

Maxnum: 90.50 25-10-2019,13:48:18 Minnum: 41.30 25-10-2019,8:03:02

Average: 52.1
