| Project: <b>Greenacres School</b> | Date: <b>10/28/19</b> |

| Inspection Type: <b>Noise and Dust Monitoring</b> | Contractor: <b>Park East</b> |

## INSPECTION REPORT

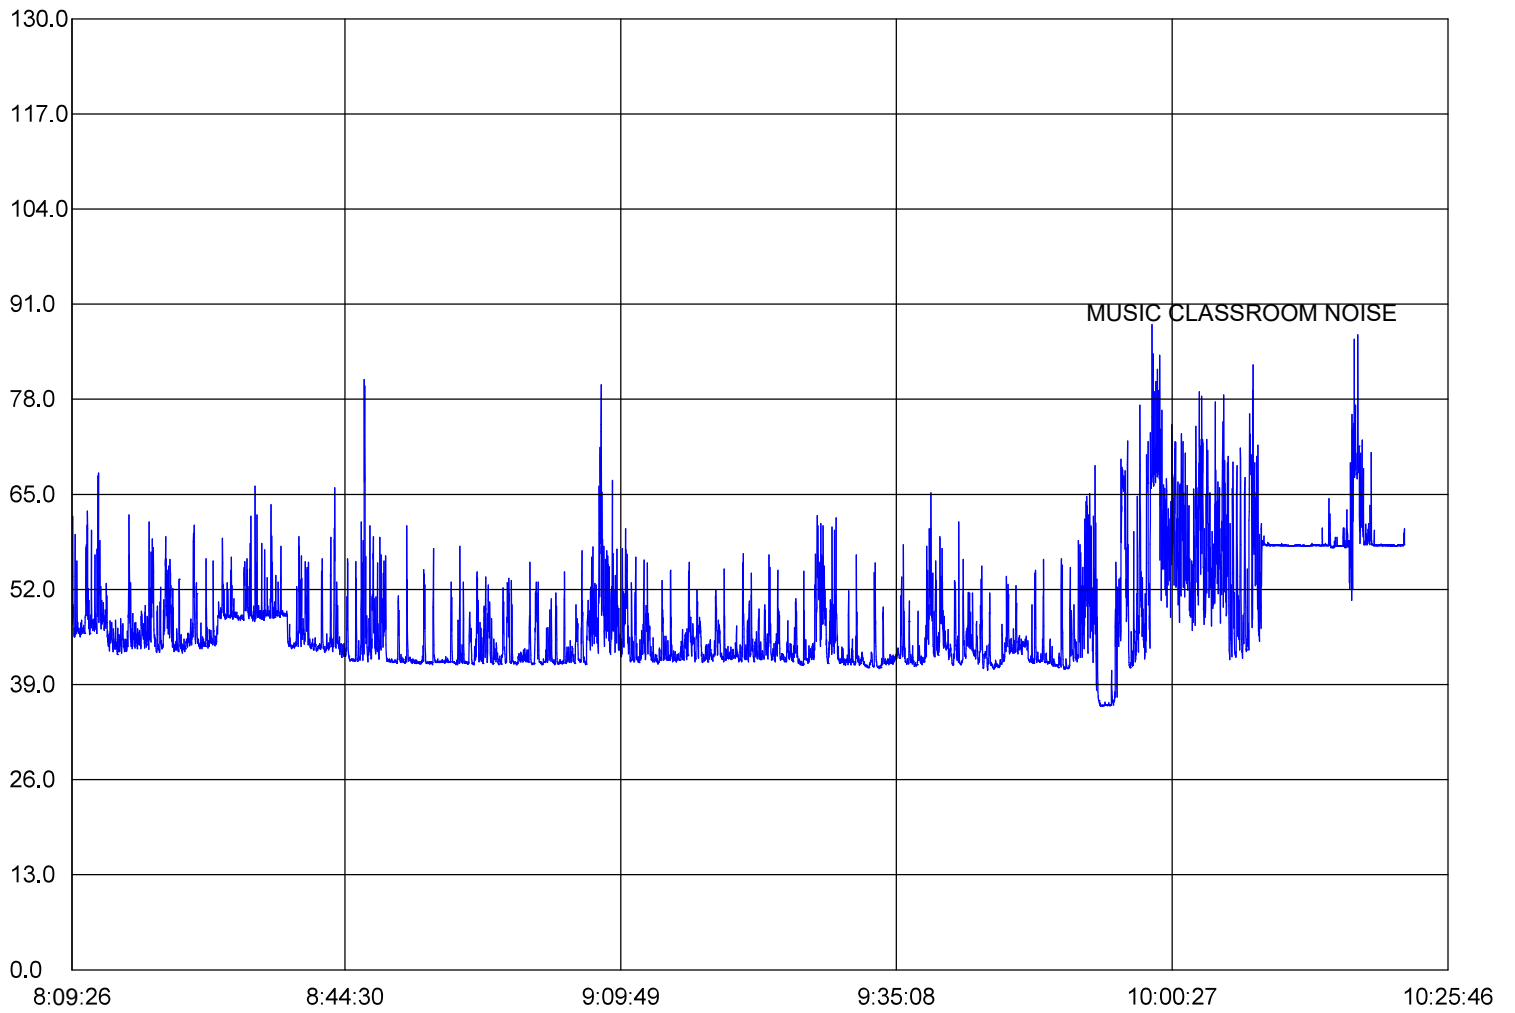
BASEMENT 1

Standard Sound Level Meter RealTime Graph  
Time: 2019-10-28 14:51:11

Start Time: 28-10-2019,8:09:26  
Maxnum: 88.20 28-10-2019,9:58:37  
Minnum: 36.00 28-10-2019,9:53:55  
Sample Rate: 1.00  
Average: 47.93

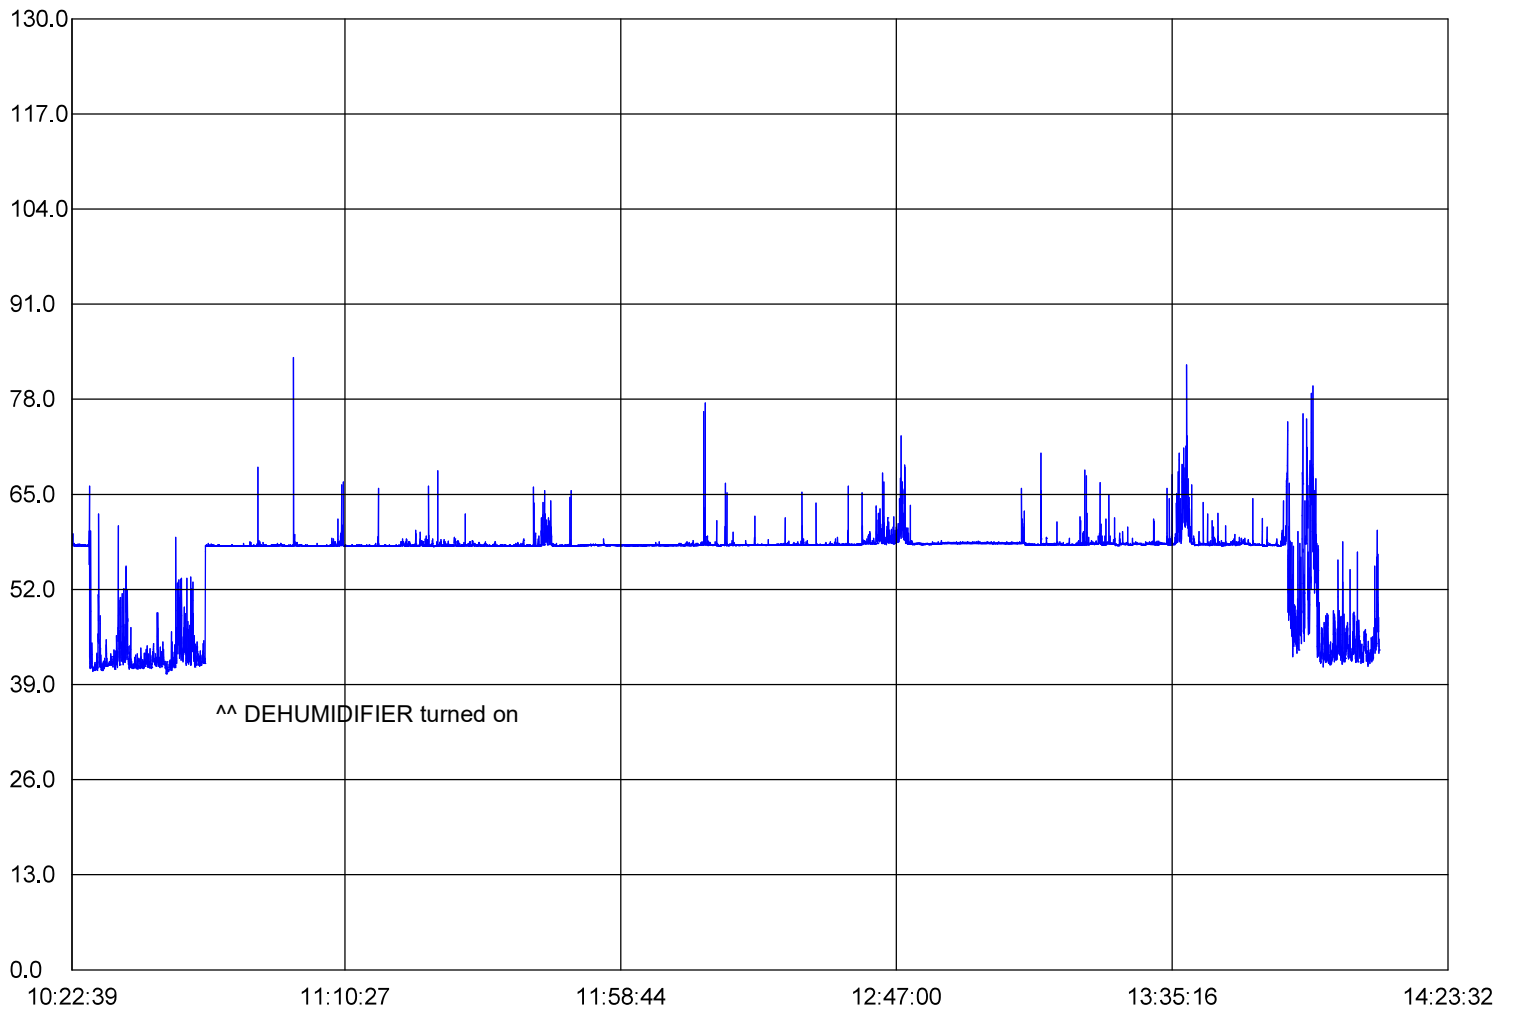
BASEMENT 2

Standard Sound Level Meter RealTime Graph  
Time: 2019-10-28 14:52:21

Start Time: 28-10-2019,10:22:39  
Maxnum: 83.70 28-10-2019,11:01:28  
Minnum: 40.50 28-10-2019,10:39:10  
Sample Rate: 1.00  
Average: 56.19
