| Project: <b>Greenacres School</b> | DATE: <b>11/04/19</b> |

| Inspection Type: <b>Noise and Dust Monitoring</b> | Contractor: <b>Park East</b> |

## INSPECTION REPORT

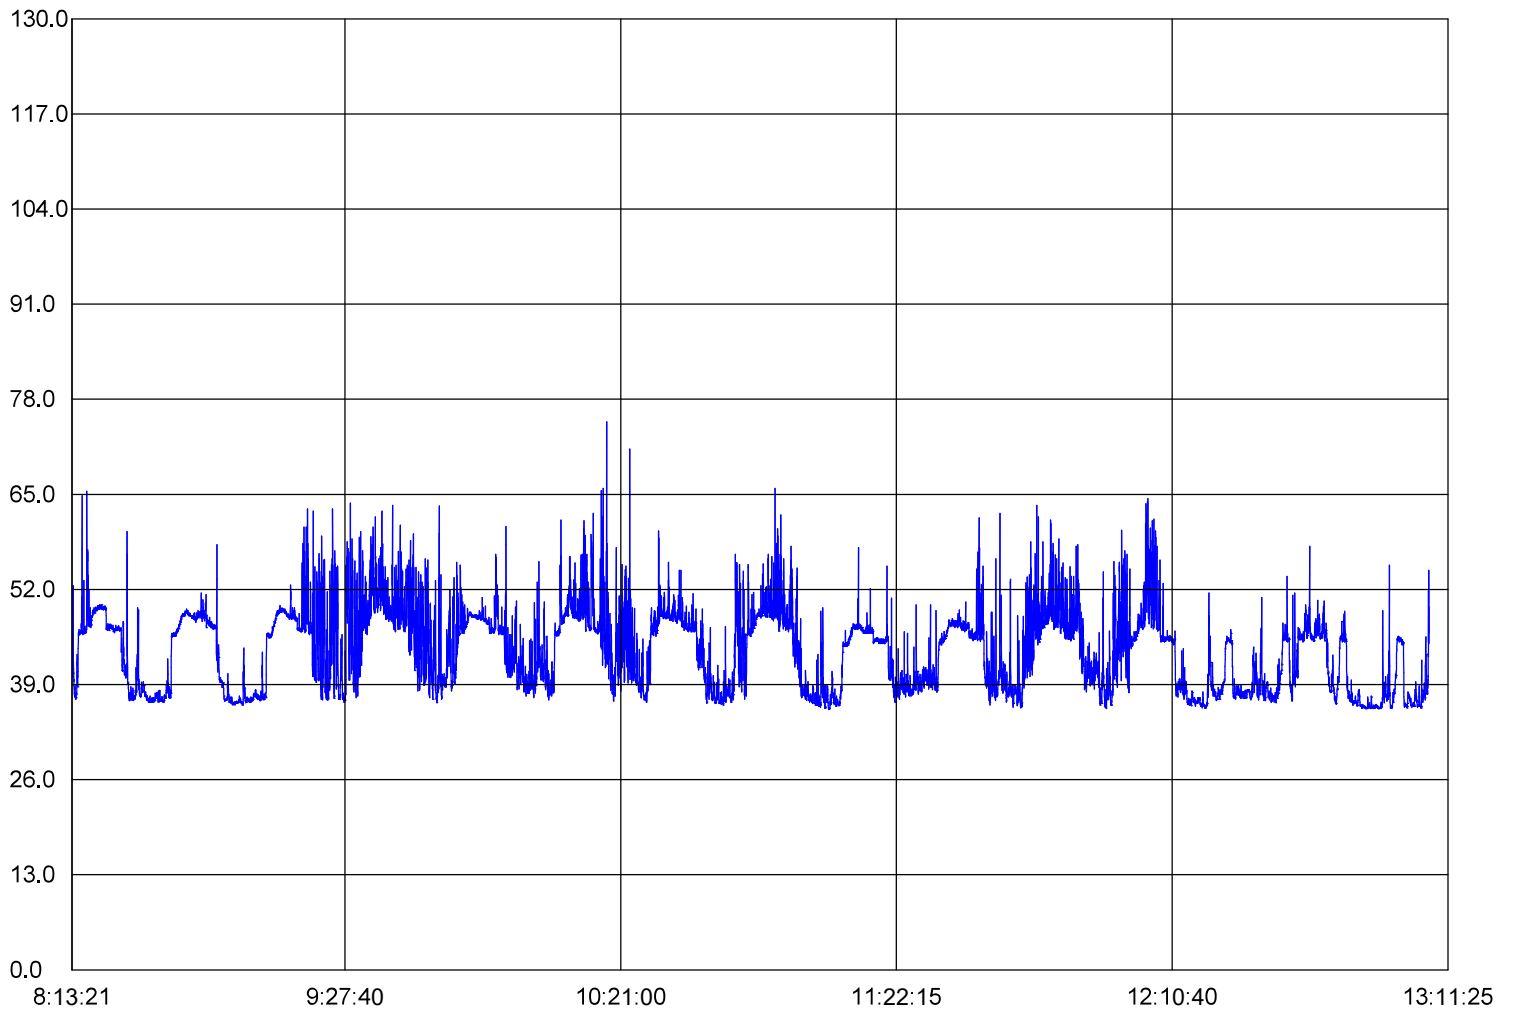
BASEMENT AM 1

Start Time: 4-11-2019,8:13:21  
Maxnum: 72.12 4-11-2019,11:19:10  
Minnum: 39.12 4-11-2019,12:12:38  
Sample Rate: 1.00  
Average: 49.12

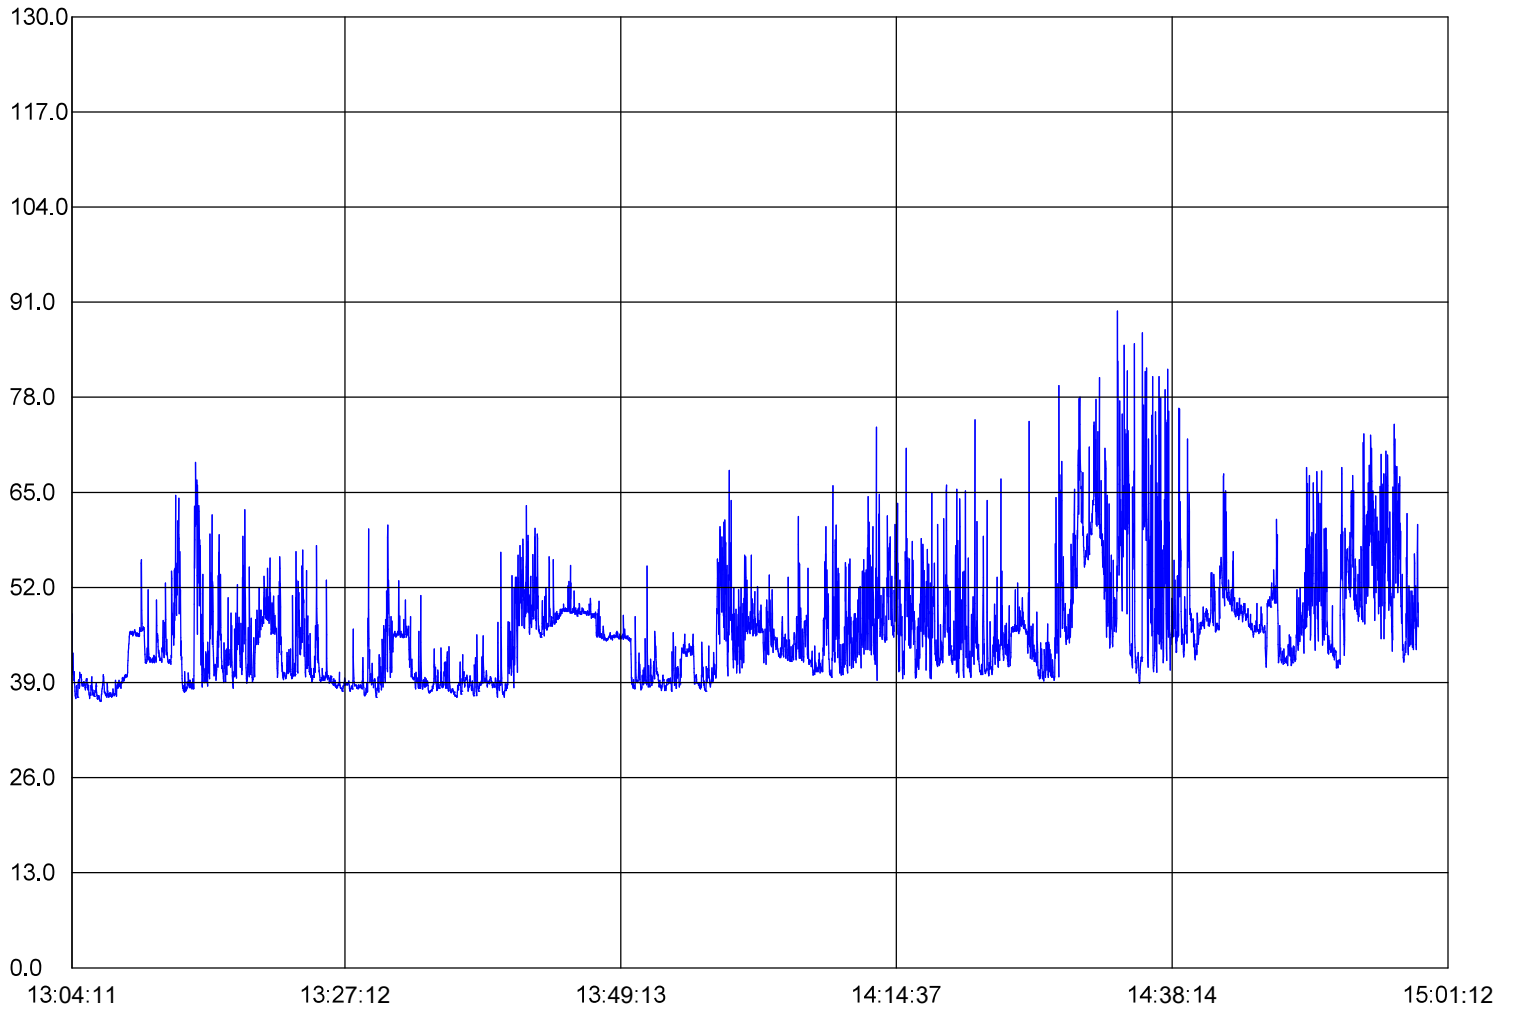
BASEMENT AM 2

Start Time: 4-11-2019,13:04:11  
Maxnum: 83.17 04-11-2019,11:25:39  
Minnum: 39.24 04-11-2019,13:01:12  
Sample Rate: 1.00  
Average: 49.02
