## INSPECTION REPORT

Project: <b>Greenacres School</b>	<b>DATE: 11/08/19</b>
Address: <b>41 Huntington Avenue, Scarsdale NY 10583</b>	<b>JOB ID:</b>
Client: <b>Park East Construction</b>	<b>WEATHER: SUNNY</b>

Inspection Type: <b>Noise and Dust Monitoring</b>	Contractor: <b>Park East</b>
Present At Site: <b>7:00AM</b>	Sub-Contractor:
General Area: <b>Northern Yard of School</b>	CM/Designer:
Specific Location: <b>Northern Side of school 1st, 2nd floor, Basement</b>	
Last Inspection:	Building Code Section:
Reviewed	Drawings:
Approved	Submittals
	Other:

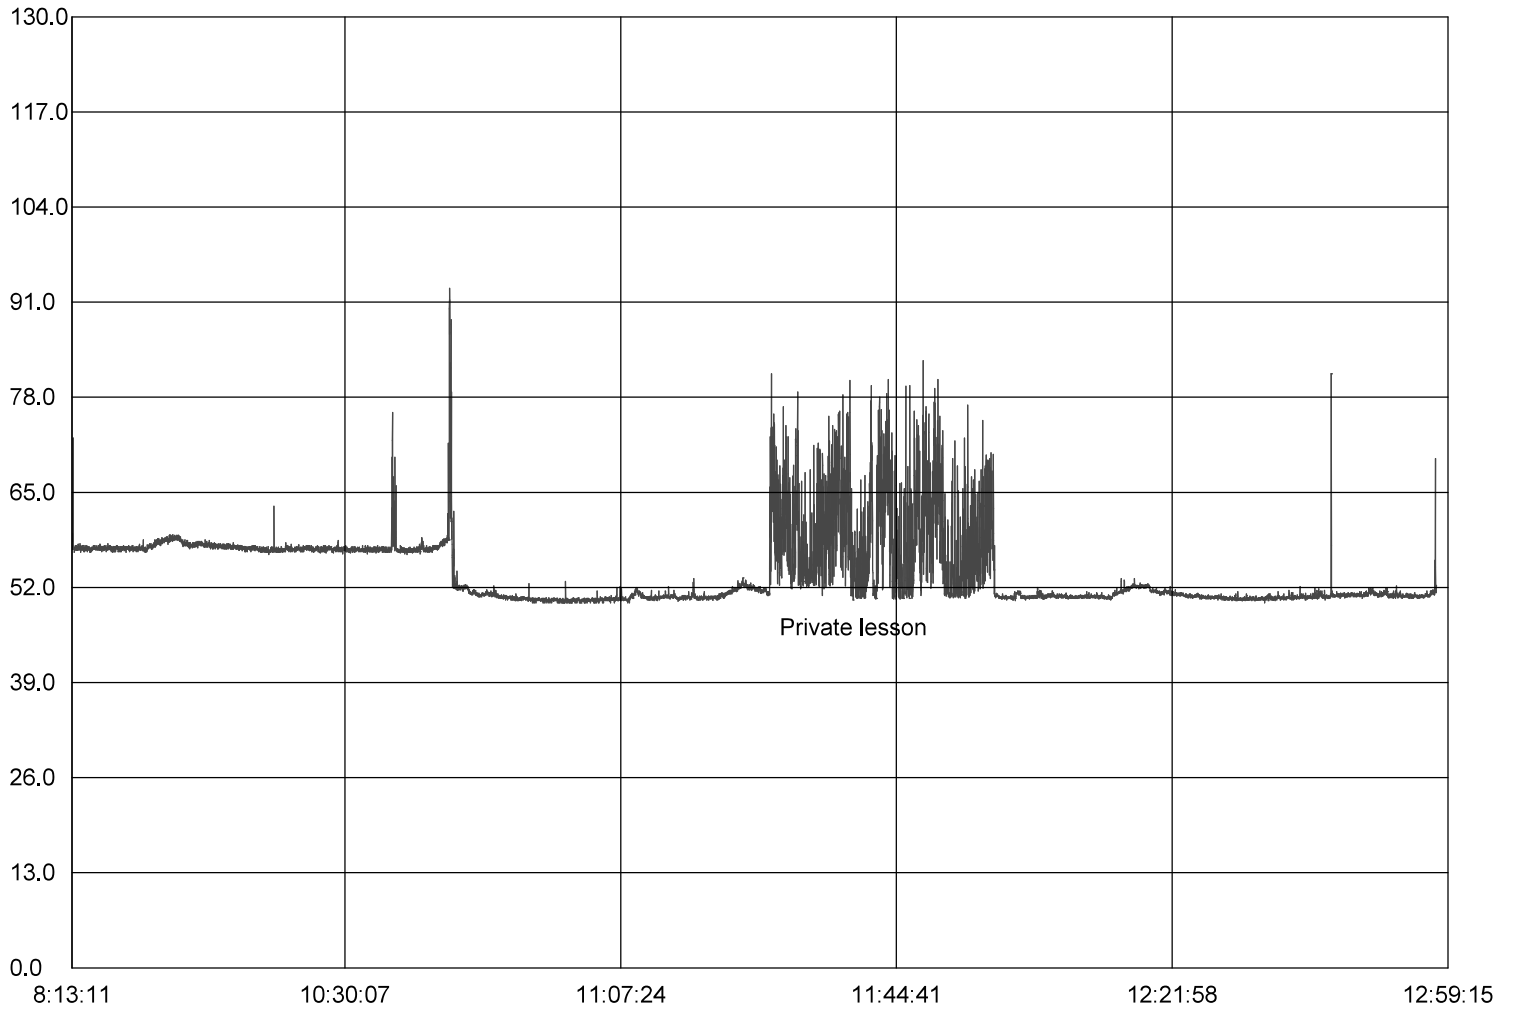
2ND FLOOR STORAGE CLOSET

Standard Sound Level Meter RealTime Graph  
Time: 2019-11-8 14:59:22

Start Time: 08-11-2019,8:13:11  
Maxnum: 92.90 08-11-2019,10:44:17  
Minnum: 49.90 08-11-2019,10:55:29  
Sample Rate: 1.00  
Average: 54.13

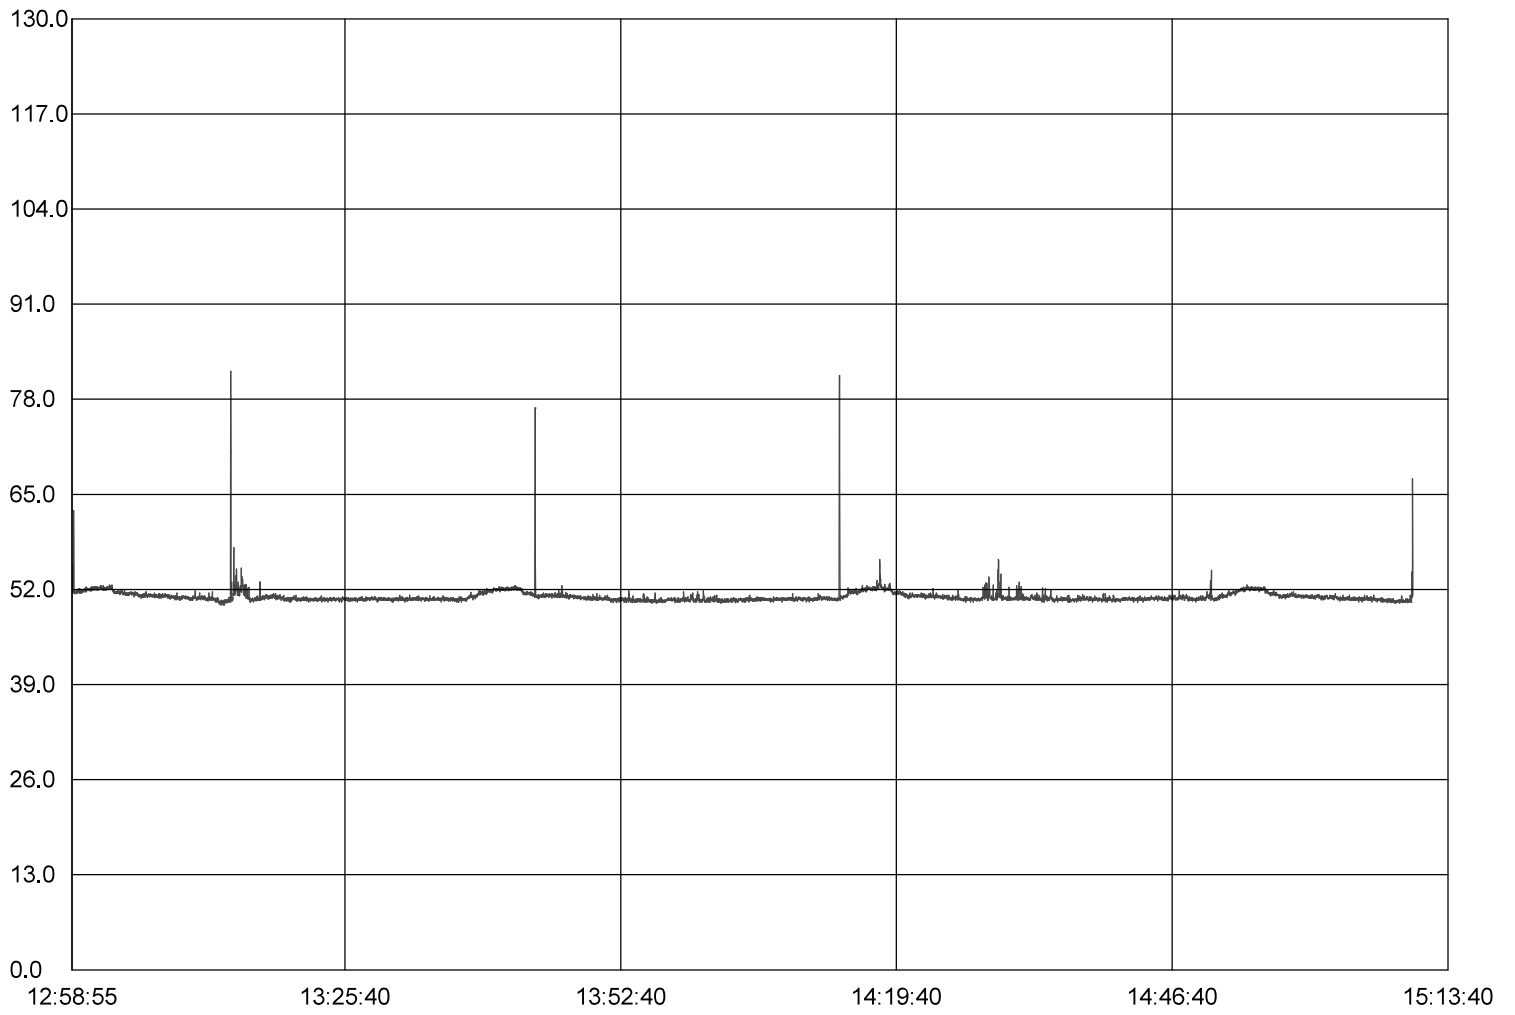
2nd Floor Storage 2

Standard Sound Level Meter RealTime Graph  
Time: 2019-11-8 14:59:33

Start Time: 08-11-2019,12:58:55  
Maxnum: 81.80 08-11-2019,13:14:29  
Minnum: 49.90 08-11-2019,13:13:26  
Sample Rate: 1.00  
Average: 51.00

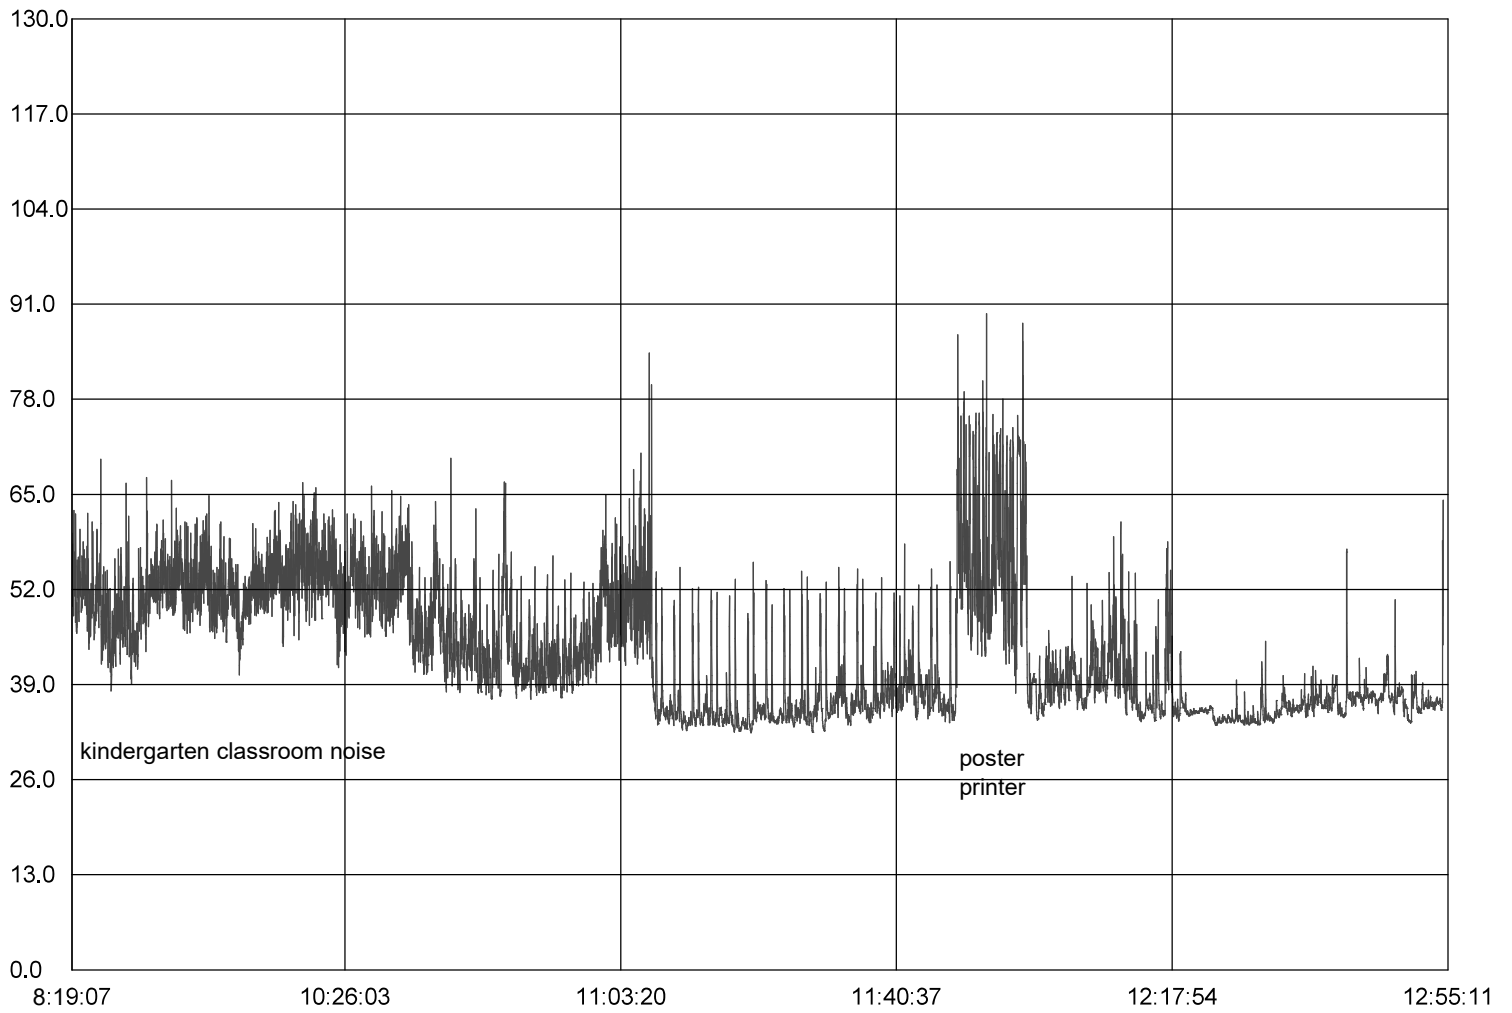
basement hallway 1

Standard Sound Level Meter RealTime Graph  
Time: 2019-11-8 14:56:23

Start Time: 08-11-2019,8:19:07  
Maxnum: 89.70 08-11-2019,11:52:49  
Minnum: 32.40 08-11-2019,11:20:58  
Sample Rate: 1.00  
Average: 43.37

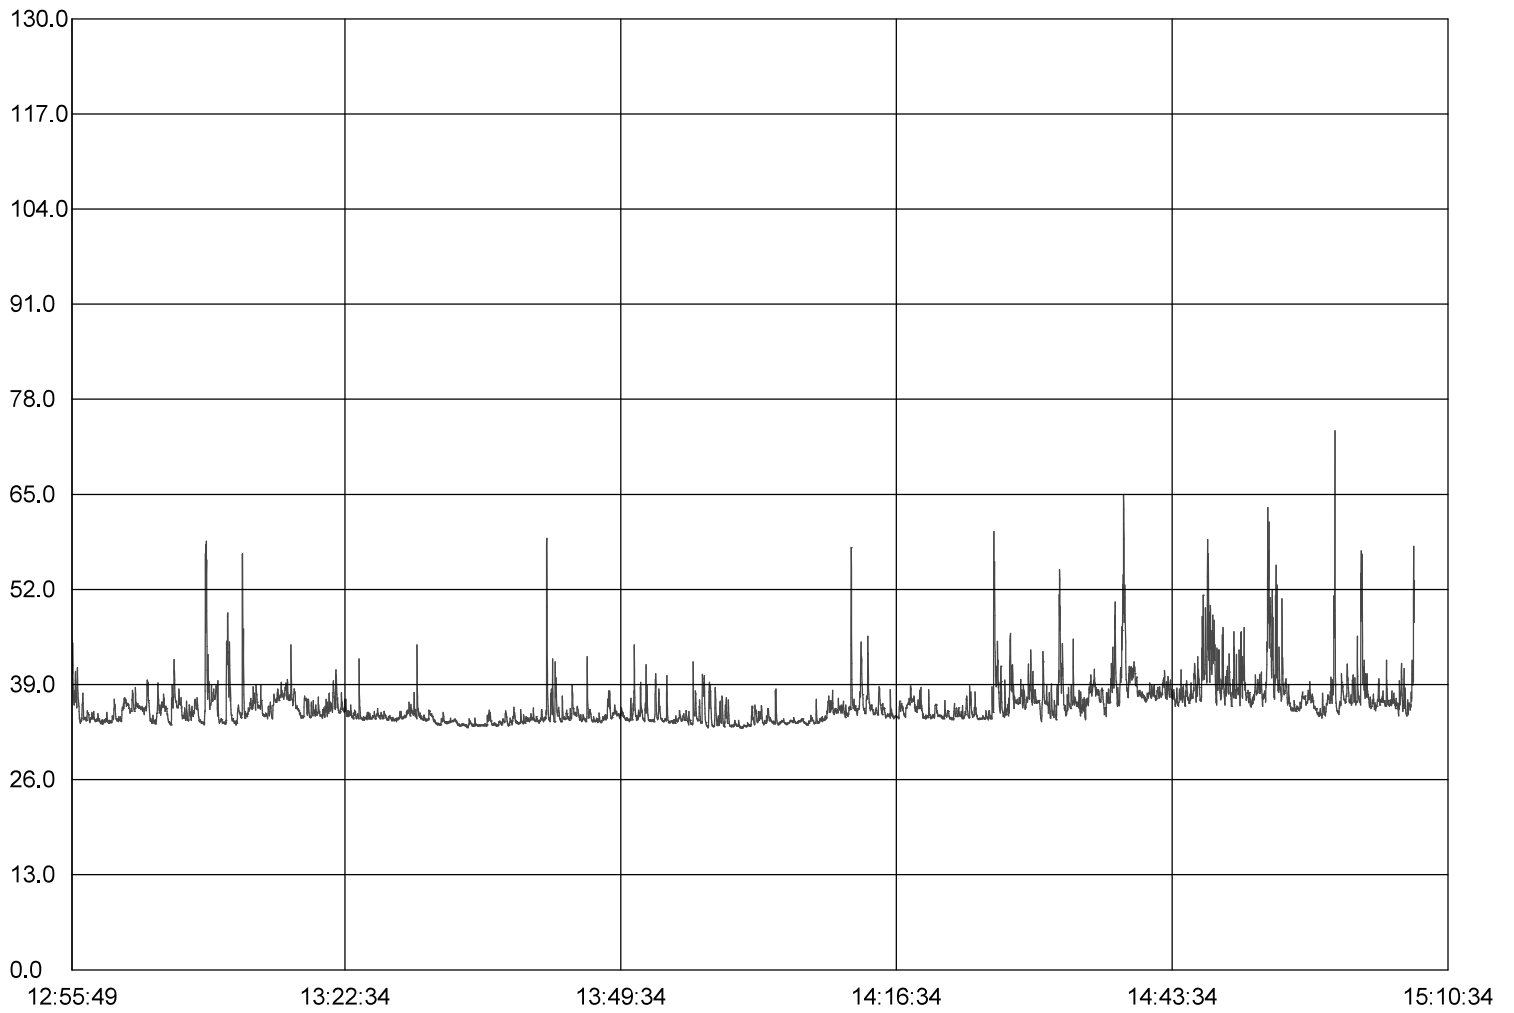
basement hallway 2

Standard Sound Level Meter RealTime Graph  
Time: 2019-11-8 14:56:34

Start Time: 08-11-2019,12:55:49  
Maxnum: 73.70 08-11-2019,14:59:31  
Minnum: 33.00 08-11-2019,14:01:26  
Sample Rate: 1.00  
Average: 36.13
