INSPECTION REPORT

Project: Greenacres School	Date: 11/12/19						
Address: 41 Huntington Avenue, Scarsdale NY	Job ID/ MU#:						
83 Client: Park East Construction	Weather: Rain/Snow						
Inspection Type: Noise and Dust Monitoring Contractor: Park East							
Present At Site: 7:00AM	Sub-Contractor:						
General Area: Northern Yard of School	CM/Designer:						
Specific Location: Northern Side of school 1st, 2nd floor, Basement							
Last Inspection:	Building Code Section:						
Reviewed Drawings:							
Approved Submittals	Submittals						
Other:							
Deficiency:	Resolution:						
Request For Information:							
Non-Conformance Report:							
RFI# : Issued RFI # : Answered NCR # :	Issued NCR # :	Resolved NCR # : Open					
Observations/Notes:							
Noise caused by ongoing construction in the perimeter of the school was monitored using a sound level meter. Readings were taken in the basement hallway (20 feet from construction), next to the work performed today. An Average noise level of 54.69 dB was measured for the day Dust Levels within the Perimeter of the school were measured. These Readings can be found in the chart on the next page. Daily PM2.5 density = 1.8, PM10 density

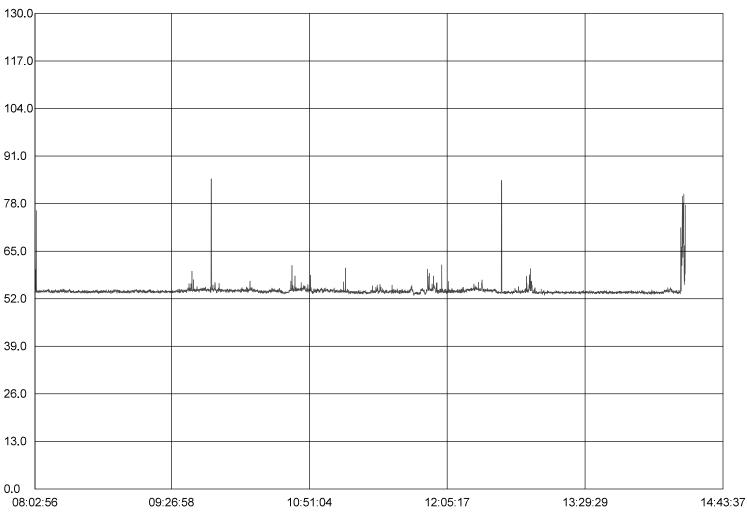
BASEMENT HALLWAY

Start Time:12-11-2019,08:02:56Maxnum:84.7012-11-2019,11:41:29Minnum:53.0012-11-2019,10:05:07Sample Rate:1.00Average:52.11

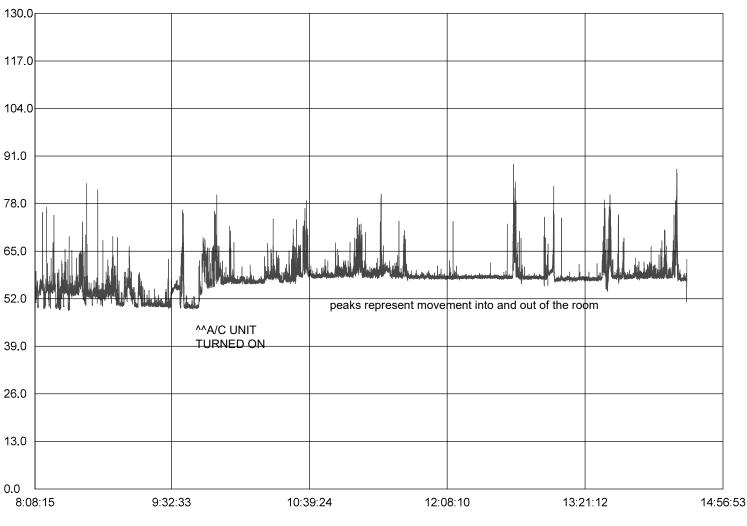
2ND FLOOR STORAGE UNIT

Start Time:
 12-11-2019,8:08:15

Maxnum:
 86.75
 12-11-2019,11:21:40

Minnum:
 44.91
 12-11-2019,9:38:20

Average:
 57.22
