**MUNICIPAL**  
TESTING LABORATORY, INC.

## INSPECTION REPORT

| Project: <b>Greenacres School</b> | Date: <b>11/26/19</b> |

| Inspection Type: <b>Noise and Dust Monitoring</b> | Contractor: <b>Park East</b> |

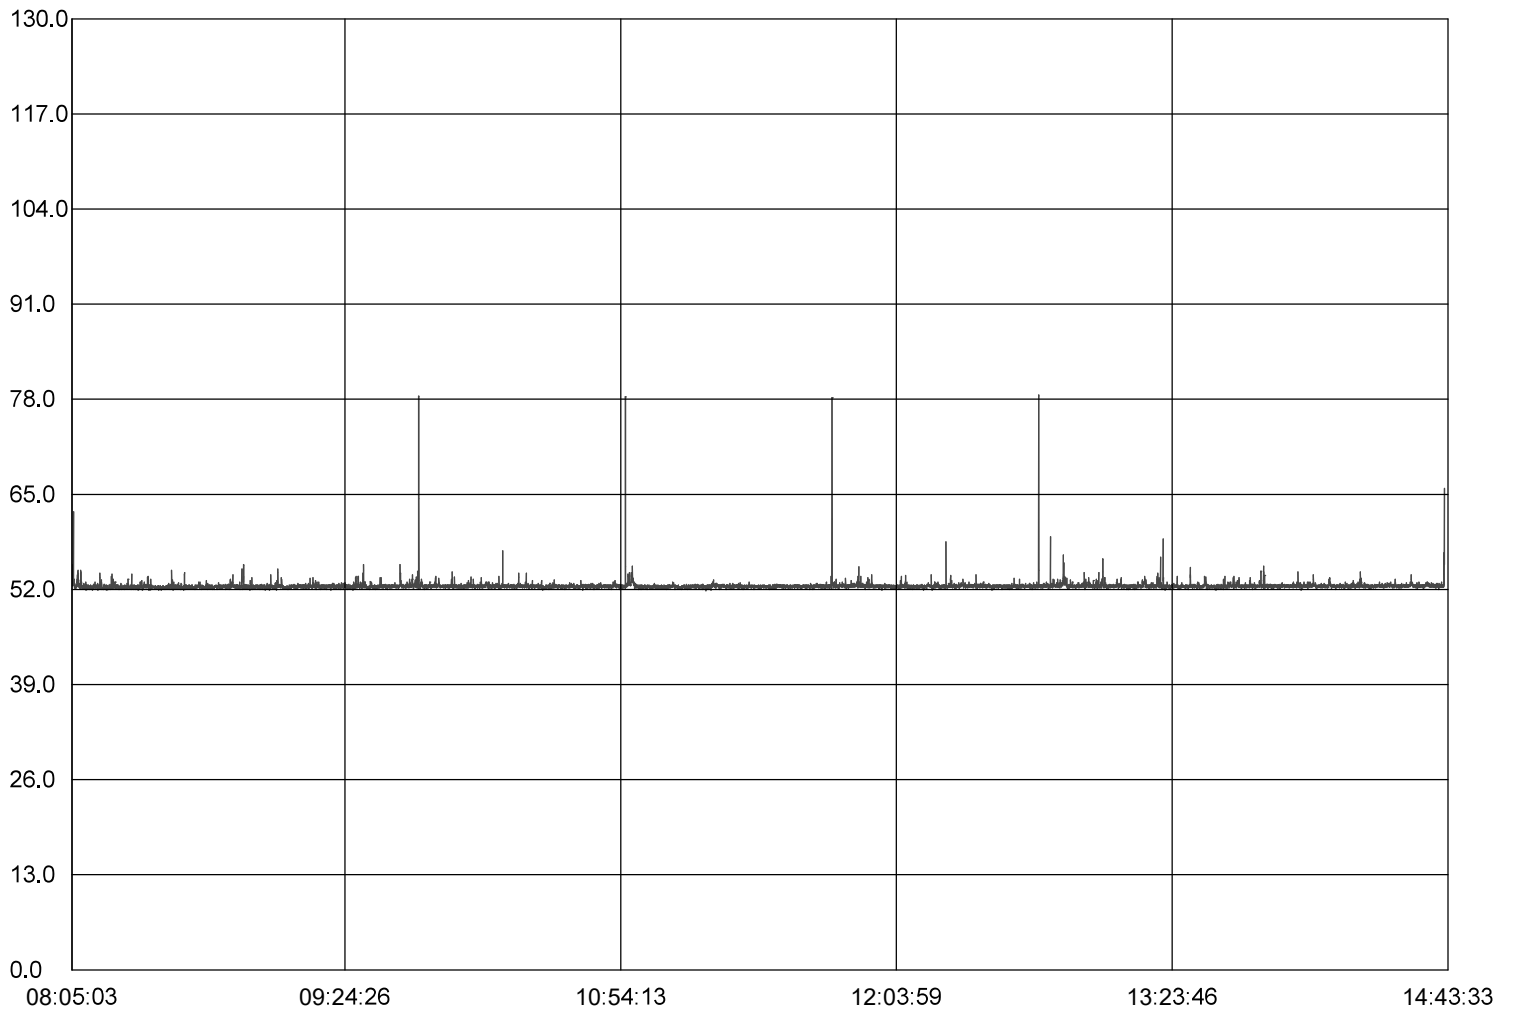
2nd floor storage

Standard Sound Level Meter RealTime Graph  
Time: 2019-11-26 14:57:22

Start Time: 26-11-2019,08:05:03  
Maxnum: 78.60 26-11-2019,14:14:31  
Minnum: 51.80 26-11-2019,13:26:32  
Sample Rate: 1.00  
Average: 52.49

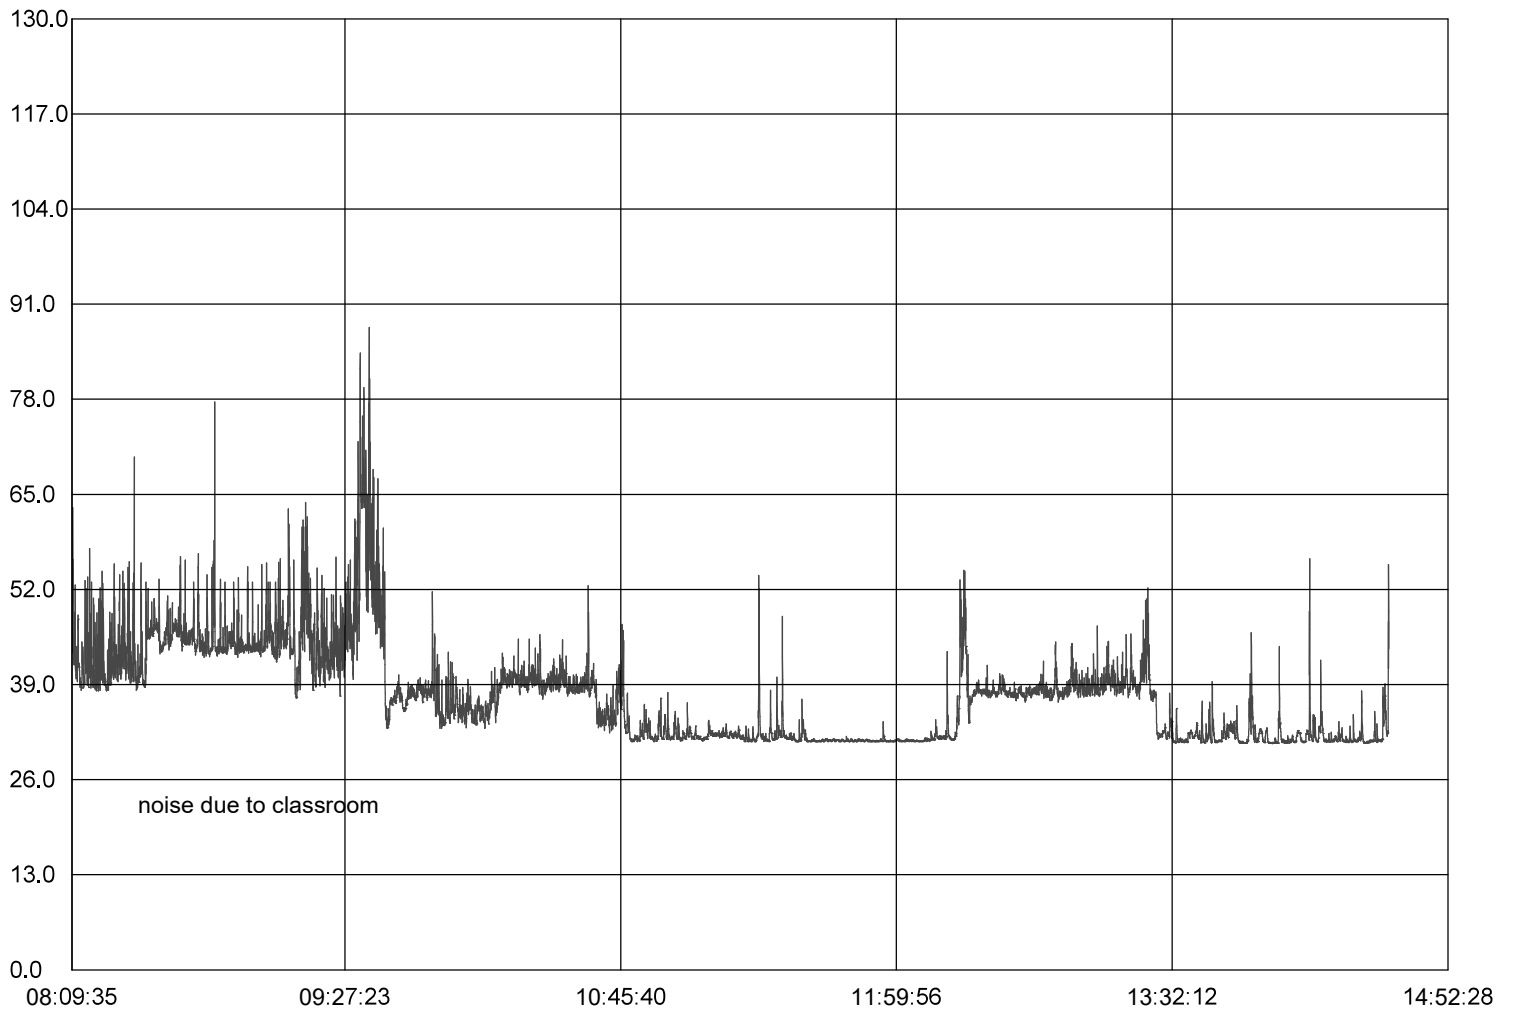
basement kindergarten hallway

Standard Sound Level Meter RealTime Graph  
Time: 2019-11-26 14:53:27

Start Time: 26-11-2019,08:09:35  
Maxnum: 87.80 26-11-2019,12:01:38  
Minnum: 30.90 26-11-2019,14:39:44  
Sample Rate: 1.00  
Average: 37.32
