Project: Greenacres Elementary School	Date: 12/10/2019
Address: 41 Huntington Avenue, Scarsdale NY	Job ID / MU #:
Client: Park East Construction	Weather: Rain

Inspection Type: Noise and Dust Report	Contractor:
Present At Site:	Sub-Contractor:
General Area:	CM/Designer:
Specific Location: Northern Side of the buildings Basement, 1st floor, 2nd floor	
Last Inspection:	Building Code Section:
Reviewed Approved	Drawings:
	Submittals
	Other:

INSPECTION REPORT

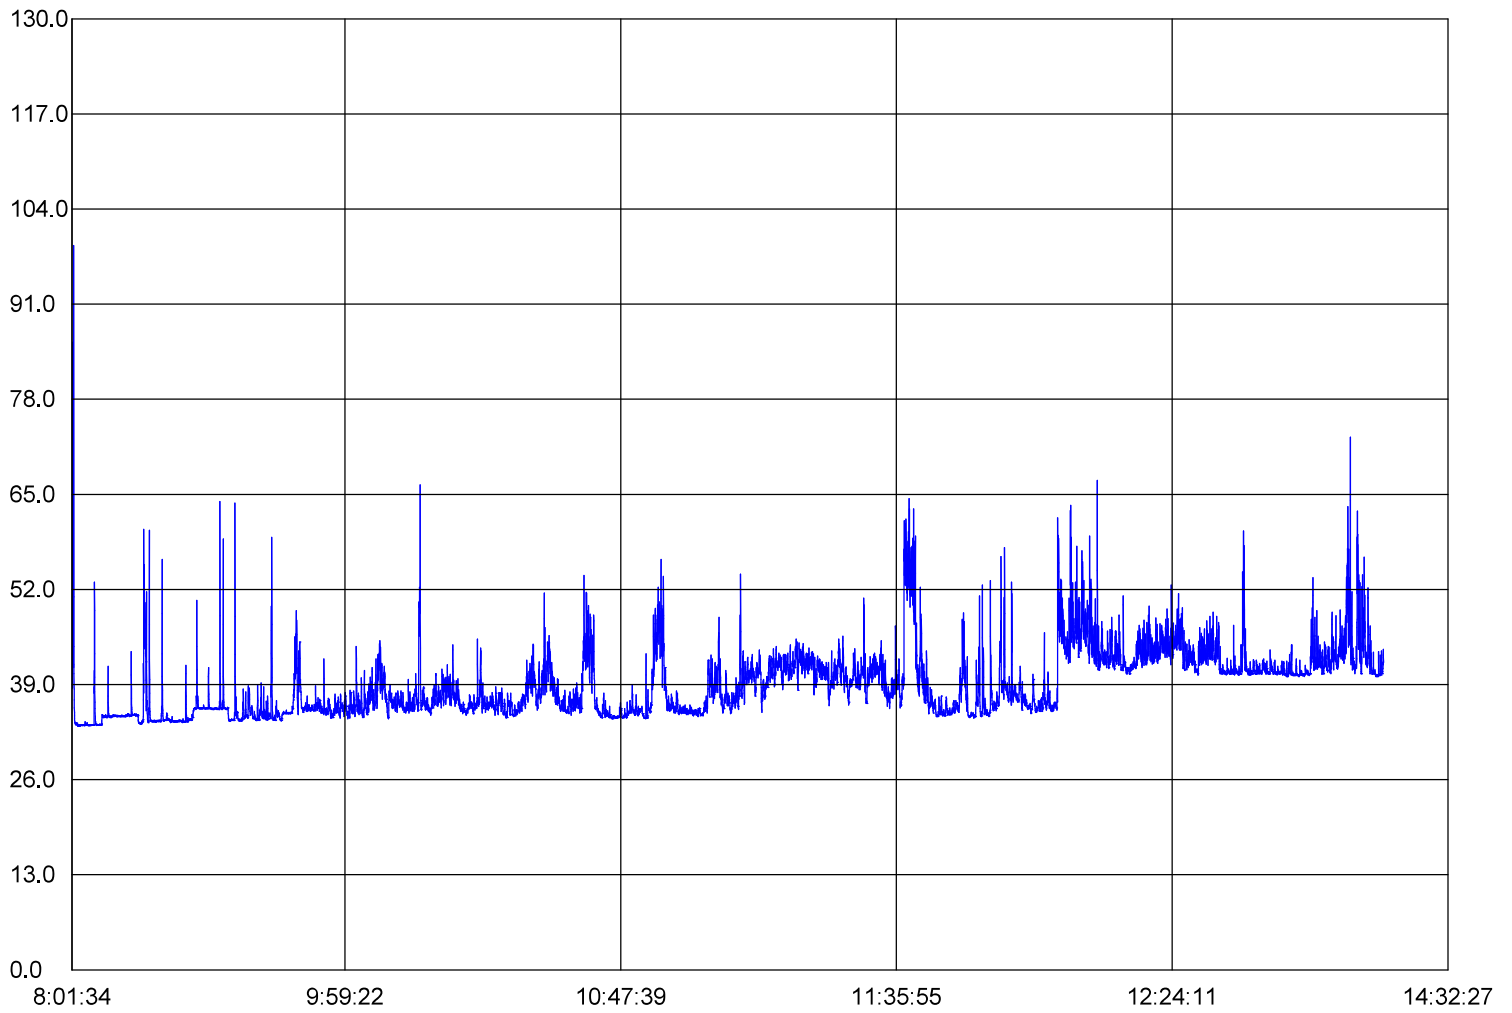
2nd floor storage

Start Time: 10-12-2019,8:01:34
Maxnum: 99.00 10-12-2019,9:11:54
Minnum: 33.30 10-12-2019,9:12:36
Sample Rate: 1.00
Average: 38.89

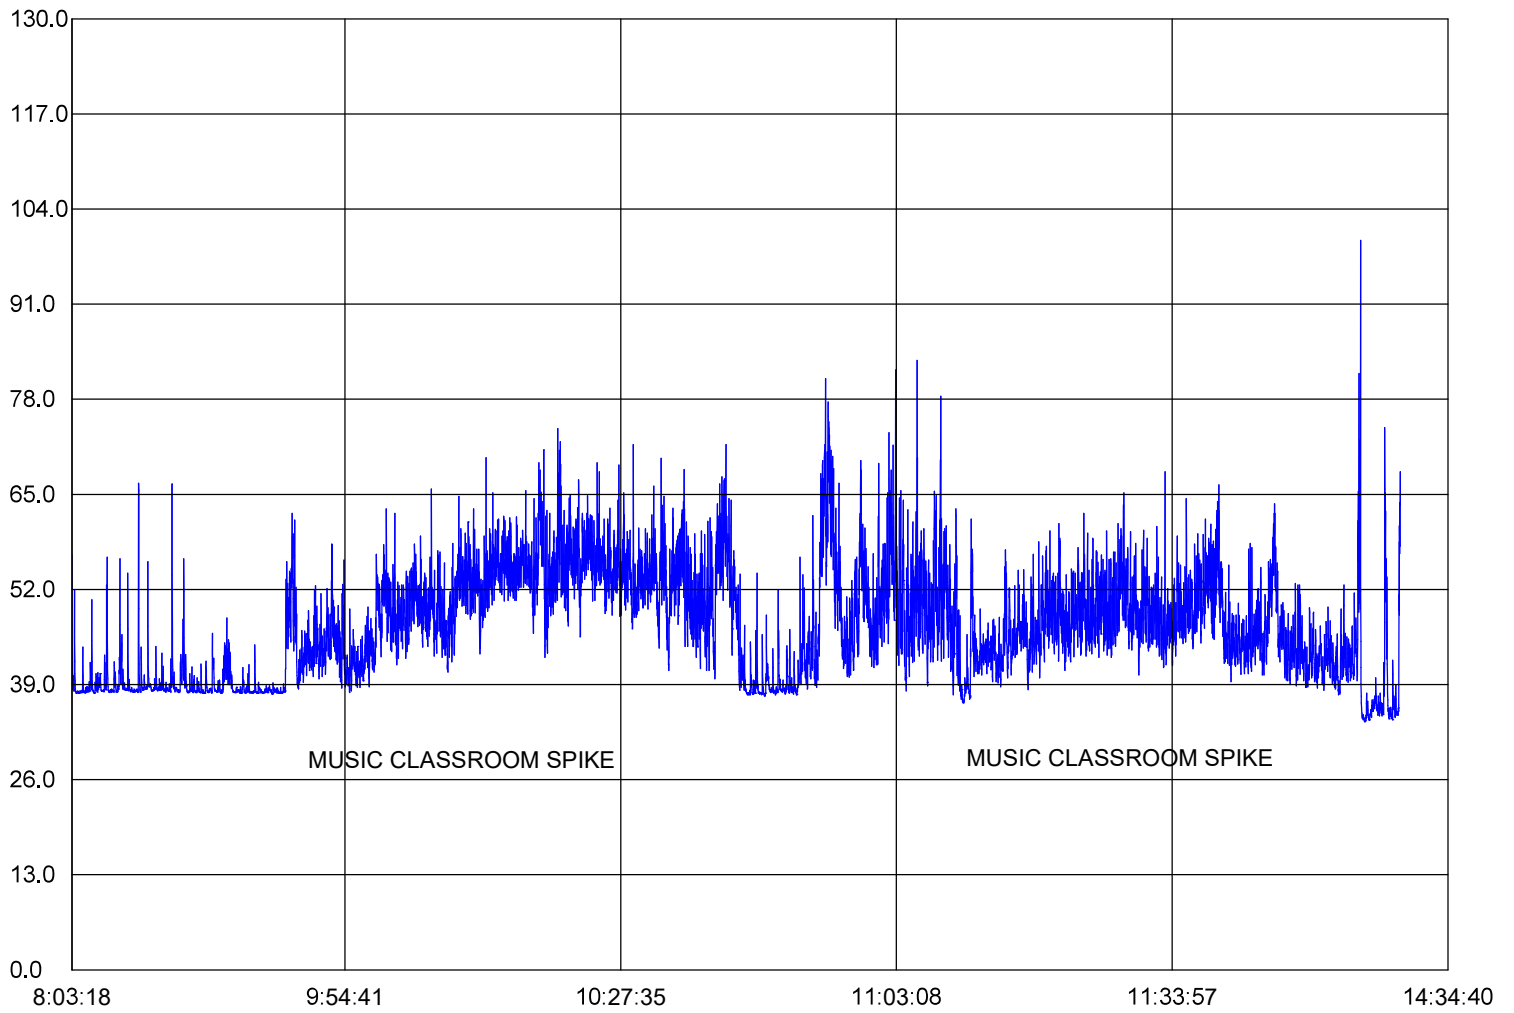
basement hallway

Start Time: 10-12-2019,8:03:28
Maxnum: 98.10 10-12-2019,10:16:14
Minnum: 31.40 10-12-2019,11:16:07
Sample Rate: 1.00
Average: 47.81
