INSPECTION REPORT

Pag	e of	STATE LES TRICETO
Project: G	REENAC	CRES E	LEMENTARY S	CHOOL			Date:	12/11/2019
			AVENUE, SCARSI		583		Job ID / M	
Client: PAI	RK EAST	CONST	RUCTION				Weather: S	SNOW
Inspection	Туре: NOI	SE AND I	OUST MONITORING		Contract	or:		
Present At					Sub-Con	tractor:		
General Are	ea:				CM/Desig	gner:		
Specific Loc	cation: NC	RTHER	N SIDE OF SCHOO	L BASEME	NT, 1ST, 2	ND FLOOR		
Last Inspec	tion:				Building	Code Section	n:	
Reviewed	Drawing	ζS:						
Approved	Submitta	als						
ripprovou	Other:							
Deficiency:					Resoluti	on:		
Request Fo	r Informa	tion:						
Non-Confo								
RFI#:	Issued	RFI#	: Answered	NCR # :	Issued	NCR # :[Resolved	d NCR # : Open
Observation	ns/Notes:							
	adings w	-	construction in the	•				using a sound level xt to the work
An averag	e noise l	evel of	43.25 dB was m	easured for	the day.			
			meter of the scho //2.5 Density = 1				dings can t	pe found in the chart

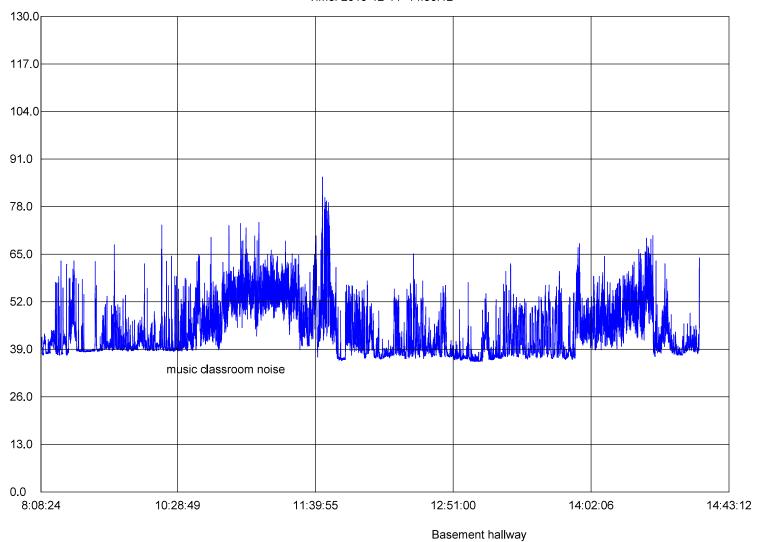
Standard Sound Level Meter RealTime Graph Time: 2019-12-11 14:50:12

Maxnum: 85.20 11-12-2019,11:43:37 Minnum: 34.10 11-12-2019,13:01:21

Sample Rate: 1.00 Average: 44.10

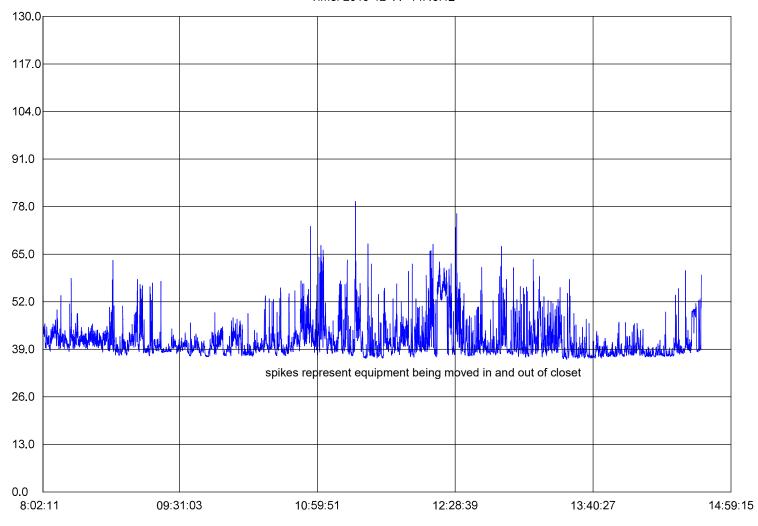
Standard Sound Level Meter RealTime Graph Time: 2019-12-11 14:49:12

Maxnum: 78.10 11-12-2019,13:17:19 Minnum: 35.10 11-12-2019,12:11:52

Sample Rate: 1.00 Average: 42.39 2nd floor storage closet
