**INSPECTION REPORT**

Project: GREENACRES ELEMENTARY	Date: 12/16/2019
Address: 41 HUNTINGTON AVENUE, SCARSDALE NY	Job ID / MU #:
Client: PARK EAST CONSTRUCTION	Weather: CLOUDY
Inspection Type: Noise and Dust Monitoring	Contractor:
Present At Site: 7:00AM	Sub-Contractor:
General Area:	CM/Designer:
Specific Location: Northern side of the school basement, 2	, ,
Last Inspection:	Building Code Section:
Reviewed Drawings:	
Submittals	
Approved Other:	
Deficiency:	Resolution:
Deficiency.	nesolution.
December 1975	
Request For Information:	
Non-Conformance Report:	I NCD # Develop NCD # Develop
RFI # : Issued RFI # : Answered NCR # :	Issued   NCR # : Resolved   NCR # : Open
Observations/Notes:	
Noise caused by ongoing construction in the perimeter meter. Readings were taken in the basement hallway performed today.	
ponomica today.	
An average noise level of 54.27 dB was measured for	the day.
Dust levels within the perimeter of the school were moon the next page. Daily PM2.5 Density = 3.5, PM10 D	<u> </u>

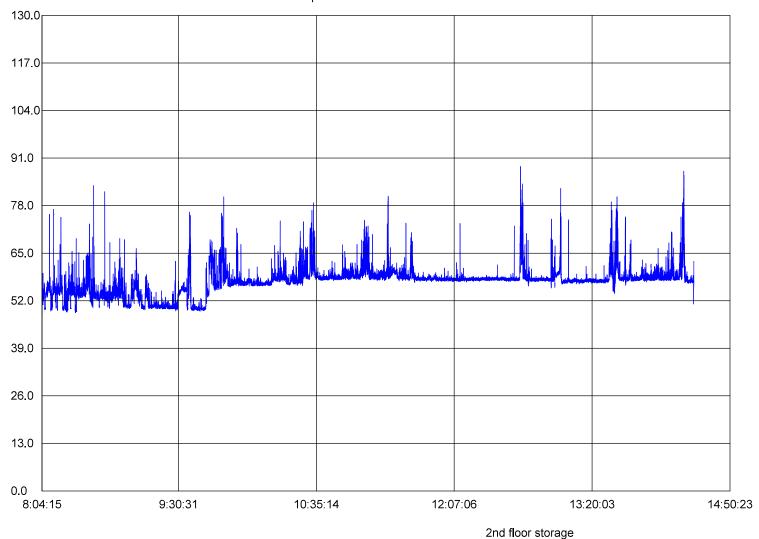
## Standard Sound Level Meter RealTime Graph Time: 2019-12-16 14:51:12

Start Time: 16-12-2019,8:04:15 Maxnum: 84.55 16-12-2019,11:15:24 Minnum: 42.41 16-12-2019,9:32:10

Sample Rate: 1.00 Average: 57.22

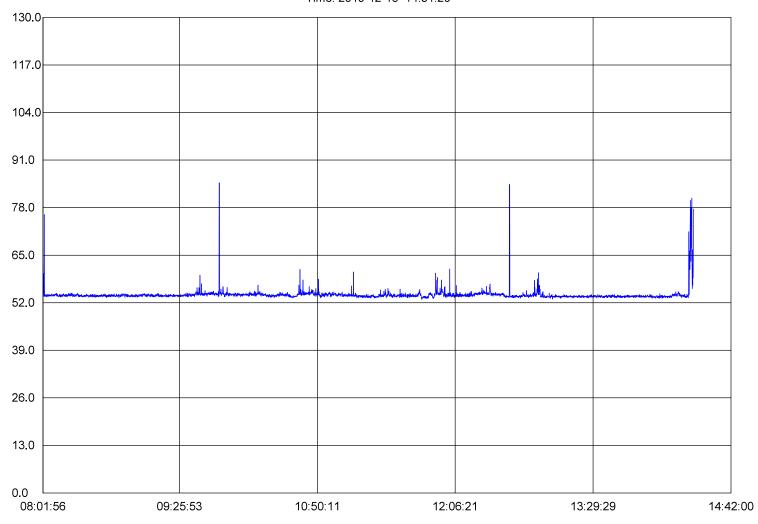
## Standard Sound Level Meter RealTime Graph Time: 2019-12-16 14:51:20

Start Time:
 16-12-2019,08:01:56

Maxnum:
 83.50
 16-12-2019,9:51:29

Minnum:
 51.00
 16-12-2019,11:25:07

Sample Rate: 1.00 Average: 51.31 BASEMENT HALLWAY
