INSPECTION REPORT

REPORT #
72

Project: GREENACRES ELEMENTARY SCHOOL	Date: 12/17/2019
Address: 41 HUNTINGTON AVENUE, SCARSDALE NY	Job ID / MU #:
Client: PARK EAST CONSTRUCTION	Weather: SNOW/CLOUDY

Inspection Type: NOISE AND DUST MONITORING	Contractor:
Present At Site: 7:00AM	Sub-Contractor:
General Area:	CM/Designer:
Specific Location: NORTHERN SIDE OF THE SCHOOL BASEMENT, 1ST FLOOR, 2ND FLOOR	
Last Inspection:	Building Code Section:
Reviewed Approved	Drawings:
	Submittals
	Other:

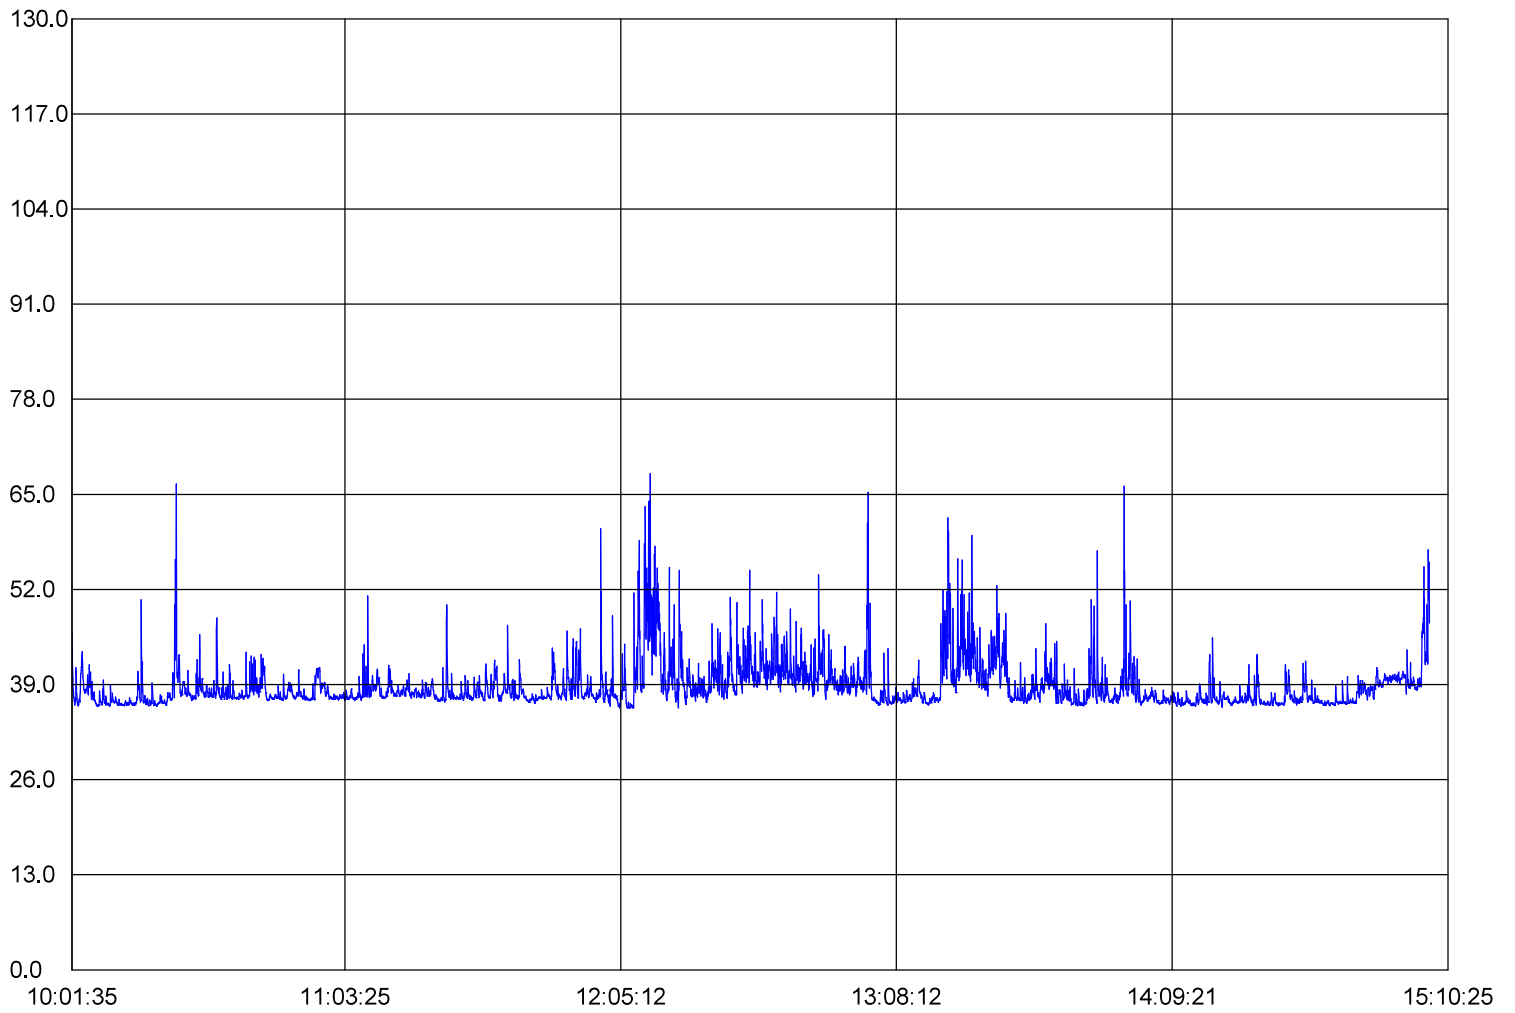
BASEMENT HALLWAY

Standard Sound Level Meter RealTime Graph
Time: 2019-12-17 15:03:37

Start Time: 17-12-2019,10:01:35
Maxnum: 67.80 17-12-2019,12:18:16
Minnum: 35.80 17-12-2019,14:24:13
Sample Rate: 1.00
Average: 38.74
