INSPECTION REPORT

REPORT #
74

| Project: Greenacres Elementary School | Date: 12/19/2019 |

| Inspection Type: Noise and Dust Monitoring | Contractor: |

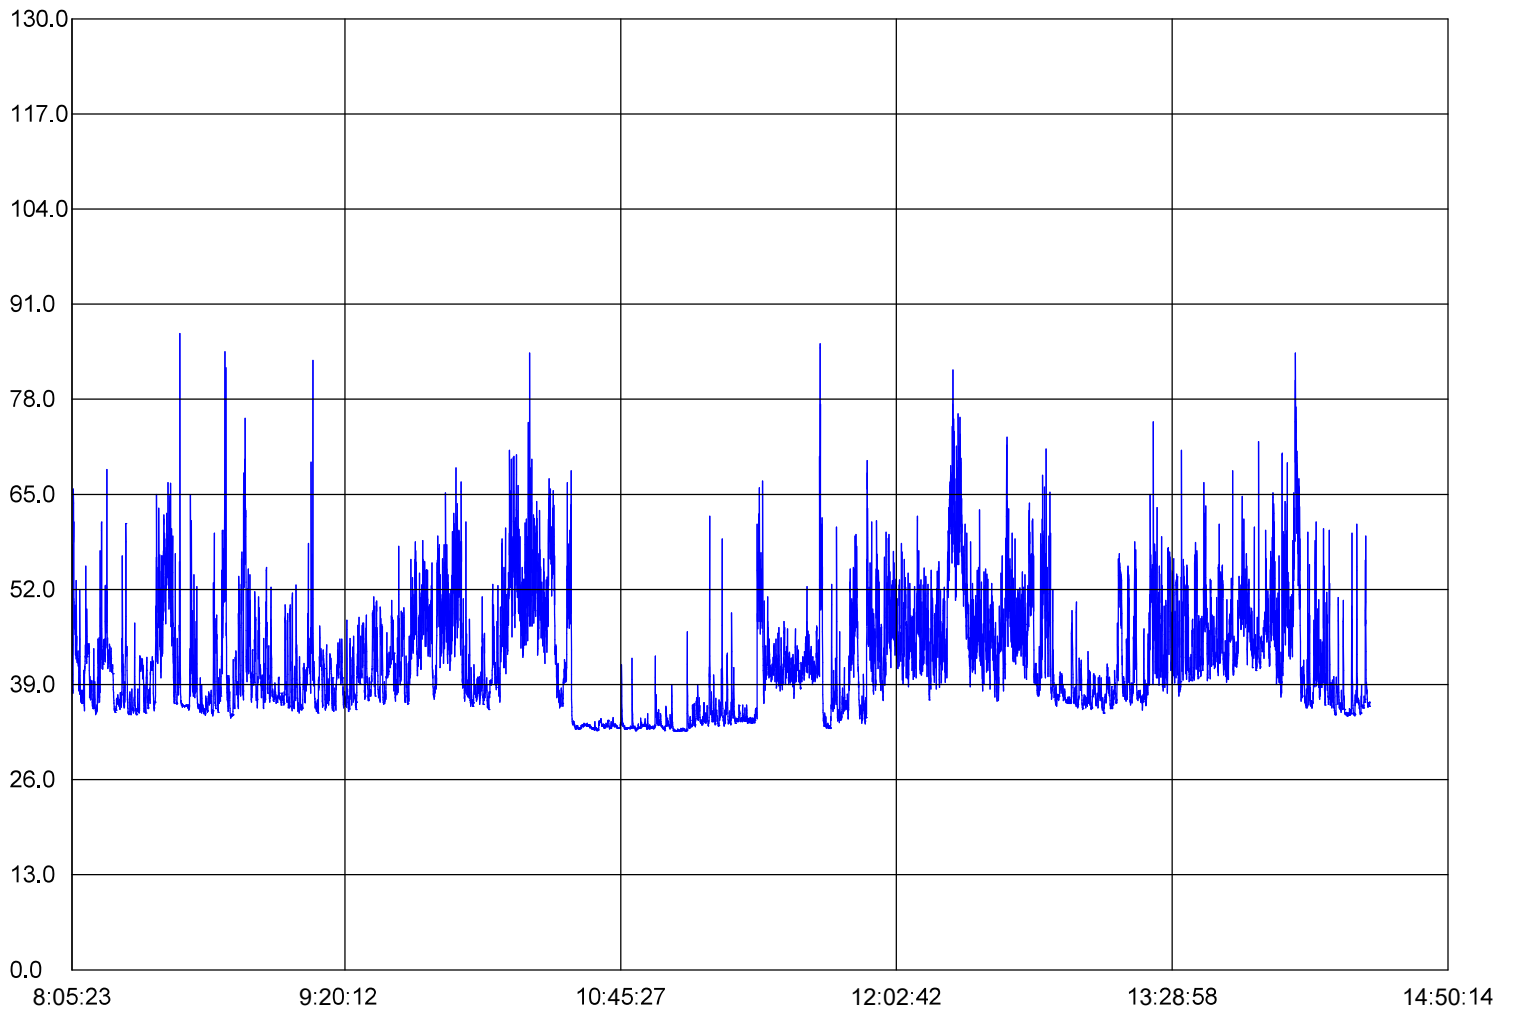
2nd floor storage

Standard Sound Level Meter RealTime Graph
Time: 2019-12-19 14:55:50

Start Time: 19-12-2019,8:05:23
Maxnum: 87.00 19-12-2019,9:43:08
Minnum: 32.60 19-12-2019,11:05:04
Sample Rate: 1.00
Average: 42.22

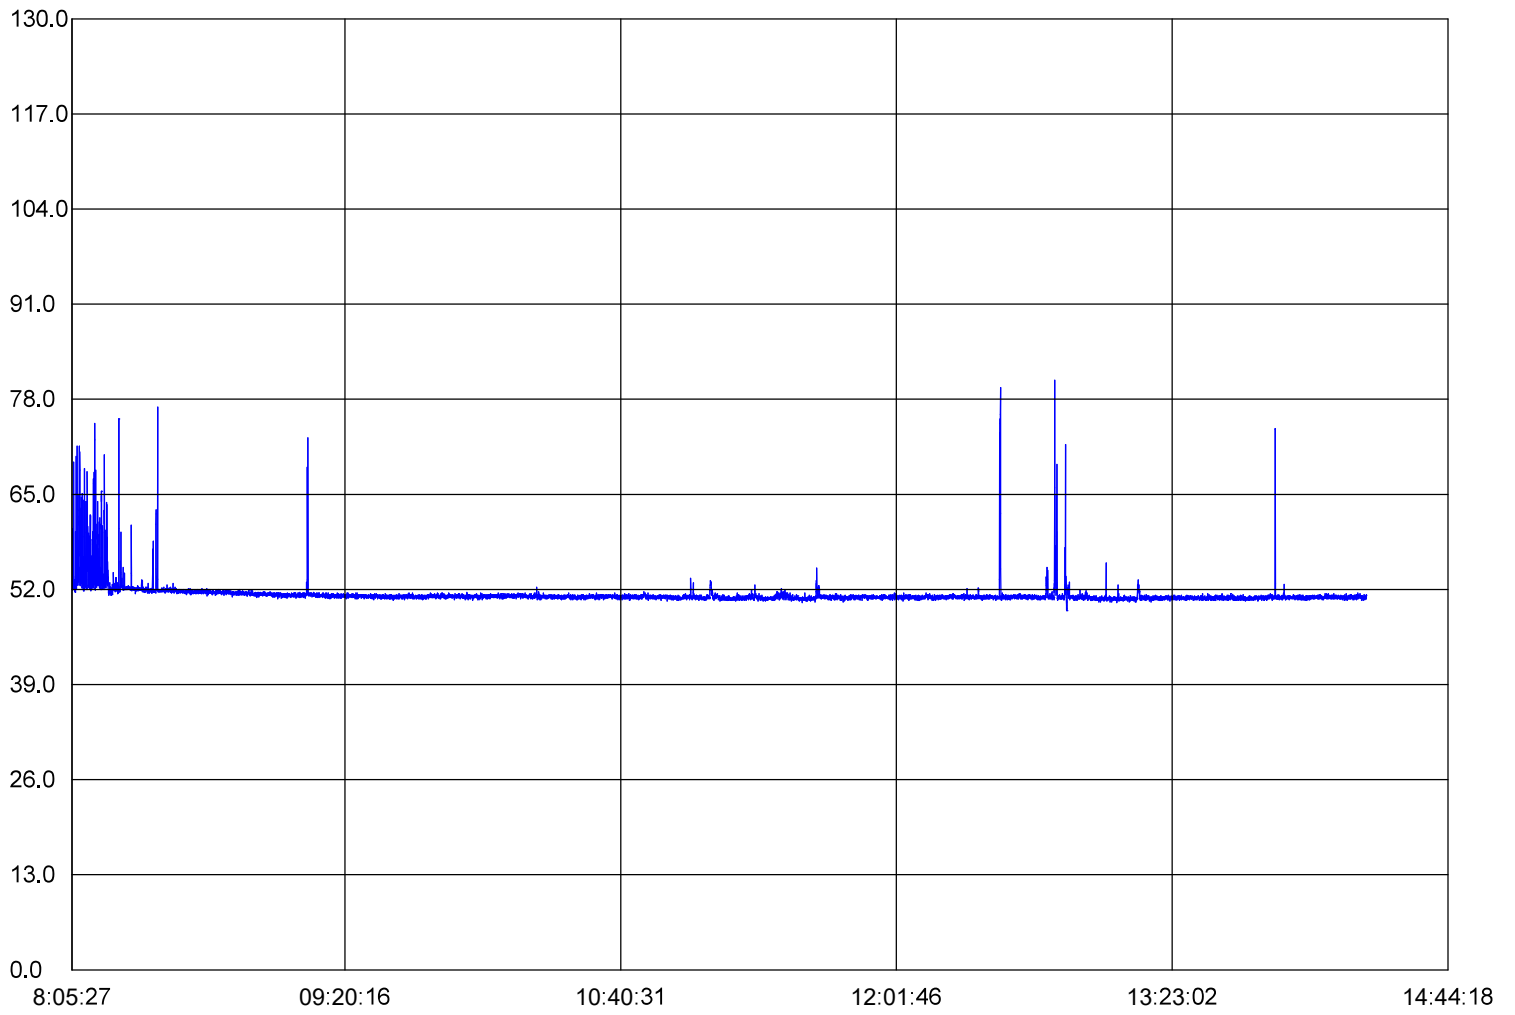
basement hallway

Standard Sound Level Meter RealTime Graph
Time: 2019-12-19 14:52:24

Start Time: 19-12-2019,8:05:27
Maxnum: 80.60 19-12-2019,12:09:46
Minnum: 49.10 19-12-2019,12:11:44
Sample Rate: 1.00
Average: 51.25
