INSPECTION REPORT

| REPORT # | |
|---|--|
| 63 | |

| Project: GI | REENACRES ELEMENTARY SCHOOL | Date: 12 | /04/2019 | | | | | | |
| Inspection ' | Type: NOISE AND DUST MONITORING | Contractor: PARK FA | СТ | | | | | | |

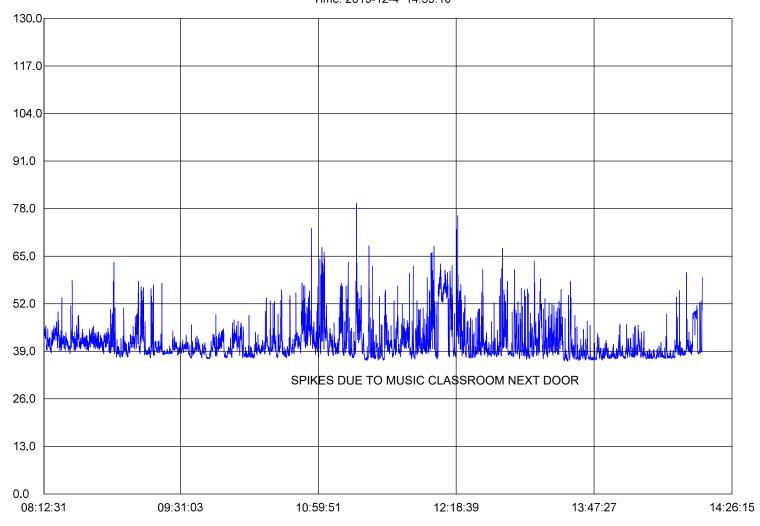
Standard Sound Level Meter RealTime Graph Time: 2019-12-4 14:39:10

Start Time: 04-12-2019, 08:12:31

Maxnum: 79.40 04-12-2019,14:07:49 Minnum: 36.20 04-12-2019,14:51:58

Sample Rate: 1.00 Average: 41.34 **BASEMENT HALLWAY**
