## INSPECTION REPORT

Project: Greenacres Elementary School	Date: 12/06/2019
Address: 41 Huntington Avenue	Job ID / MU #:
Client: Park East Construction	Weather: Cloudy

Inspection Type: Noise and Dust Report	Contractor:
Present At Site:	Sub-Contractor:
General Area:	CM/Designer:
Specific Location: Northern Side of the building basement, 1st floor, 2nd floor	
Last Inspection:	Building Code Section:
Reviewed Approved	Drawings:
	Submittals
	Other:

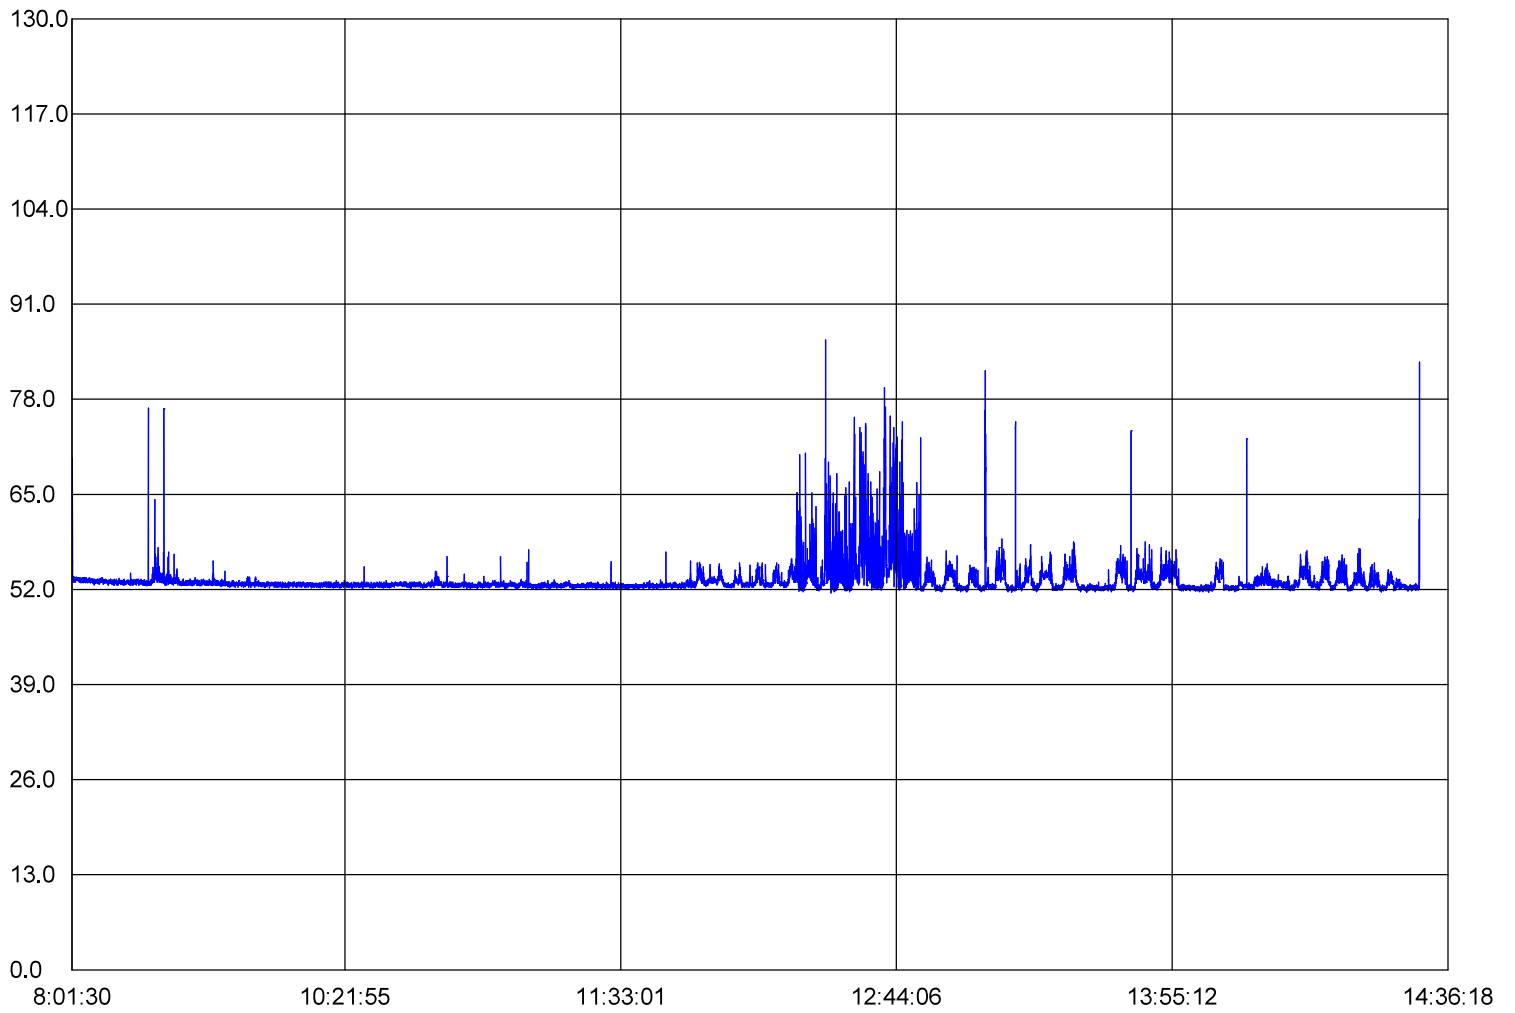
Basement hallway

Standard Sound Level Meter RealTime Graph  
Time: 2019-12-6 14:49:18

Start Time: 06-12-2019,8:01:30  
Maxnum: 86.10 06-12-2019,12:25:52  
Minnum: 51.50 06-12-2019,12:27:15  
Sample Rate: 1.00  
Average: 53.19

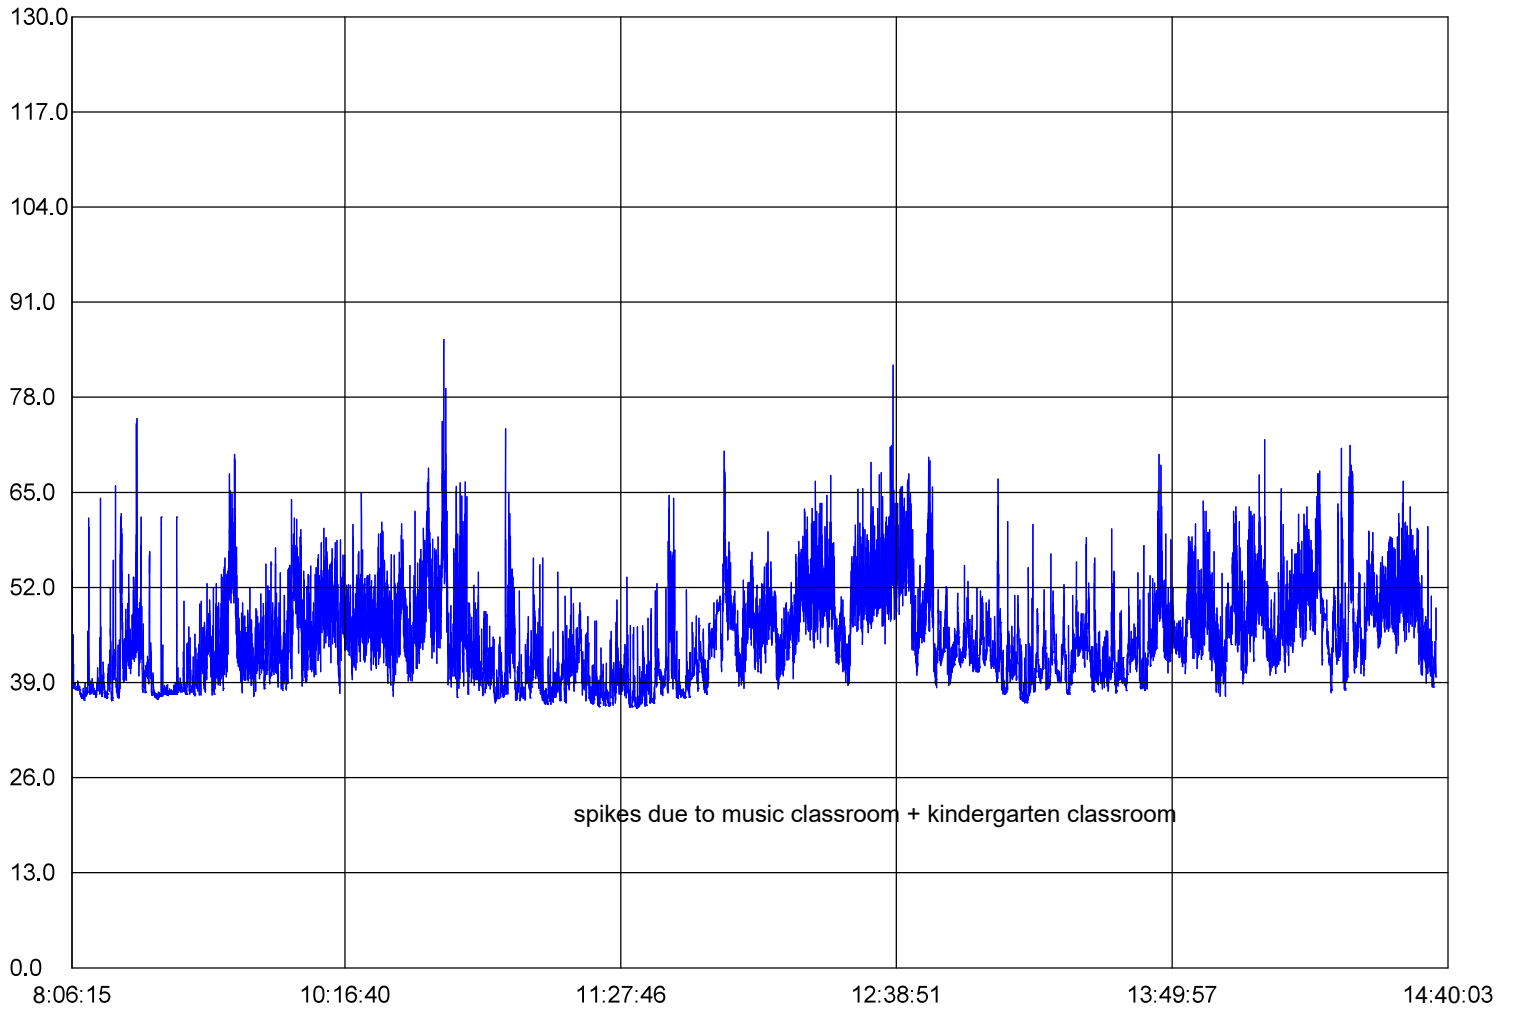
2nd floor storage closet

Standard Sound Level Meter RealTime Graph  
Time: 2019-12-6 14:52:51

Start Time: 06-12-2019,8:06:15  
Maxnum: 85.90 06-12-2019,10:42:08  
Minnum: 35.50 06-12-2019,11:31:51  
Sample Rate: 1.00  
Average: 45.09
