INSPECTION REPORT

REPORT #
66

Project: Greenacres Elementary School	Date: 12/09/2019
Address: 41 Hunting Avenue, Scarsdale NY	Job ID / MU #:
Client: Park East Construction	Weather: Rain

Inspection Type: Noise and Dust Report	Contractor:
Present At Site:	Sub-Contractor:
General Area:	CM/Designer:
Specific Location: Northern Side of the building Basement, 1st floor, 2nd floor	
Last Inspection:	Building Code Section:
Reviewed Approved	Drawings:
	Submittals
	Other:

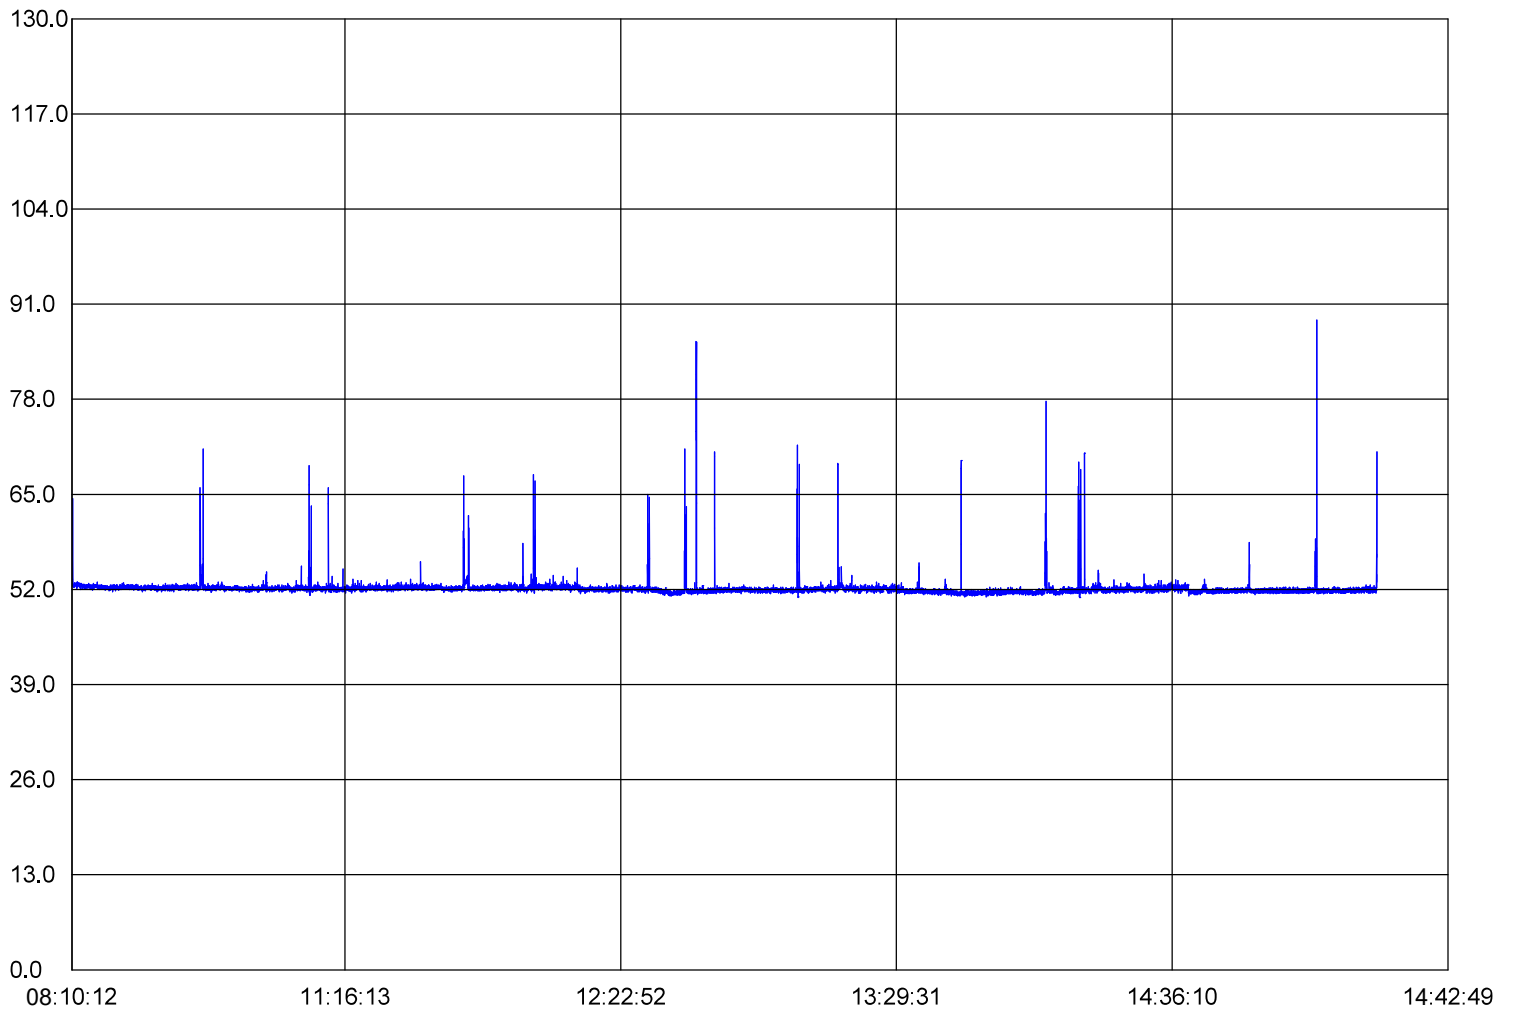
2nd floor storage

Standard Sound Level Meter RealTime Graph
Time: 2019-12-9 14:58:8

Start Time: 09-12-2019,08:10:12
Maxnum: 88.80 09-12-2019,15:11:09
Minnum: 50.90 09-12-2019,13:05:46
Sample Rate: 1.00
Average: 52.08
