DoB Special Inspection Agency #0230		KEPUKI #
Dob special hispection Agency #0230		103
INSPECTION REPORT		
	100	SAMPLES TAKEN

Project: G	Project: GREENACRES ELEMENTARY SCHOOL		Date: 02/13/2020		
	Address: 41 HUNTINGTON AVENUE, SCARSDALE NY		Job ID / MU #:		
G11			Weather: RAIN		
Inspection '	Type: NOISE AND DUST MONITOR	Contractor:			
Present At S		Sub-Contractor:			
General Are	ea:	CM/Designer:			
Specific Loc	ation: N AND S BASEMENT 1ST FI	OOR 2ND FLC	OOR		
Last Inspec	Specific Location: N AND S BASEMENT, 1ST FLOOR, 2ND FLOOR Last Inspection: Building Code Section:				
Reviewed	Drawings:				
Approved	Submittals				
Арргочец	Other:				
Deficiency: Resolution:		Resolution:			
Request For	r Information:				
	mance Report:				
RFI#:	Issued RFI # : Answered NCR # :	Issued NCR # :	Resolved NCR # : Open		
Observation	ns/Notes:				
Noise caused by ongoing construction in the perimeter of the school was monitored using a sound level meter. Readings were taken in the basement hallway (20 feet from construction) next to the work performed today. An average noise level of 55.9 db was measured for the day. Dust levels within the perimeter of the school were measured. These readings can be fo

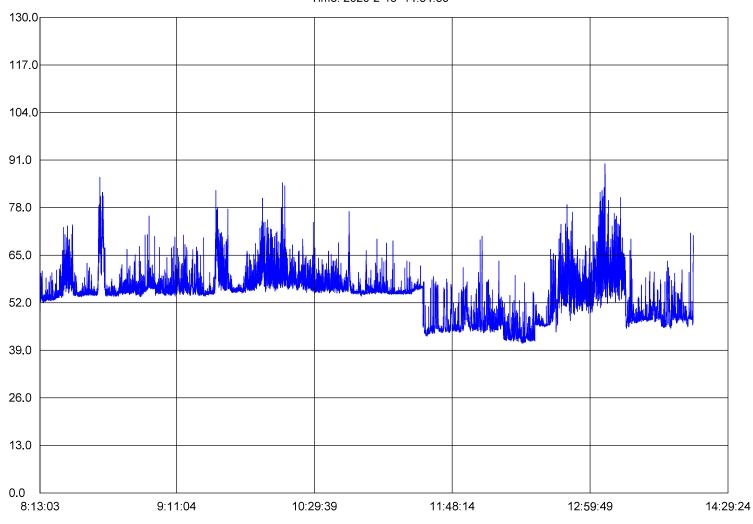
Standard Sound Level Meter RealTime Graph Time: 2020-2-13 14:54:59

Maxnum: 90.00 13-02-2020,12:33:09 Minnum: 40.90 13-02-2020,11:57:52

Sample Rate: 1.00 Average: 55.88 **BASEMENT HALLWAY**
