INSPECTION REPORT

Project: GREENACRES ELEMENTARY SCH	OOL	Date: 02.14.2020								
Address: 41 HUNTINGTON AVENUE, SCAR		Job ID / MU #:								
Client: PARK EAST CONSTRUCTION		Weather: SUNNY								
Inspection Type: NOISE AND DUST REPORT	Contractor:									
Present At Site:	Sub-Contractor:									
General Area:	CM/Designer:									
Specific Location: N AND S BASEMENT, 1ST FLOOR, 2ND FLOOR										
Last Inspection:	Building Code Section:									
Reviewed Drawings:	1									
Submittals										
Approved Other:										
Deficiency:	Resolution:									
Request For Information:										
Non-Conformance Report:										
RFI # : Issued RFI # : Answered NCR # :	Issued NCR # :	Resolved NCR # : Open								
Observations/Notes:	<u> </u>	1								
Noise caused by ongoing construction in the perimeter of the school was monitored using a sound level meter. Readings were taken in the basement hallway (20 feet from construction) next to the work performed today.

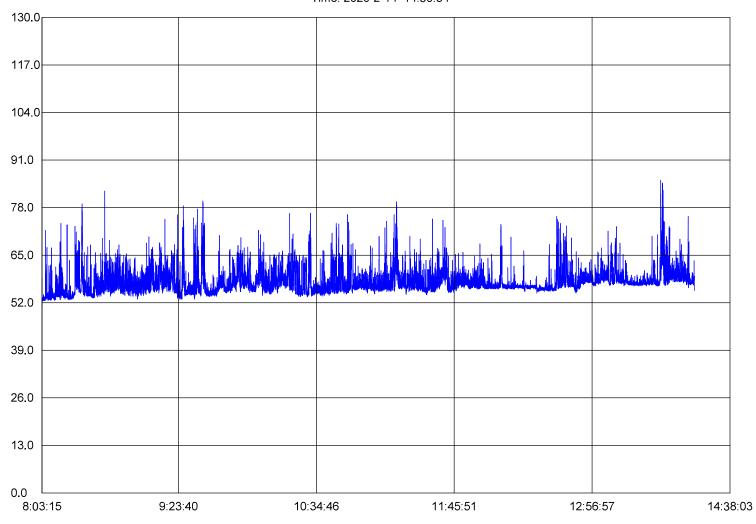
## Standard Sound Level Meter RealTime Graph Time: 2020-2-14 14:50:54

Maxnum: 85.50 14-02-2020,13:32:21 Minnum: 50.70 14-02-2020,8:13:15

Sample Rate: 1.00 Average: 56.27 **BASEMENT HALLWAY**
