GREENACRES ELEMENTARY SCHOOL

Address: 4	ess: 41 HUNTINGTON AVENUE, SCARSDALE NY				Job ID / MU #:				
Client: PA	nt: PARK EAST CONSTRUCTION					Weather: CLOUDY			
Inspection Type: NOISE AND DUST MONITOR Present At Site:			Sub-Contractor:						
General Area:			CM/Designer:						
	763757	ANDS	RASEMENI	T 1ST FI		** - C (5-1) -	nOR		
Specific Location: N AND S BASEMENT, 1ST FLOOR, 2ND FLOOR Last Inspection: Building Code Section:									
D 1	Drawing	S:							
Reviewed	Submittals								
Approved	Other:								
Deficiency:			Resolution:						
Request Fo	r Informat	ion:							
Non-Conformance Report:									
RFI # :	Issued	RFI#:	Answered	NCR # :	Issued	NCR#:	Resolved	NCR # : Open	
Observations/Notes:									
Noise caused by ongoing construction in the perimeter of the school was monitored using a sound level meter. Readings were taken in the basement hallway (20 feet from construction) next to the work performed today.									
An average noise level of 57.13 db was measured for the day.

INSPECTION REPORT

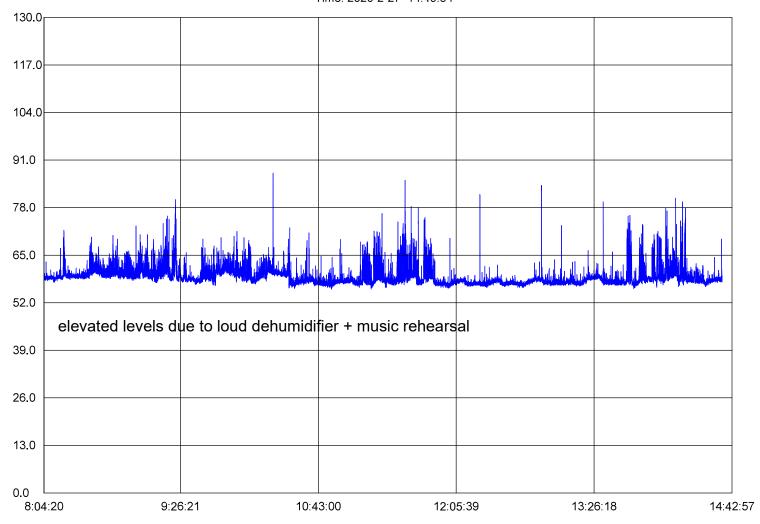
BASEMENT HALLWAY

Maxnum:
 87.40
 27-02-2020,10:31:07

Minnum:
 55.70
 27-02-2020,10:59:22

Sample Rate: 1.00 Average: 57.13
