INSPECTION REPORT

GREENACRES ELEMENTARY SCHOOL 03.02.2020								<u>2.2020 </u>	
Address: 41 HUNTINGTON AVENUE, SCARS					SDALE	NY	Job ID / MU #	# :	
Client: PARK EAST CONSTRUCTION						Weather: SUNNY			
					Contract	or:			
Inspection Type: NOISE AND DUST MONITOR Present At Site:				Sub-Contractor:					
Transfer 1977				CM/Designer:					
Specific Loc	ation: N	ANDSE	RASEMEN	T 1ST FI	OOR	ND FLO	OOR		
Specific Location: N AND S BASEMENT, 1ST FLOOR, 2ND FLOOR Last Inspection: Building Code Section:									
Reviewed	Drawing	s:		31	V:				
Approved	Submitta	als							
Арргочец	Other:								
Deficiency:				Resolution:					
					Ž.				
Request For	r Informa	tion:			- 10 - 10 - 10 - 10 - 10 - 10 - 10 - 10				
Non-Confor									
RFI#:	Issued	RFI#:	Answered	NCR # :	Issued	NCR#:	Resolved	NCR # : Open	
Observation	ns/Notes:						<u> </u>		
Readings v	were take	n in the base		(20 feet fro	m constru			sound level meter. performed today.

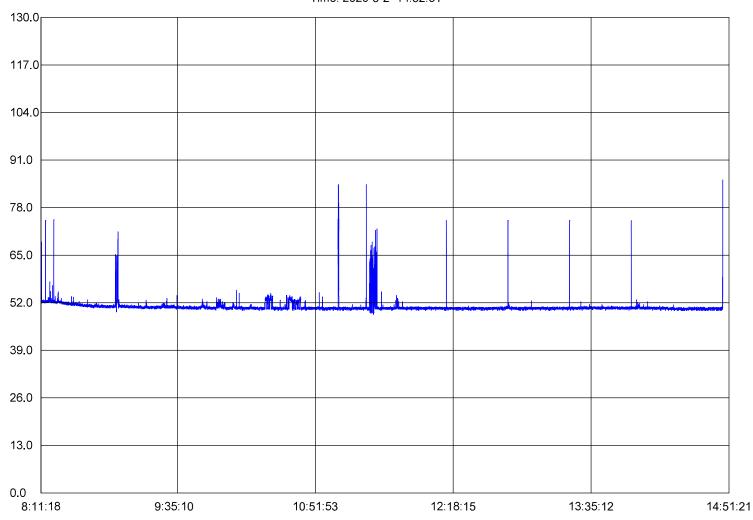
Standard Sound Level Meter RealTime Graph Time: 2020-3-2 14:52:31

Start Time: 02-03-2020,8:11:18

Maxnum: 72.50 02-03-2020,11:08:51 Minnum: 51.30 02-03-2020,12:10:13

Sample Rate: 1.00 Average: 53.12

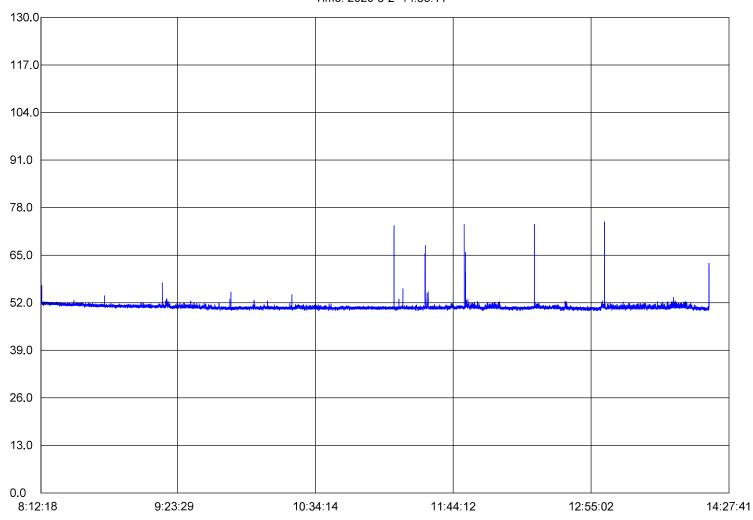
Standard Sound Level Meter RealTime Graph Time: 2020-3-2 14:53:11

Start Time: 03-02-2020,9:15:21

Maxnum: 72.30 03-02-2020,11:54:52 Minnum: 49.70 03-02-2020,10:35:15

Sample Rate: 1.00 Average: 52.11
