| Project: GREENACRES ELEMENTARY SCHOOL | Date: 03.05.2020 |

| Inspection Type: NOISE AND DUST REPORT | | Contractor: | |

MUNICIPAL
TESTING LABORATORY, INC.

INSPECTION REPORT

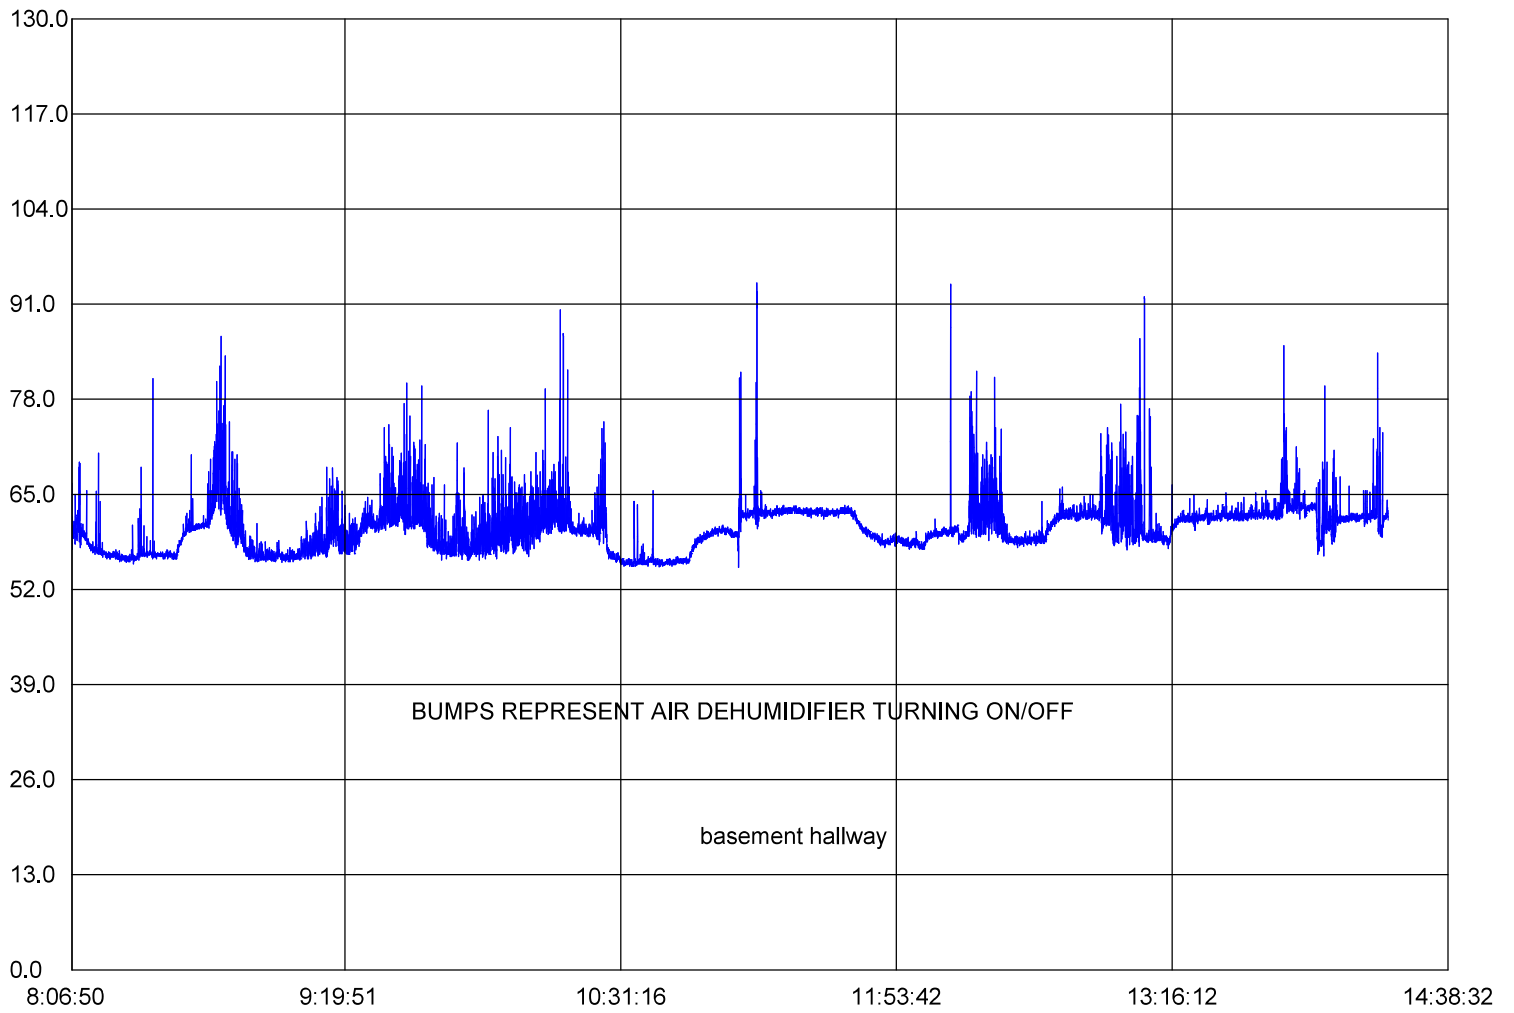
Standard Sound Level Meter RealTime Graph
Time: 2020-3-5 14:46:28

Start Time: 05-03-2020,08:06:50
Maxnum: 93.90 05-03-2020,11:00:14
Minnum: 55.00 05-03-2020,12:09:26
Sample Rate: 1.00
Average: 58.86

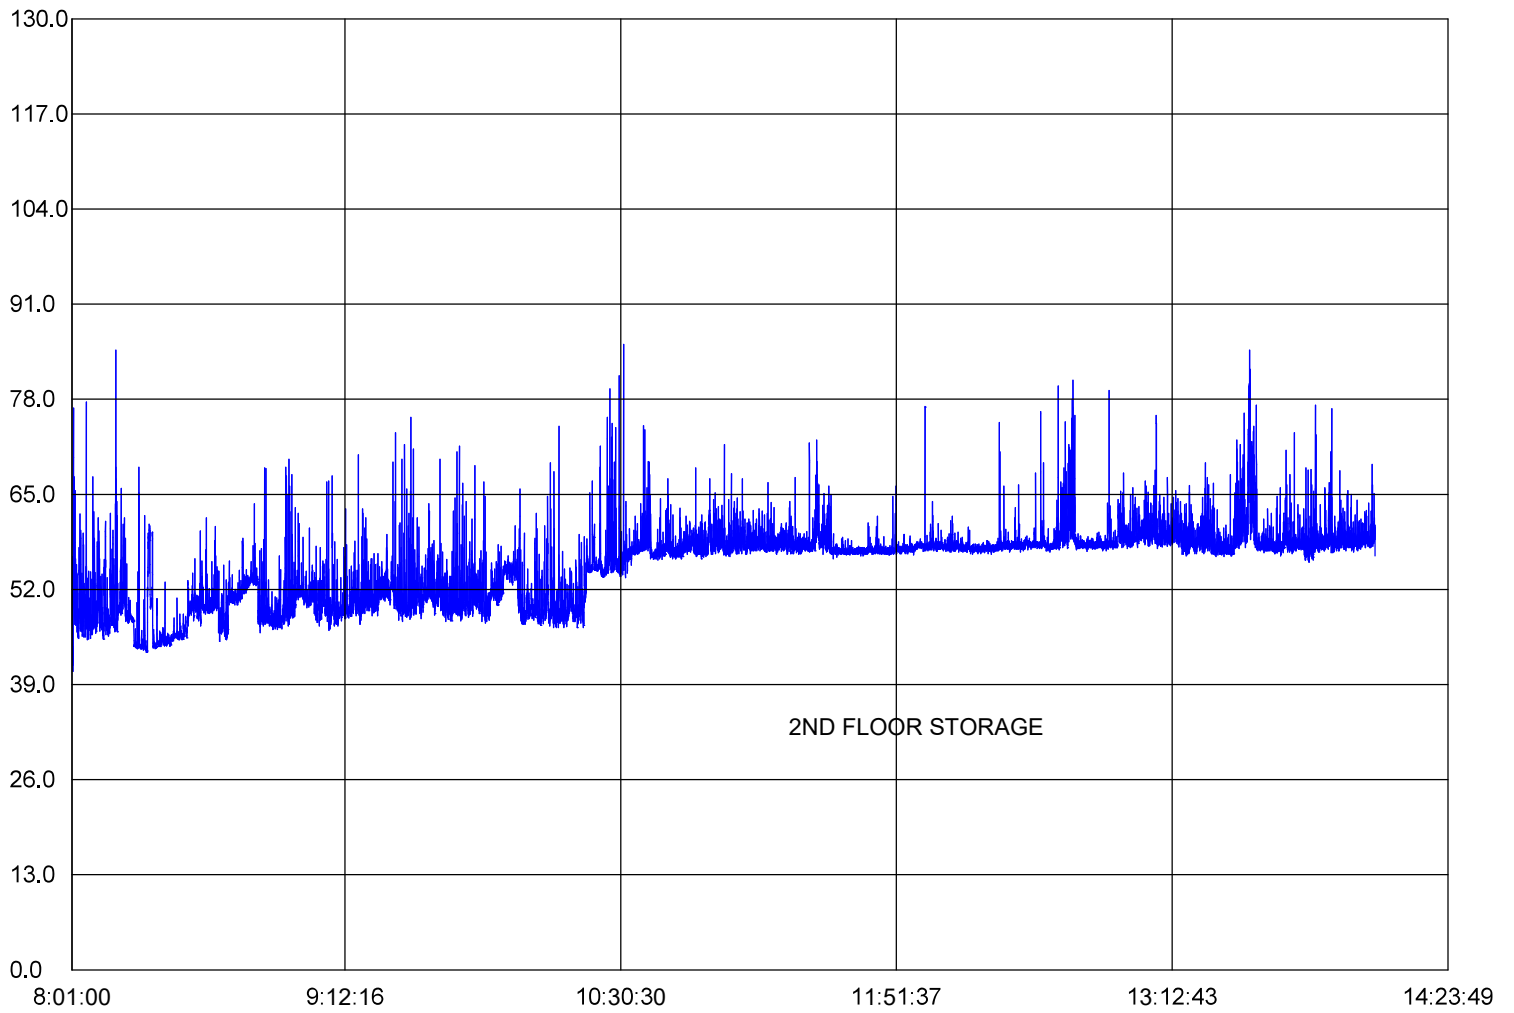
Standard Sound Level Meter RealTime Graph
Time: 2020-3-5 14:50:12

Start Time: 05-03-2020,8:01:01
Maxnum: 82.30 05-03-2020,10:31:01
Minnum: 40.80 05-03-2020,10:12:11
Sample Rate: 1.00
Average: 56.91
