Re: Greenacres Elementary School Post-Construction Air Quality Evaluation

Executive Summary

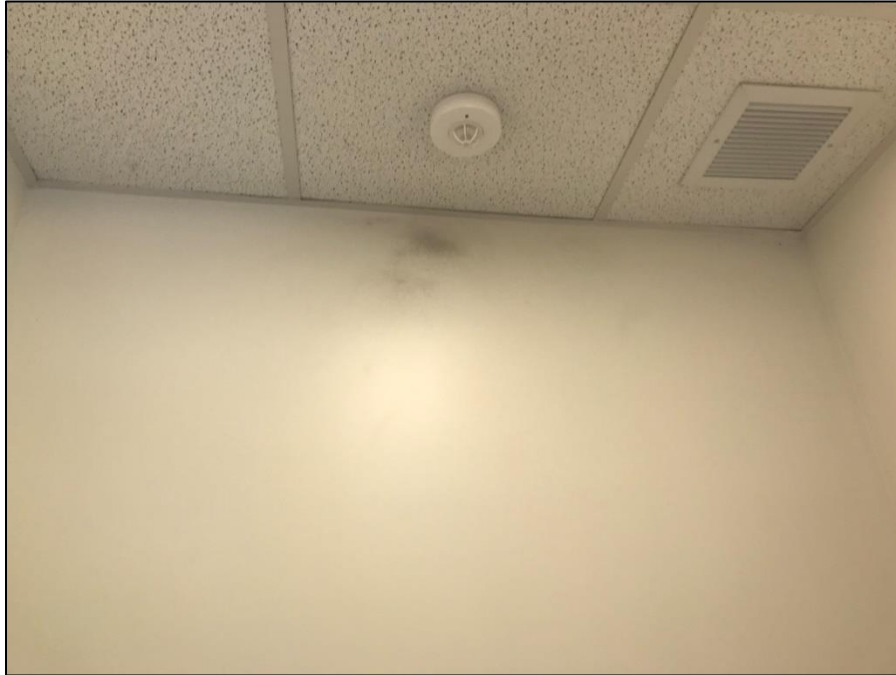
Classroom	Observation
4	Level (tool) found.
5	Dust on bathroom wall.
6	Minor dust/debris on shelf under AC. Dust on bathroom wall.
7	None.
8	Exposed radiator piping and missing trim in bathroom.
9	None.
10	Exposed wires on wall near entrance and pin board had fallen from wall.
10A	None.
11	Exposed nails, loose screws and outlet covers.
12	None.
13	Minor debris on AC coils.

Room 5 – Dust on bathroom wall.

1. Rectify the action items identified during the visual inspection prior to opening of the school.
2. Provide additional ventilation to the rooms (open windows) during remaining preparation activities (cleaning, waxing, etc.)

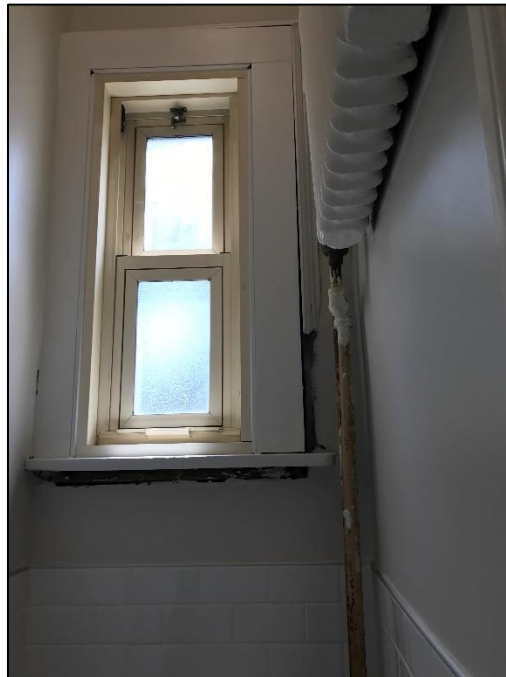
Room 8 – Exposed radiator piping and missing trim.

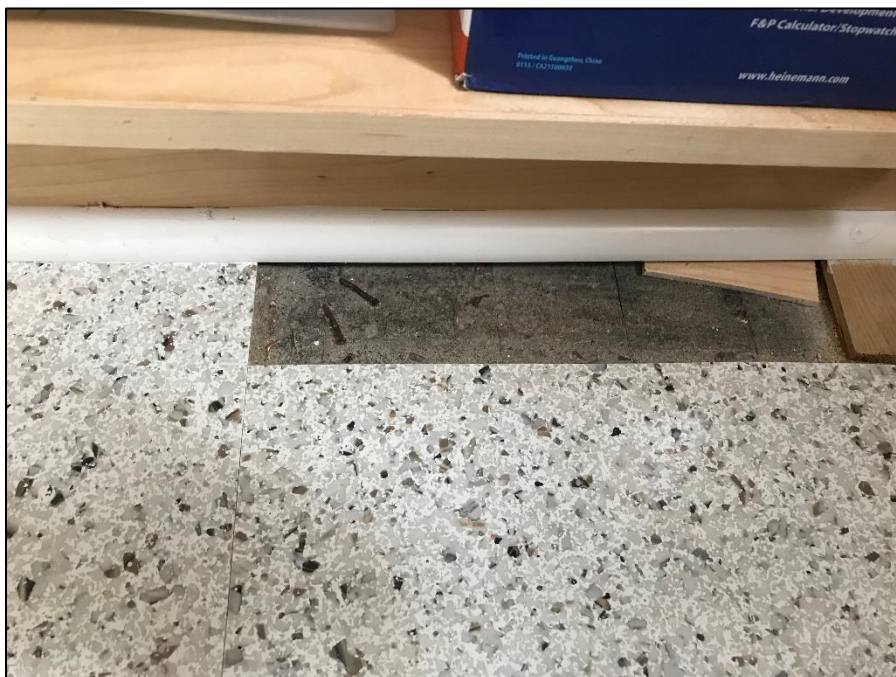
Room 11 – Exposed nails.

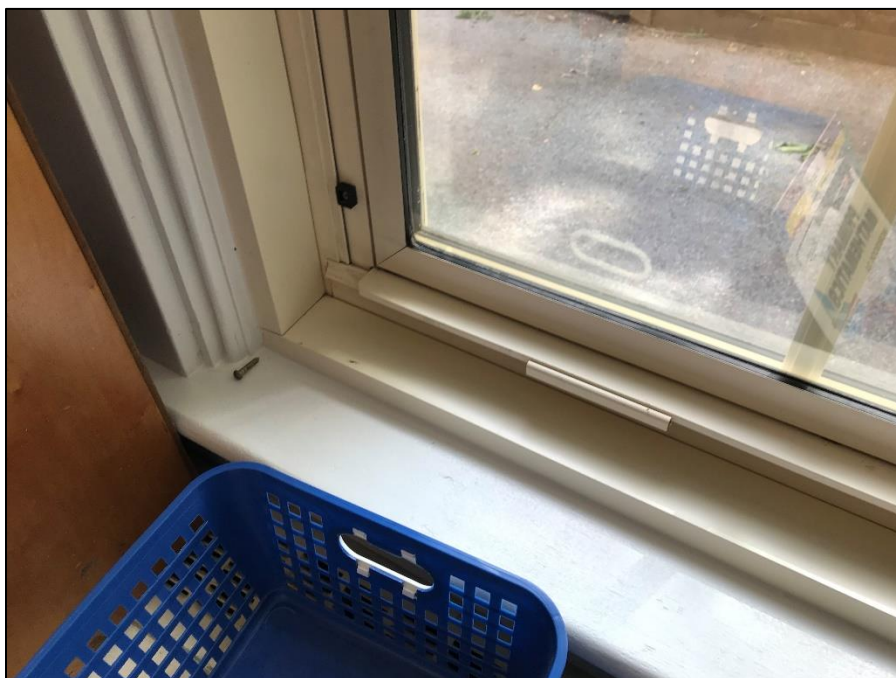
Room 11 – Remaining screw (removed).

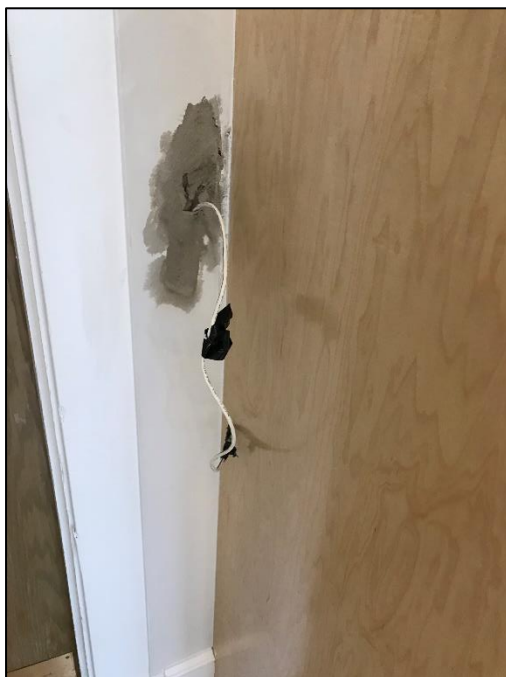
Room 10 – Exposed wires near door.

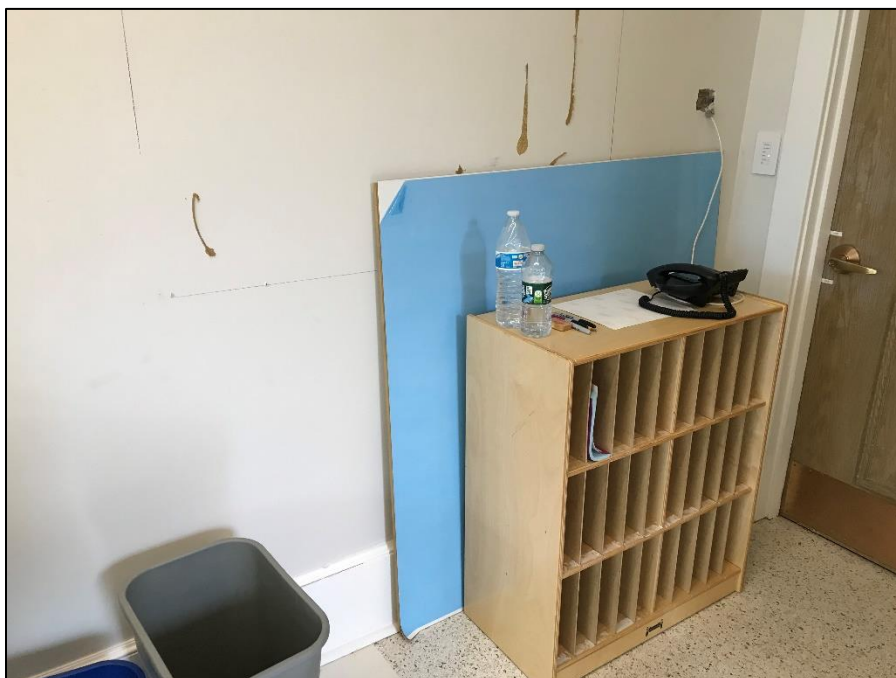
Room 10 – Fallen pin board.
