MUNICIPAL
 TESTING LABORATORY, INC.

INSPECTION REPORT

Project: Greenacres School	Date: 09/10/19
Address: 41 Huntington Avenue, Scarsdale NY 10583	Job ID / MU #:
Client: Park East Construction	Weather: Rain (AM), Sun (PM)

Inspection Type: Noise and Dust Monitoring	Contractor: Park East
Present At Site: 7:00AM	Sub-Contractor:
General Area: Northern Yard of School	CM/Designer:
Specific Location: Northern Side of school 1st, 2nd floor, Basement	
Last Inspection:	Building Code Section:
Reviewed	Drawings:
Approved	Submittals
	Other:

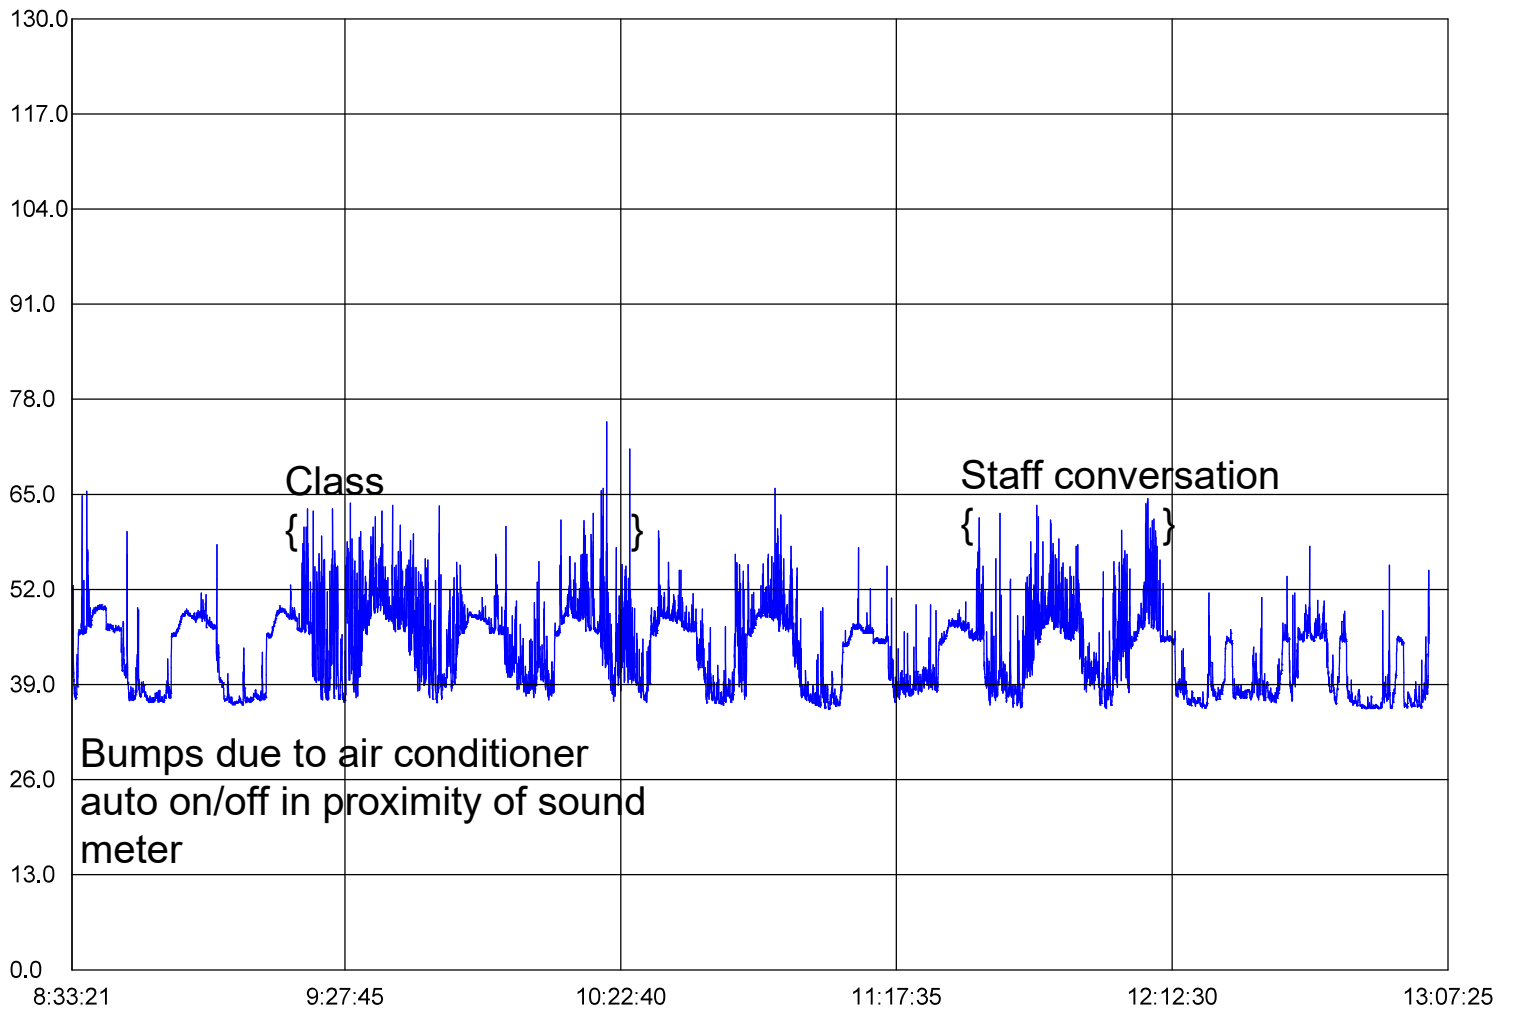
Library AM data

Standard Sound Level Meter RealTime Graph
Time: 2019-9-11 8:8:37

Start Time: 10-09-2019,8:33:21
Maxnum: 74.90 10-09-2019,10:19:52
Minnum: 35.60 10-09-2019,11:04:08
Sample Rate: 1.00
Average: 43.56

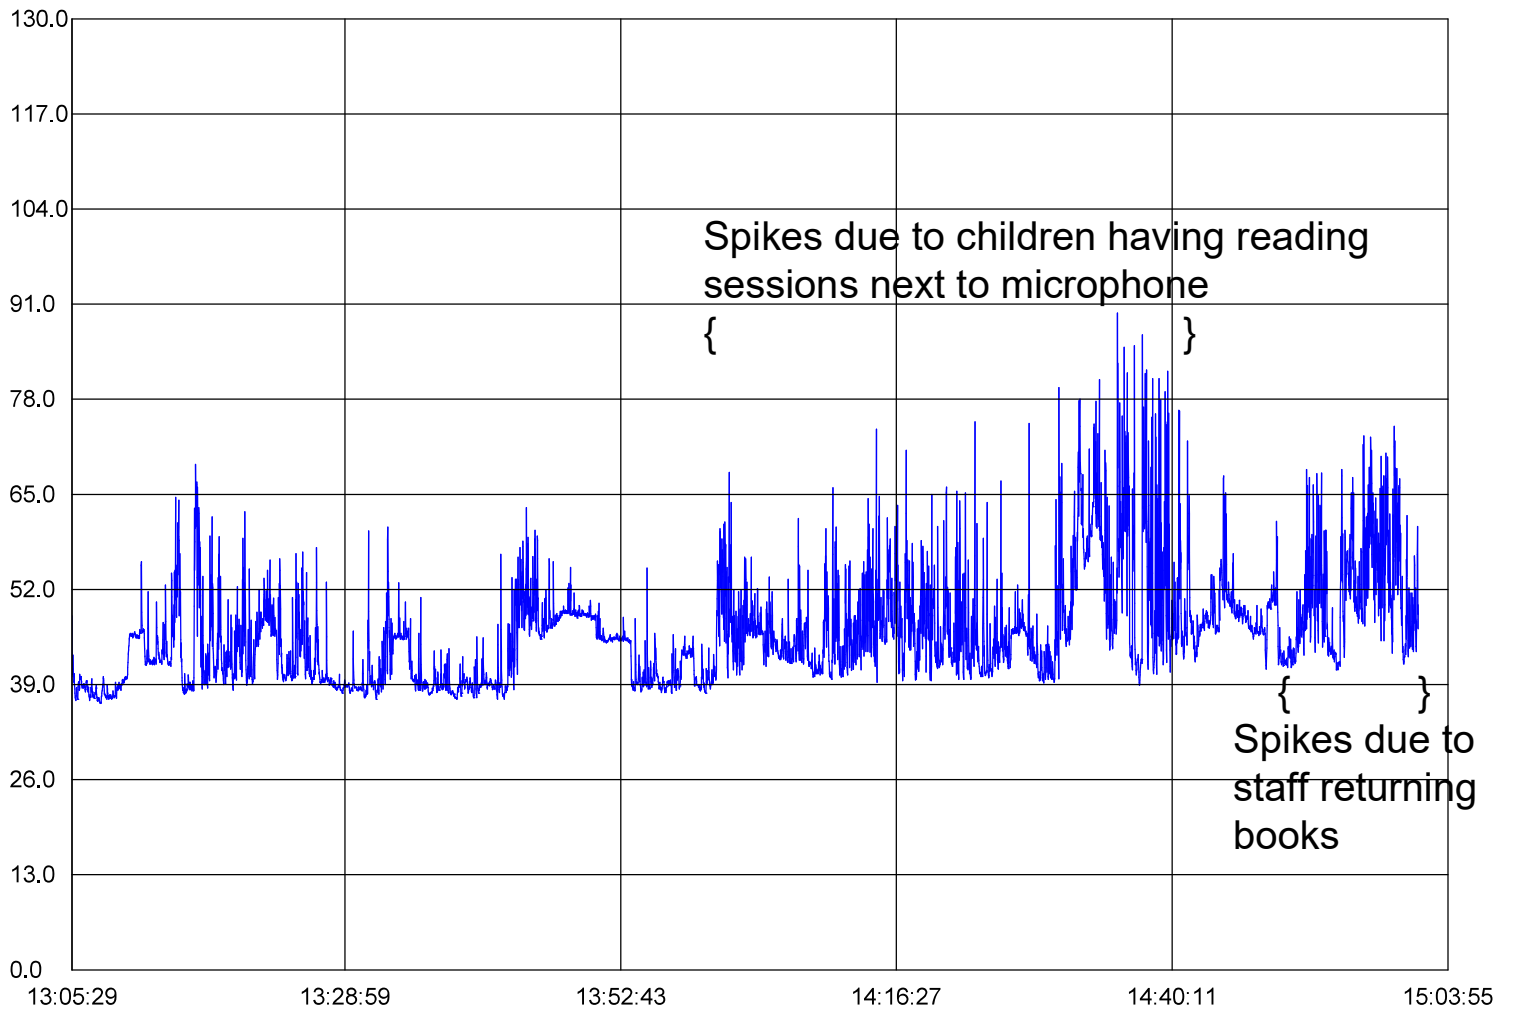
Library PM data

Start Time: 10-09-2019,13:05:29
Maxnum: 89.80 10-09-2019,14:35:29
Minnum: 36.40 10-09-2019,13:07:57
Sample Rate: 1.00
Average: 46.02
