INSPECTION REPORT

Project: Greenacres School	Date: 09/11/19
Address: 41 Huntington Avenue, Scarsdale NY 10583	Job ID / MU #:
Client: Park East Construction	Weather: Sunny

Inspection Type: Noise and Dust Monitoring	Contractor: Park East
Present At Site: 7:00AM	Sub-Contractor:
General Area: Northern Yard of School	CM/Designer:
Specific Location: Northern Side of school 1st, 2nd floor, Basement	
Last Inspection:	Building Code Section:
Reviewed	Drawings:
Approved	Submittals
	Other:

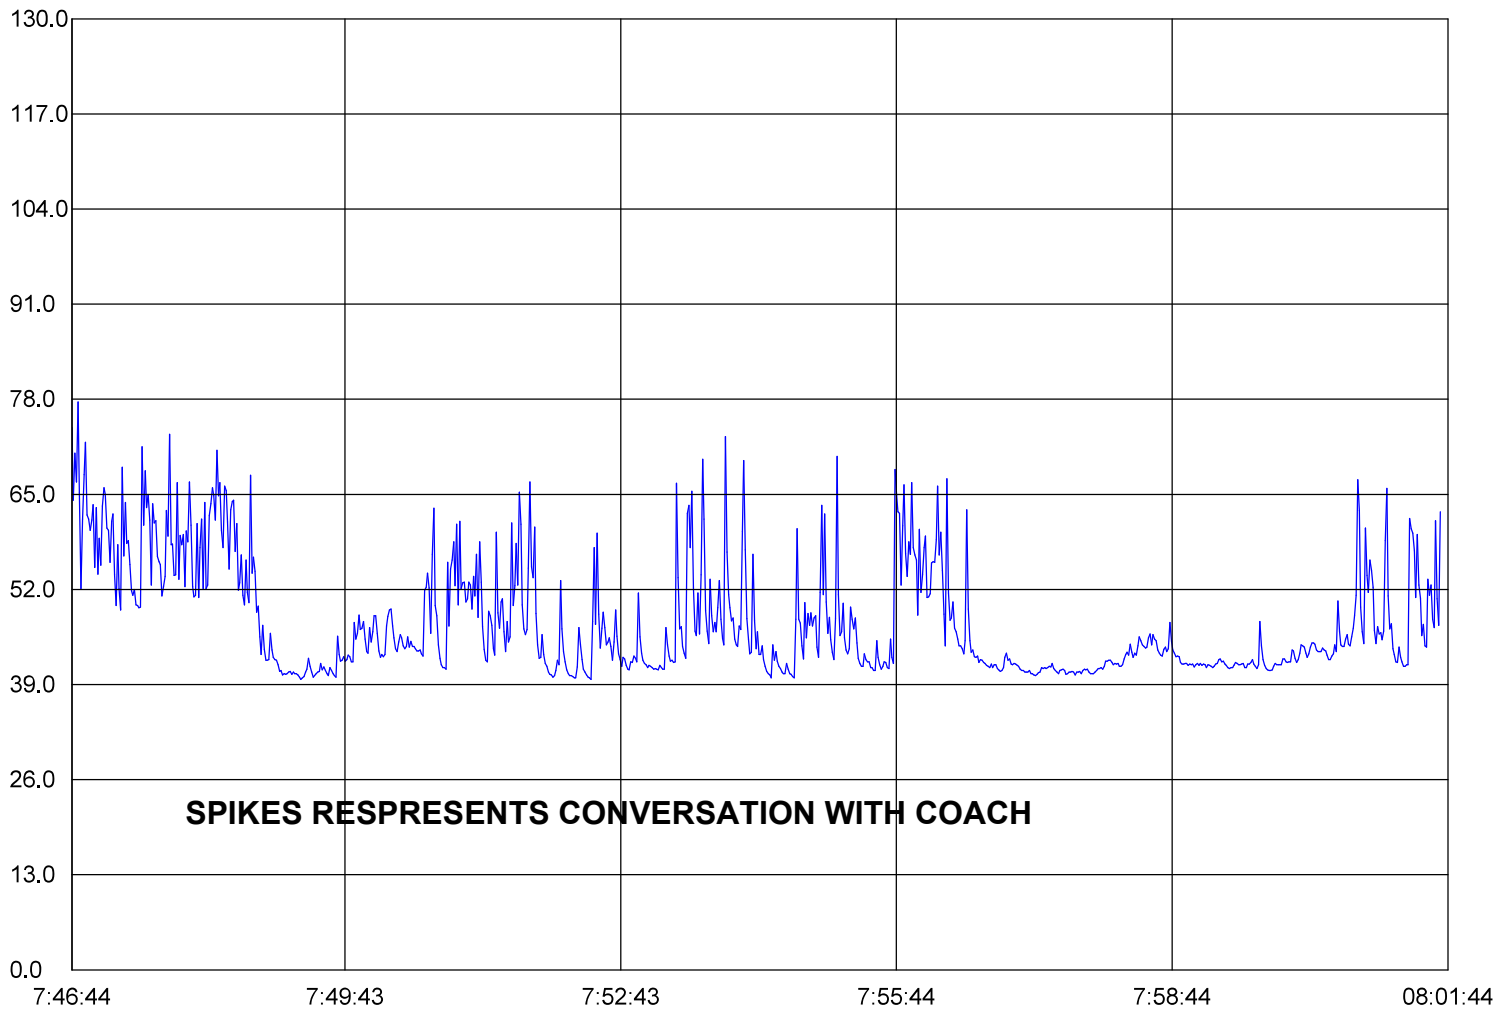
Gymnasium AM

Standard Sound Level Meter RealTime Graph
Time: 2019-9-11 8:13:58

Start Time: 11-09-2019,7:46:44
Maxnum: 77.60 11-09-2019,7:46:48
Minnum: 39.70 11-09-2019,7:49:14
Sample Rate: 1.00
Average: 47.49

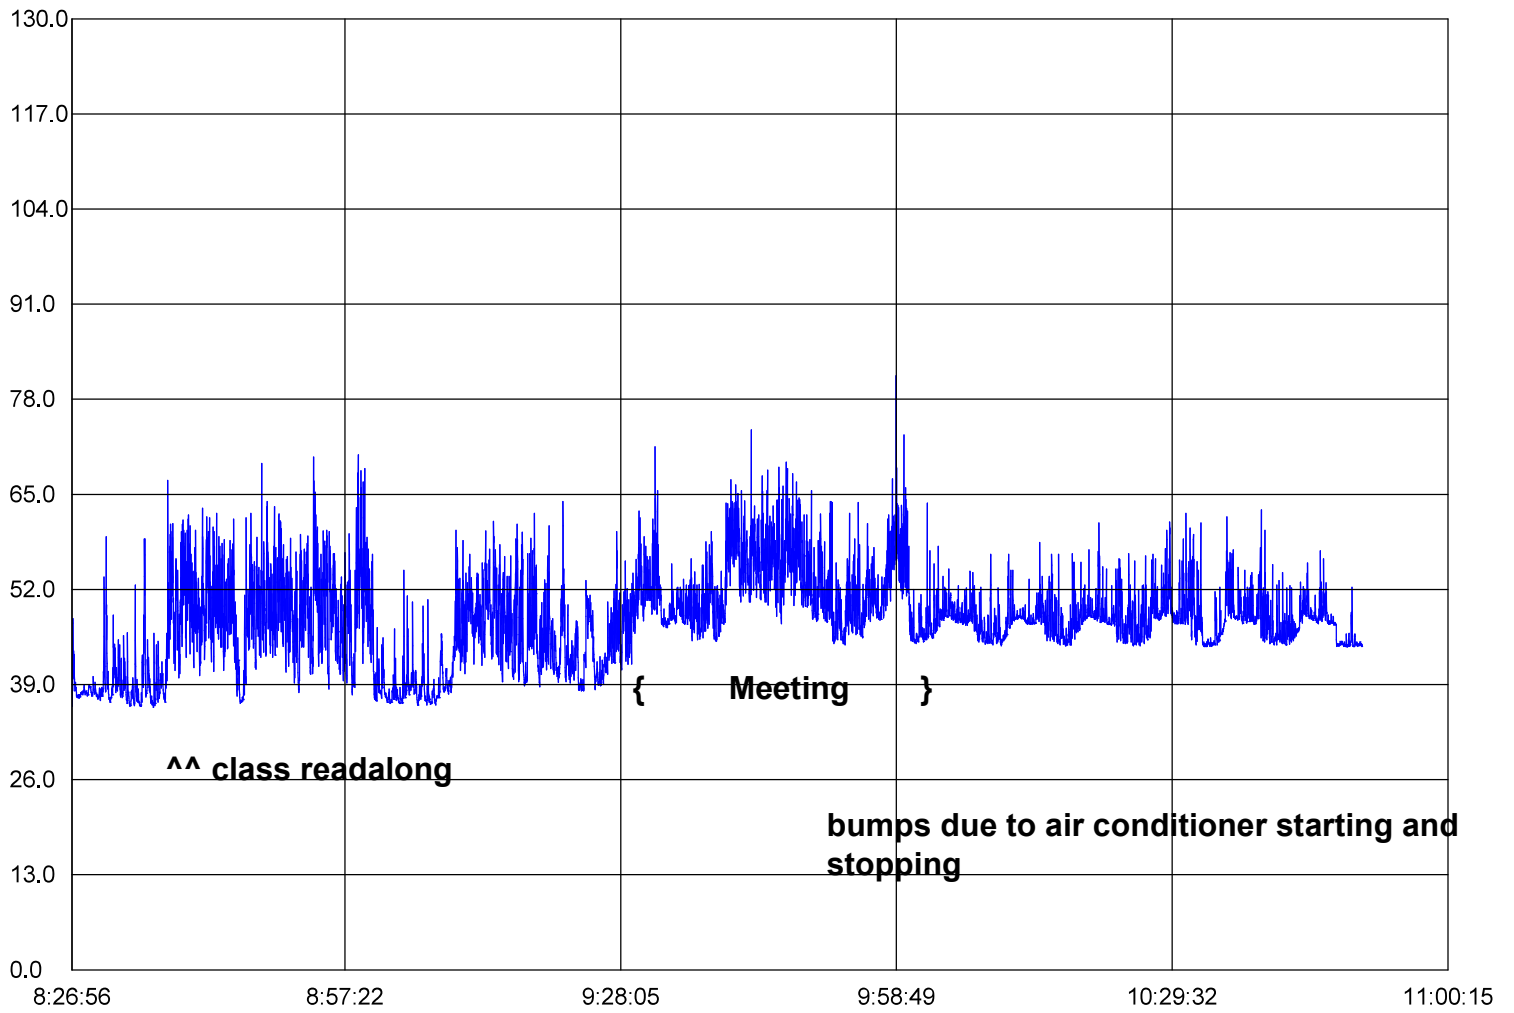
Library Data AM

Standard Sound Level Meter RealTime Graph
Time: 2019-9-11 11:50:9

Start Time: 11-09-2019,8:26:56
Maxnum: 81.20 11-09-2019,9:58:47
Minnum: 35.90 11-09-2019,8:36:01
Sample Rate: 1.00
Average: 47.69

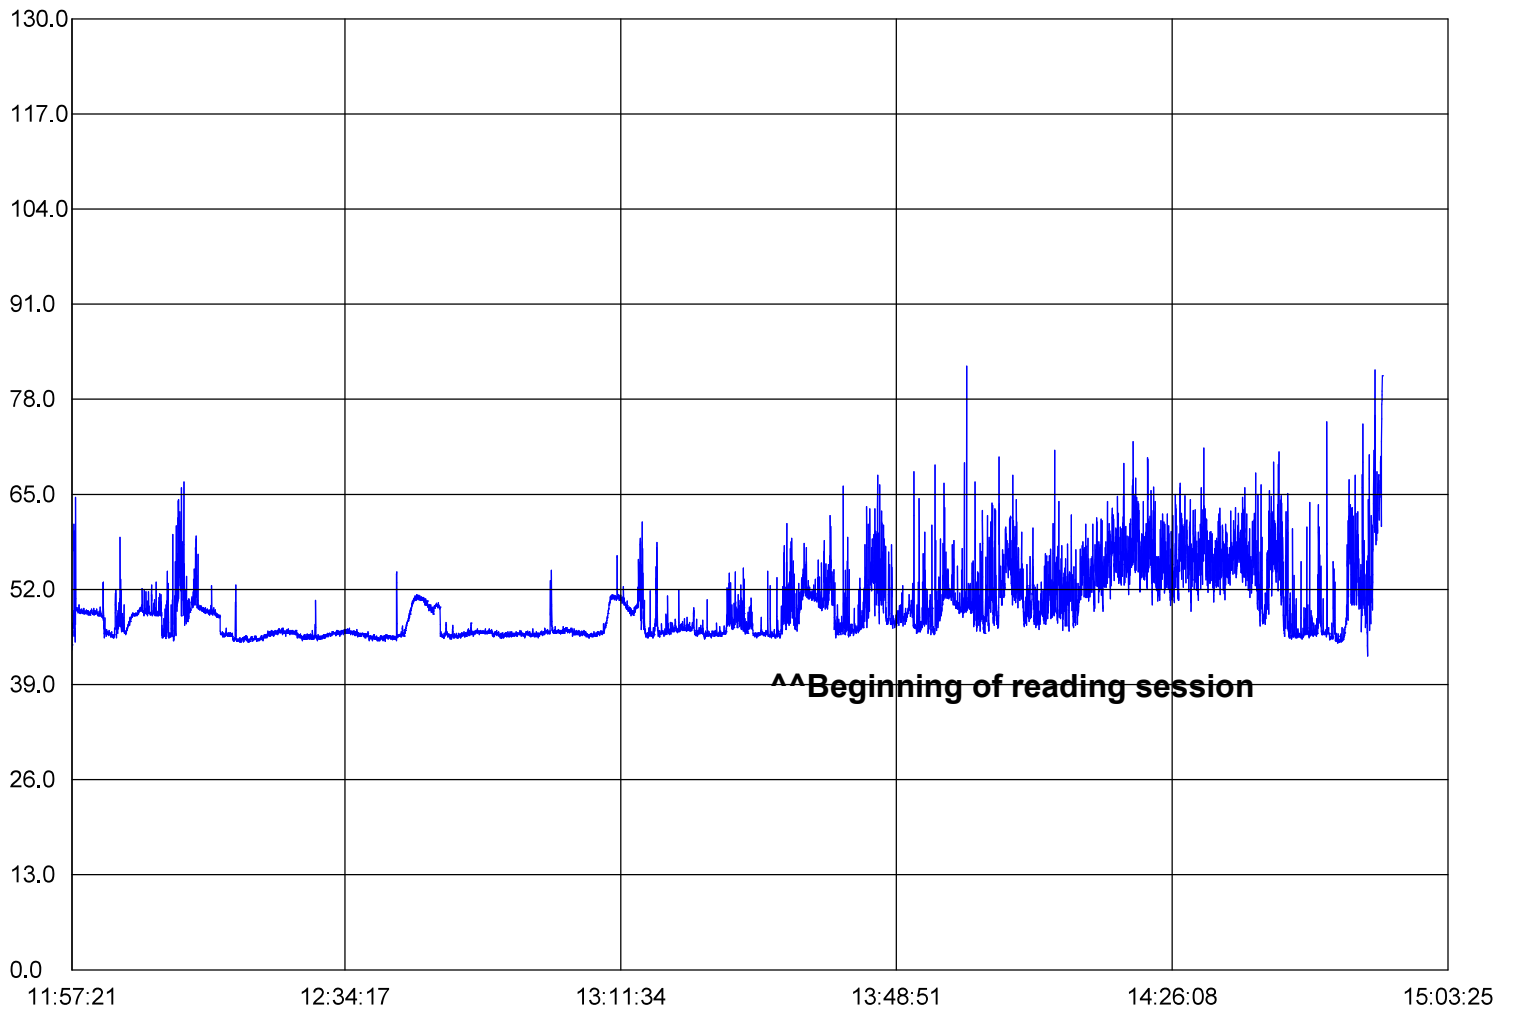
Library

Standard Sound Level Meter RealTime Graph
Time: 2019-9-12 8:4:14

Start Time: 11-09-2019,11:57:21
Maxnum: 82.50 11-09-2019,13:58:21
Minnum: 42.90 11-09-2019,14:52:34
Sample Rate: 1.00
Average: 49.60
