MUNICIPAL
TESTING LABORATORY, INC.

INSPECTION REPORT

Project: Greenacres School	Date: 09/12/19
Address: 41 Huntington Avenue, Scarsdale NY 10583	Job ID / MU #:
Client: Park East Construction	Weather: Sunny (AM) Rain (PM)

Inspection Type: Noise and Dust Monitoring	Contractor: Park East
Present At Site: 7:00AM	Sub-Contractor:
General Area: Northern Yard of School	CM/Designer:
Specific Location: Northern Side of school 1st, 2nd floor, Basement	
Last Inspection:	Building Code Section:
Reviewed	Drawings:
Approved	Submittals
	Other:

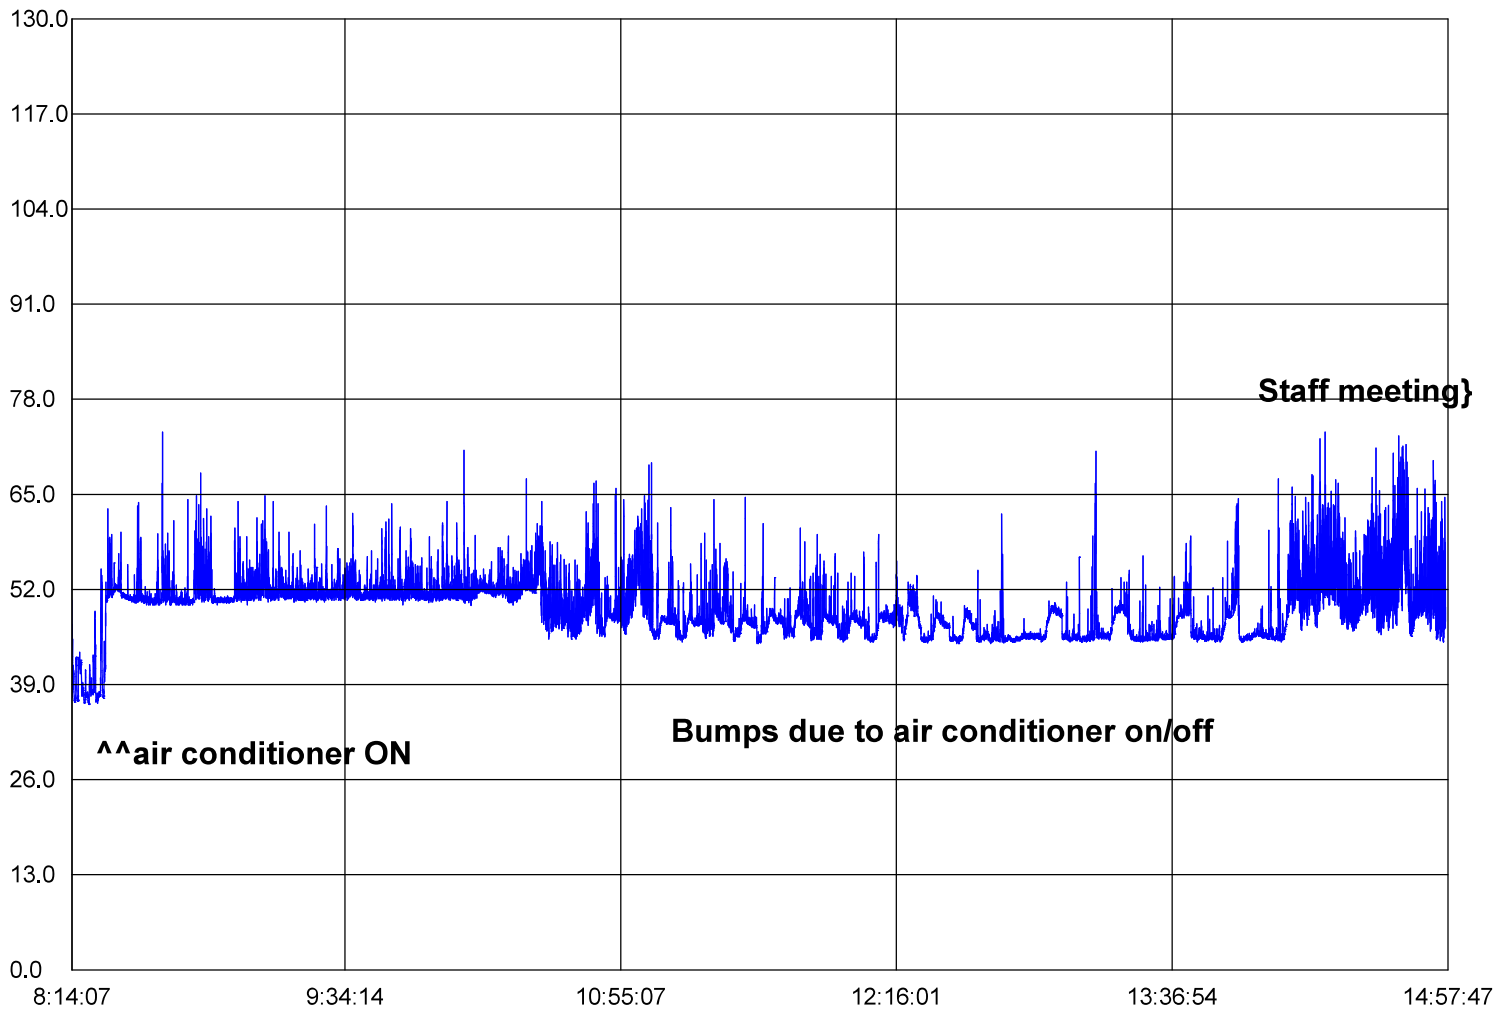
Library data

Noise caused by ongoing construction in the perimeter of the school was monitored using a sound level meter. Readings were taken in the library, next to the work performed today.

An average noise level of 49.40 was measured today

Standard Sound Level Meter RealTime Graph
Time: 2019-9-12 15:25:53

Start Time: 12-09-2019,8:14:07
Maxnum: 73.50 12-09-2019,8:40:43
Minnum: 36.30 12-09-2019,8:19:04
Sample Rate: 1.00
Average: 49.38
