Project: <b>Greenacres School</b>	Date: <b>09/13/19</b>
Address: <b>41 Huntington Avenue, Scarsdale NY 10583</b>	Job ID / MU #:
Client: <b>Park East Construction</b>	Weather: <b>Sunny (AM)</b>

Inspection Type: <b>Noise and Dust Monitoring</b>	Contractor: <b>Park East</b>
Present At Site: <b>7:00AM</b>	Sub-Contractor:
General Area: <b>Northern Yard of School</b>	CM/Designer:
Specific Location: <b>Northern Side of school 1st, 2nd floor, Basement</b>	
Last Inspection:	Building Code Section:
Reviewed	Drawings:
Approved	Submittals
	Other:

## INSPECTION REPORT

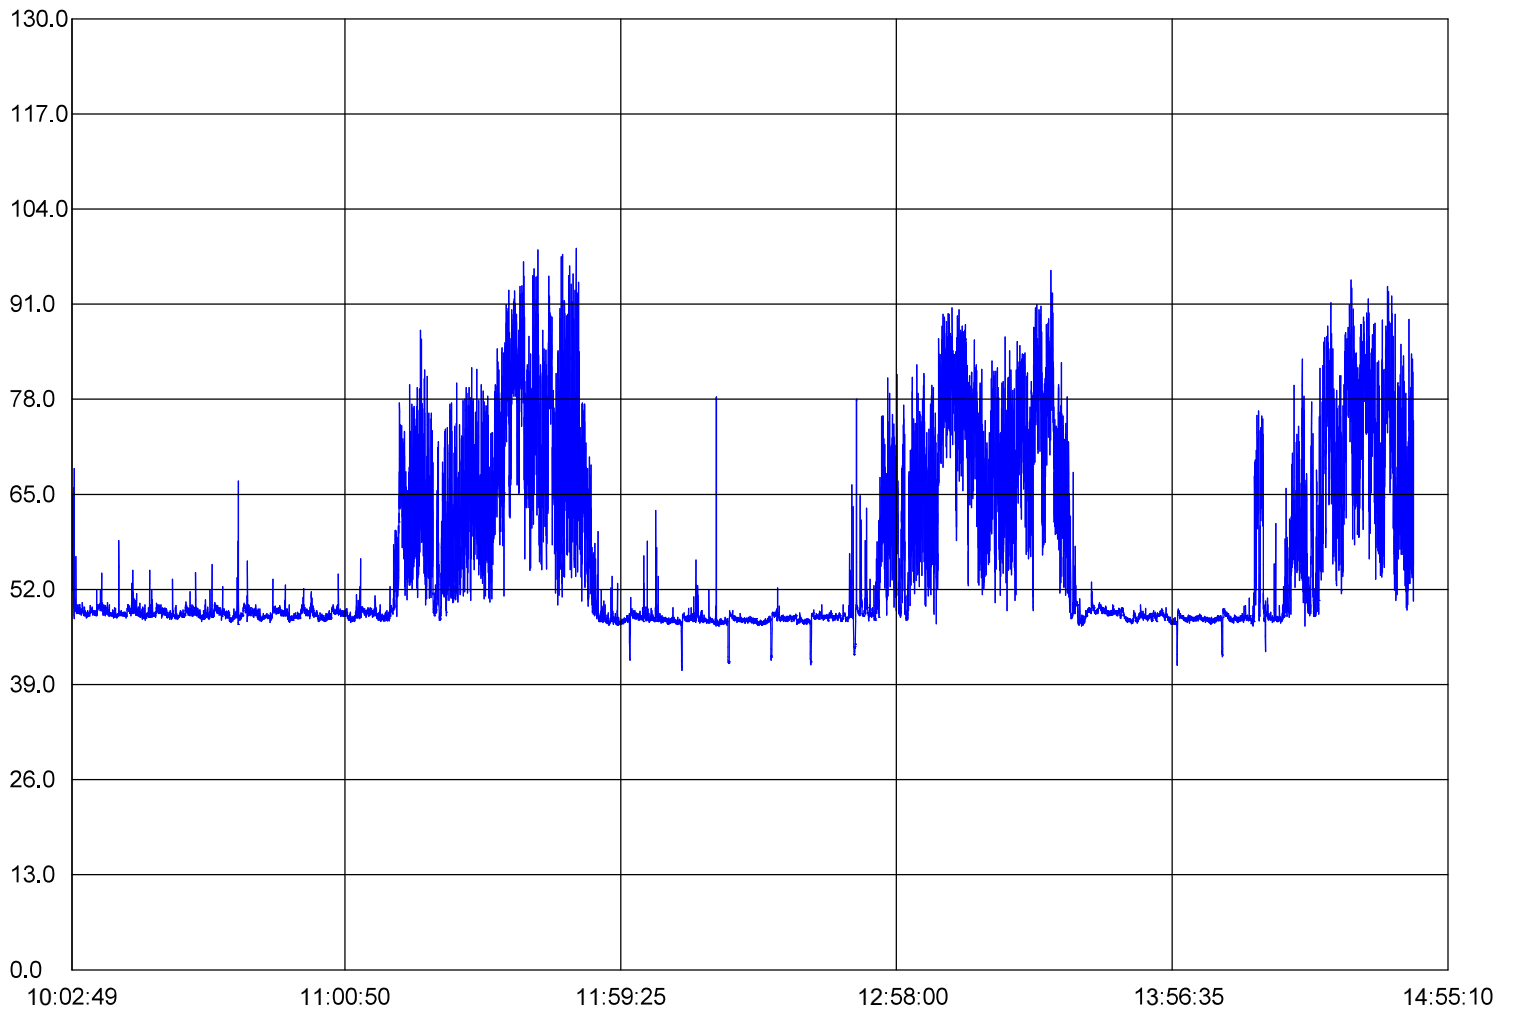
**Kindergarten**

Standard Sound Level Meter RealTime Graph  
Time: 2019-9-13 14:51:19

Start Time: 13-09-2019,10:02:49  
Maxnum: 98.60 13-09-2019 11:49:58  
Minnum: 40.90 13-09-2019,12:12:28  
Sample Rate: 1.00  
Average: 56.05

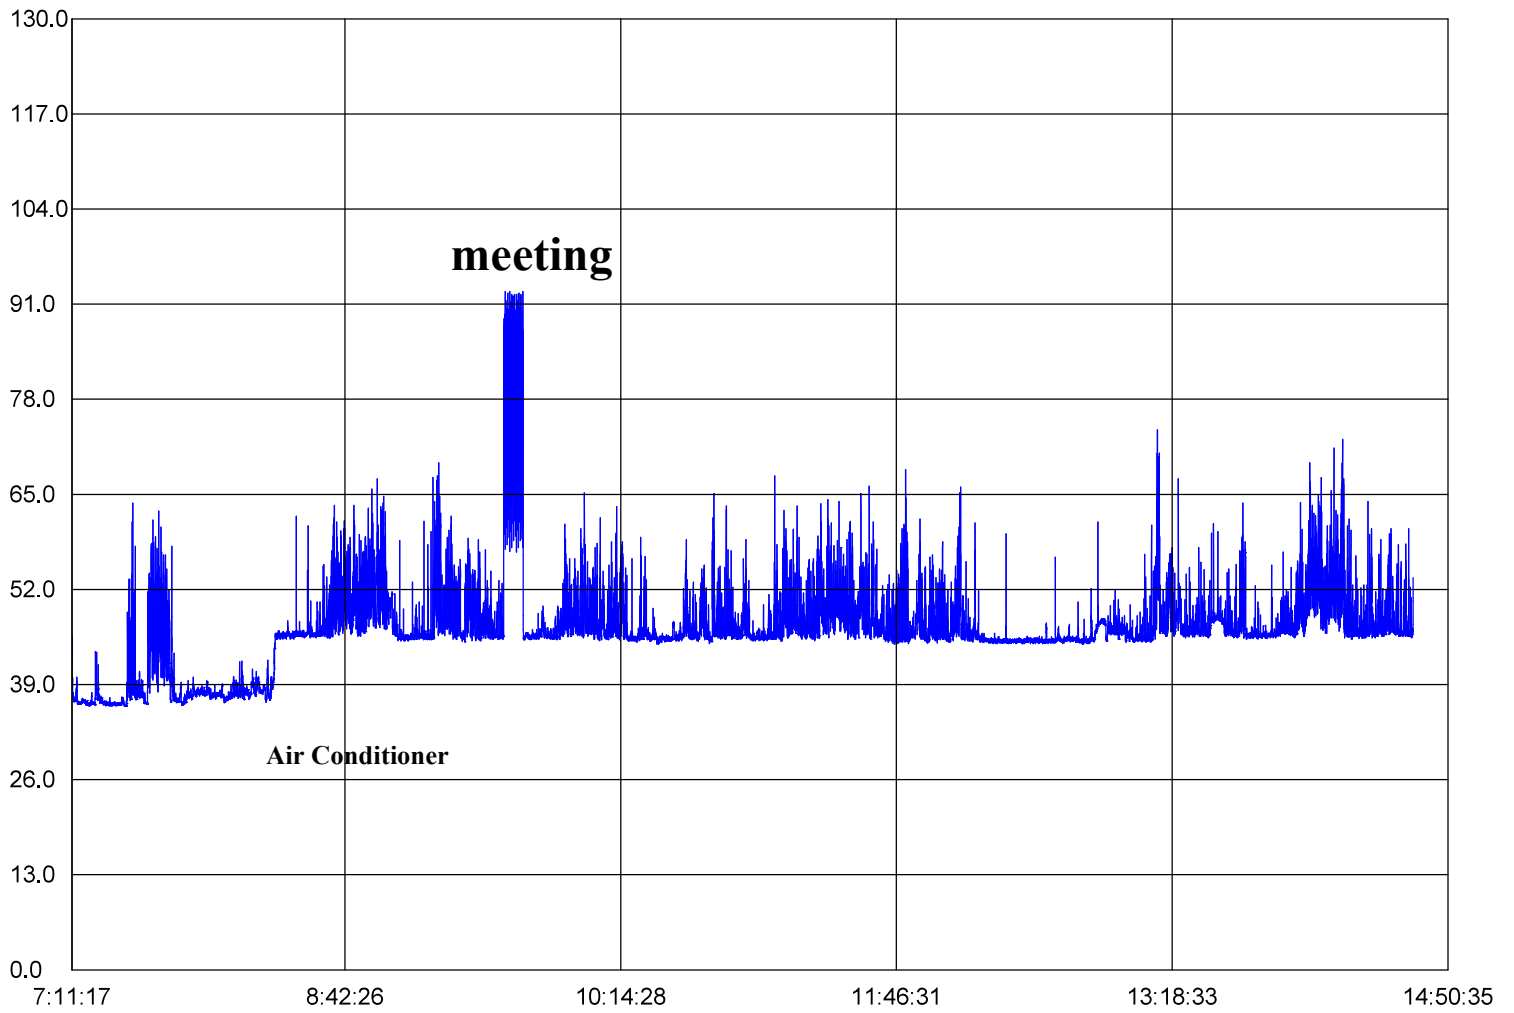
**Library Data**

Noise caused by ongoing construction in the perimeter of the school was monitored using a sound level meter. Readings were taken in the library, next to the work performed today.

An average noise level of 50,83 was measured today

Standard Sound Level Meter RealTime Graph  
Time: 2019-9-13 14:46:49

Start Time: 13-09-2019,7:11:17  
Maxnum: 92.70 13-09-2019,9:35:56  
Minnum: 36.00 13-09-2019,7:17:11  
Sample Rate: 1.00  
Average: 46.62
