**MUNICIPAL**  
TESTING LABORATORY, INC.

## INSPECTION REPORT

| Project: <b>Greenacres School</b> | Date: <b>09/17/19</b> |

| Inspection Type: <b>Noise and Dust Monitoring</b> | Contractor: <b>Park East</b> |

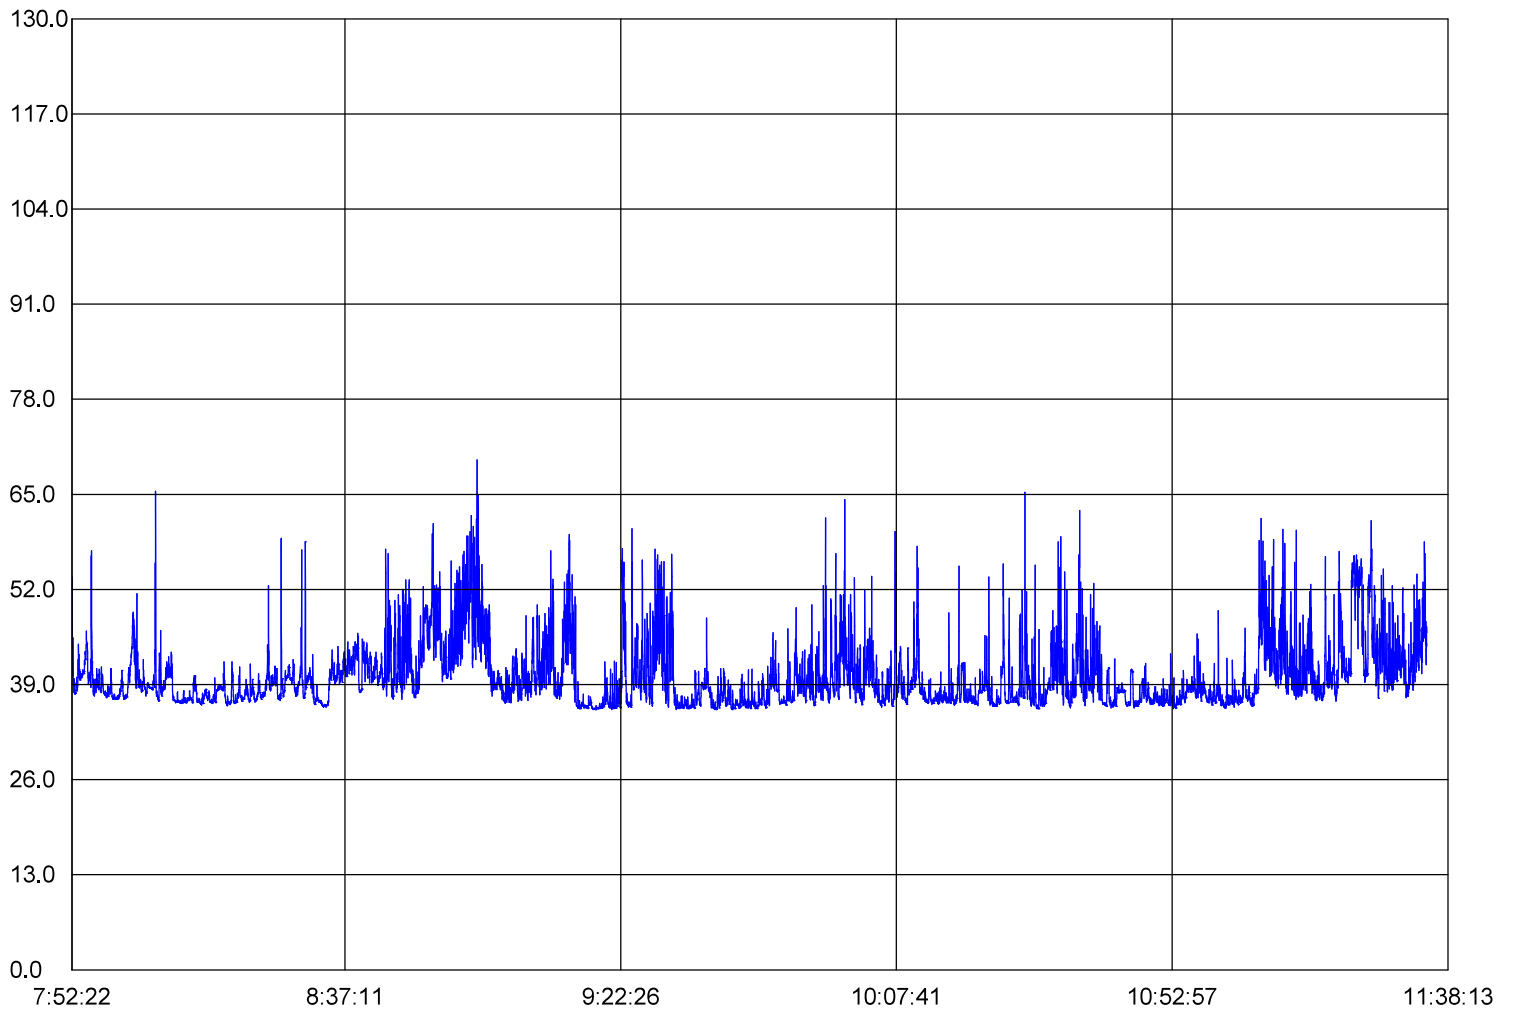
Library

Standard Sound Level Meter RealTime Graph  
Time: 2019-9-17 14:40:38

Start Time: 17-09-2019,7:52:22  
Maxnum: 69.70 17-09-2019,8:58:52  
Minnum: 35.60 17-09-2019,9:17:55  
Sample Rate: 1.00  
Average: 40.00

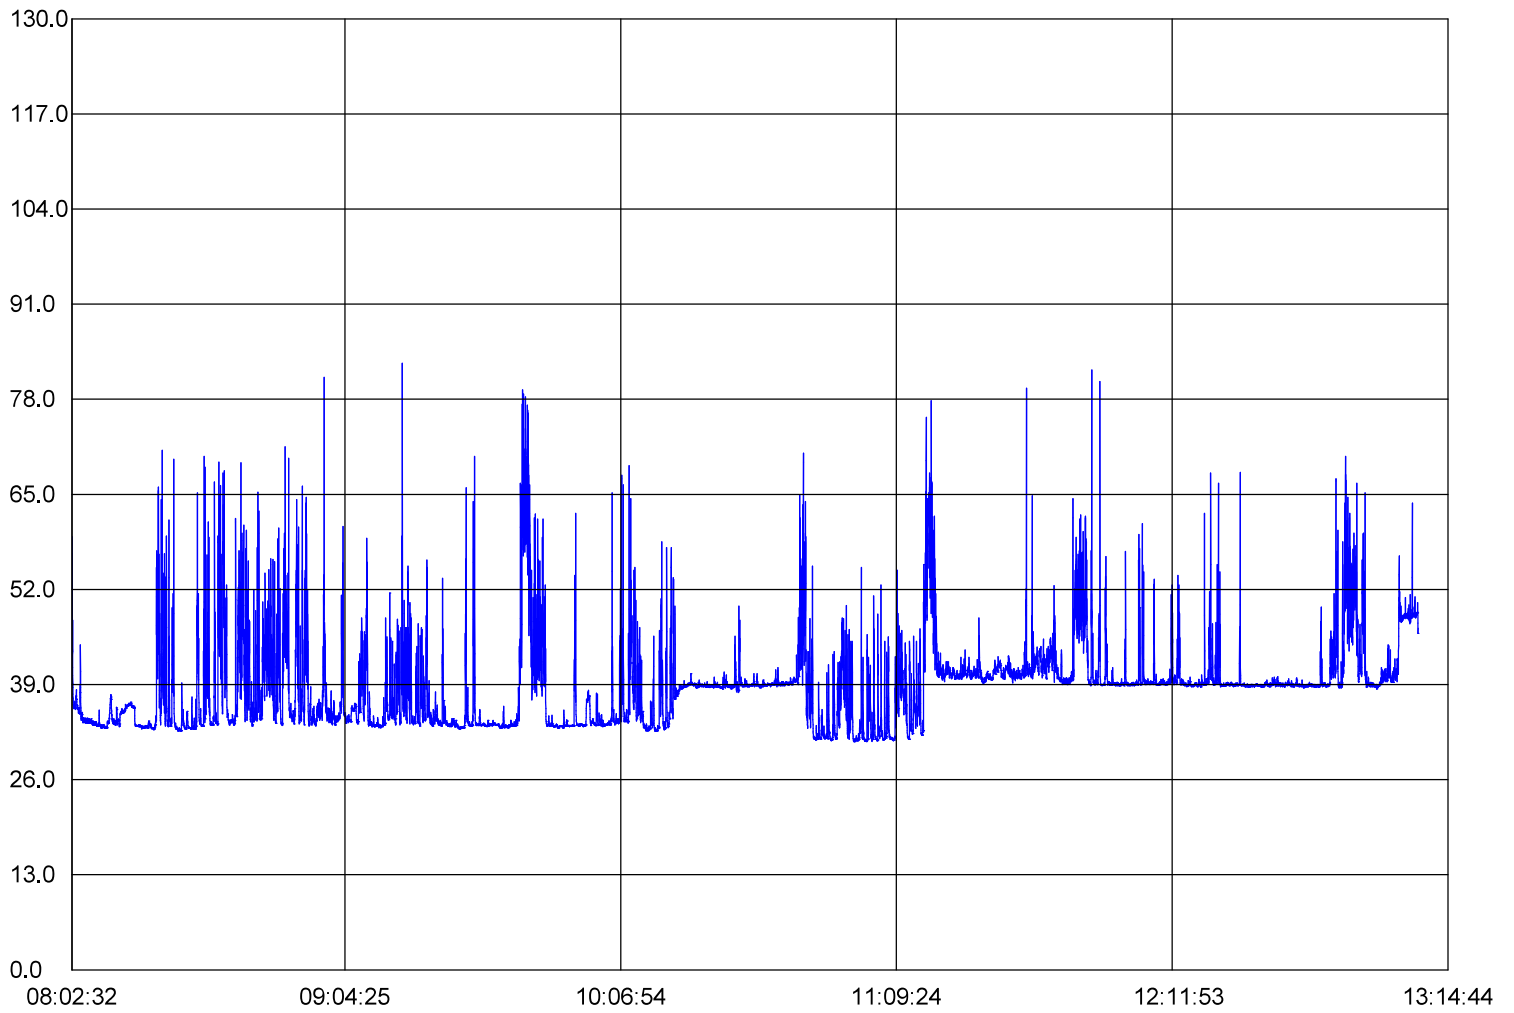
Kindergarten

Standard Sound Level Meter RealTime Graph  
Time: 2019-9-17 13:23:41

Start Time: 17-09-2019,08:02:32  
Maxnum: 82.90 17-09-2019,09:17:26  
Minnum: 31.20 17-09-2019,10:59:44  
Sample Rate: 1.00  
Average: 38.74

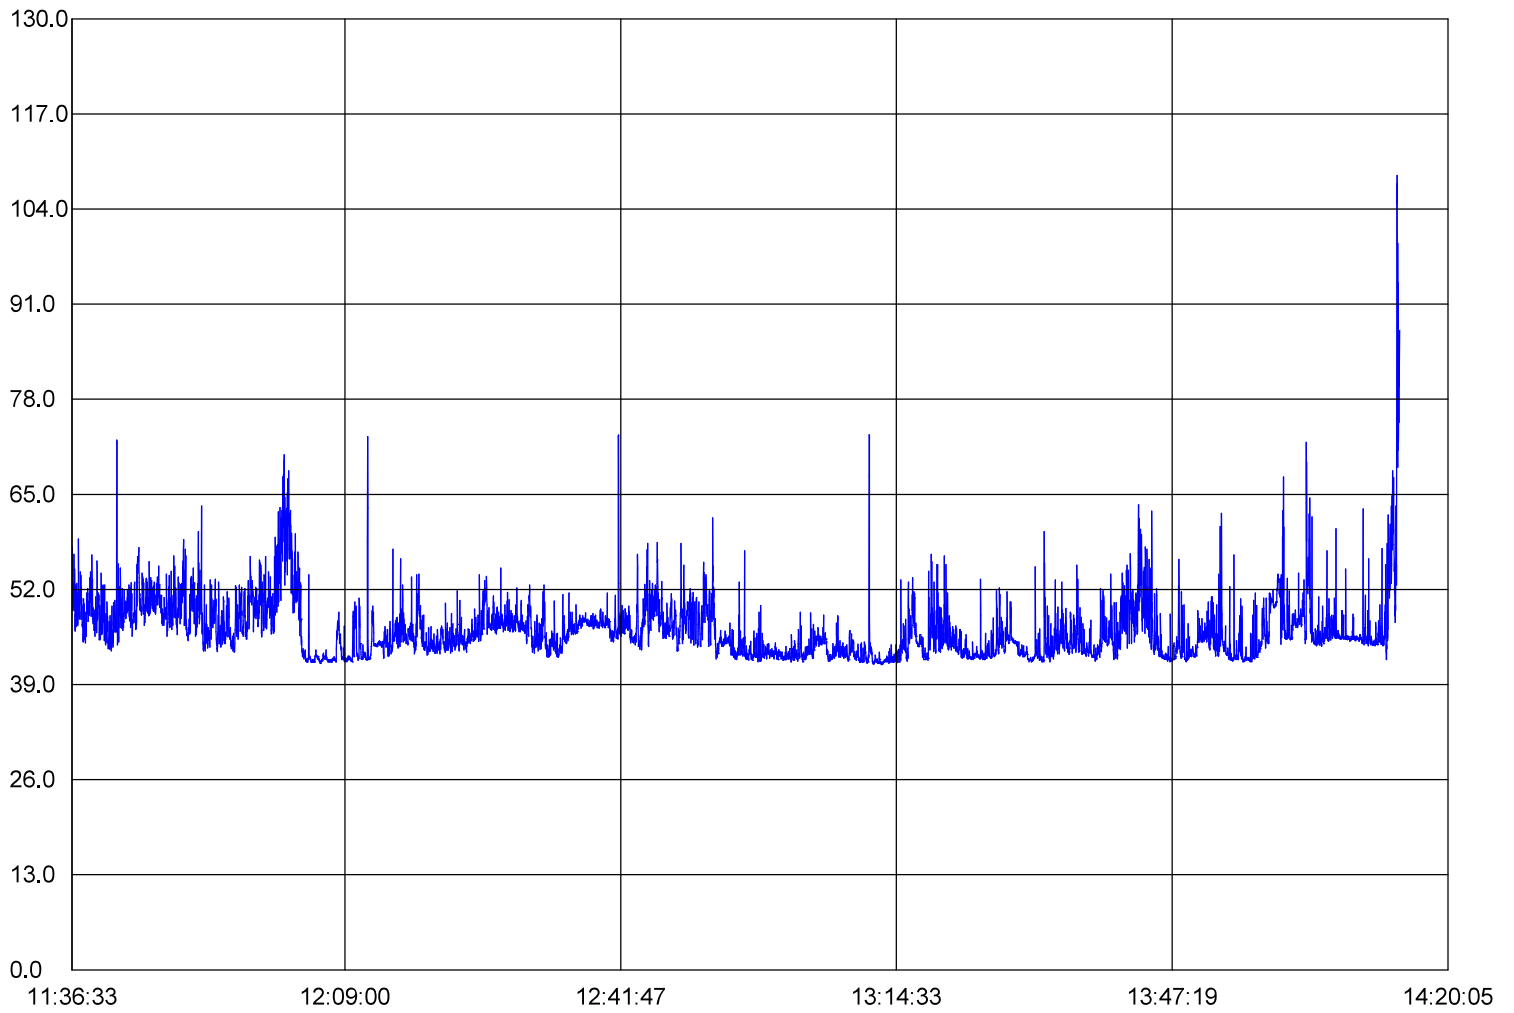
Library PM DATA

Standard Sound Level Meter RealTime Graph  
Time: 2019-9-17 14:49:52

Start Time: 17-09-2019,11:36:33  
Maxnum: 108.60 17-09-2019,14:14:05  
Minnum: 41.70 17-09-2019,13:12:46  
Sample Rate: 1.00  
Average: 46.37
