## INSPECTION REPORT

Project: <b>Greenacres School</b>	Date: <b>09/25/19</b>
Address: <b>41 Huntington Avenue, Scarsdale NY 10583</b>	Job ID / MU #:
Client: <b>Park East Construction</b>	Weather: <b>Sunny(AM)</b>

Inspection Type: <b>Noise and Dust Monitoring</b>	Contractor: <b>Park East</b>
Present At Site: <b>7:00AM</b>	Sub-Contractor:
General Area: <b>Northern Yard of School</b>	CM/Designer:
Specific Location: <b>Northern Side of school 1st, 2nd floor, Basement</b>	
Last Inspection:	Building Code Section:
Reviewed	Drawings:
Approved	Submittals
	Other:

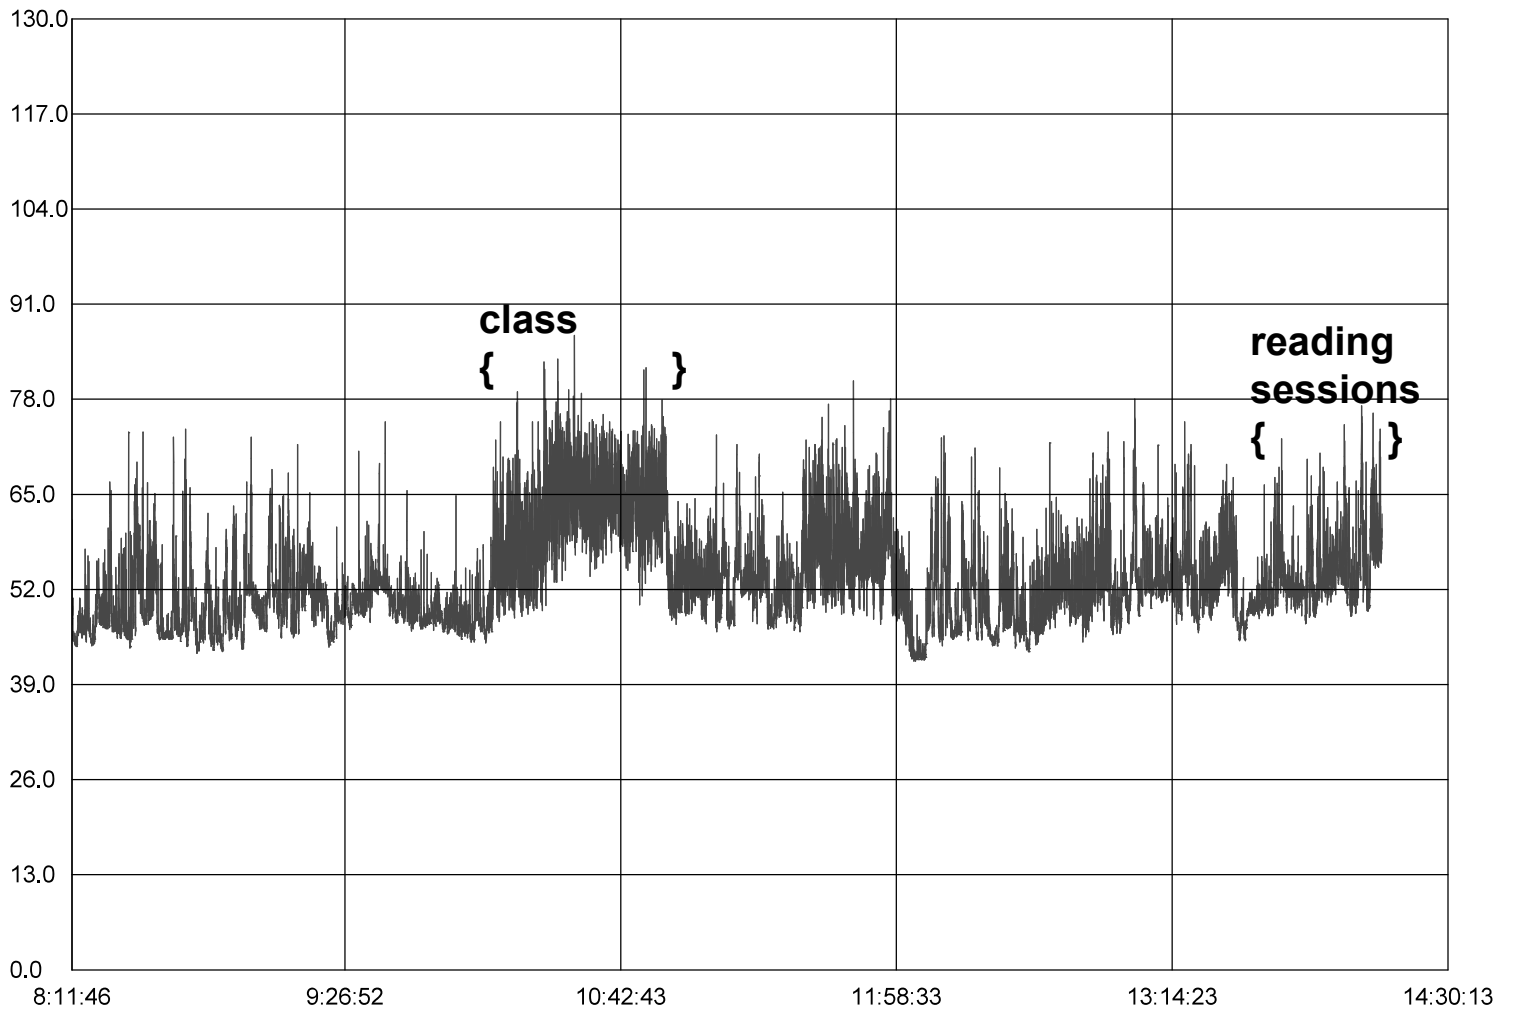
**LIBRARY**

Standard Sound Level Meter RealTime Graph  
Time: 2019-9-25 14:22:41

Start Time: 25-09-2019,8:11:46  
Maxnum: 86.70 25-09-2019,10:30:01  
Minnum: 42.20 25-09-2019,12:03:23  
Sample Rate: 1.00  
Average: 53.24

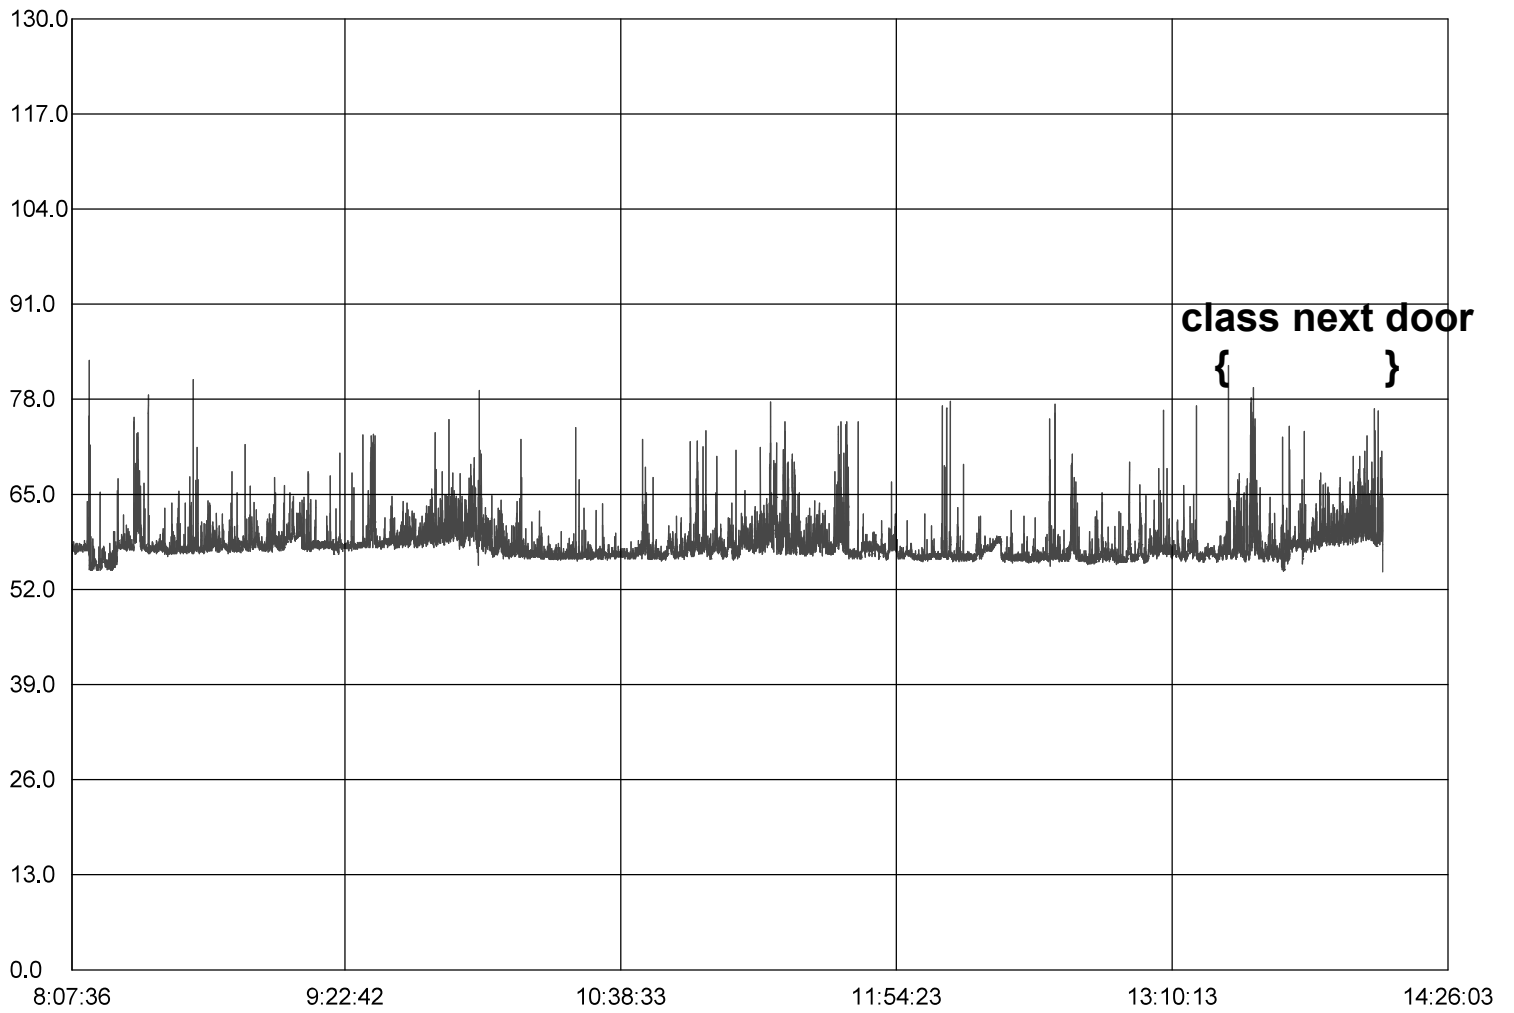
**BASEMENT HALLWAY**

Standard Sound Level Meter RealTime Graph  
Time: 2019-9-25 14:19:3

Start Time: 25-09-2019,8:07:36  
Maxnum: 83.30 25-09-2019,8:12:23  
Minnum: 52.10 25-09-2019,8:07:36  
Sample Rate: 1.00  
Average: 58.09
