## INSPECTION REPORT

| Project: <b>Greenacres School</b> | Date: <b>09/26/19</b> |

| Inspection Type: <b>Noise and Dust Monitoring</b> | Contractor: <b>Park East</b> |

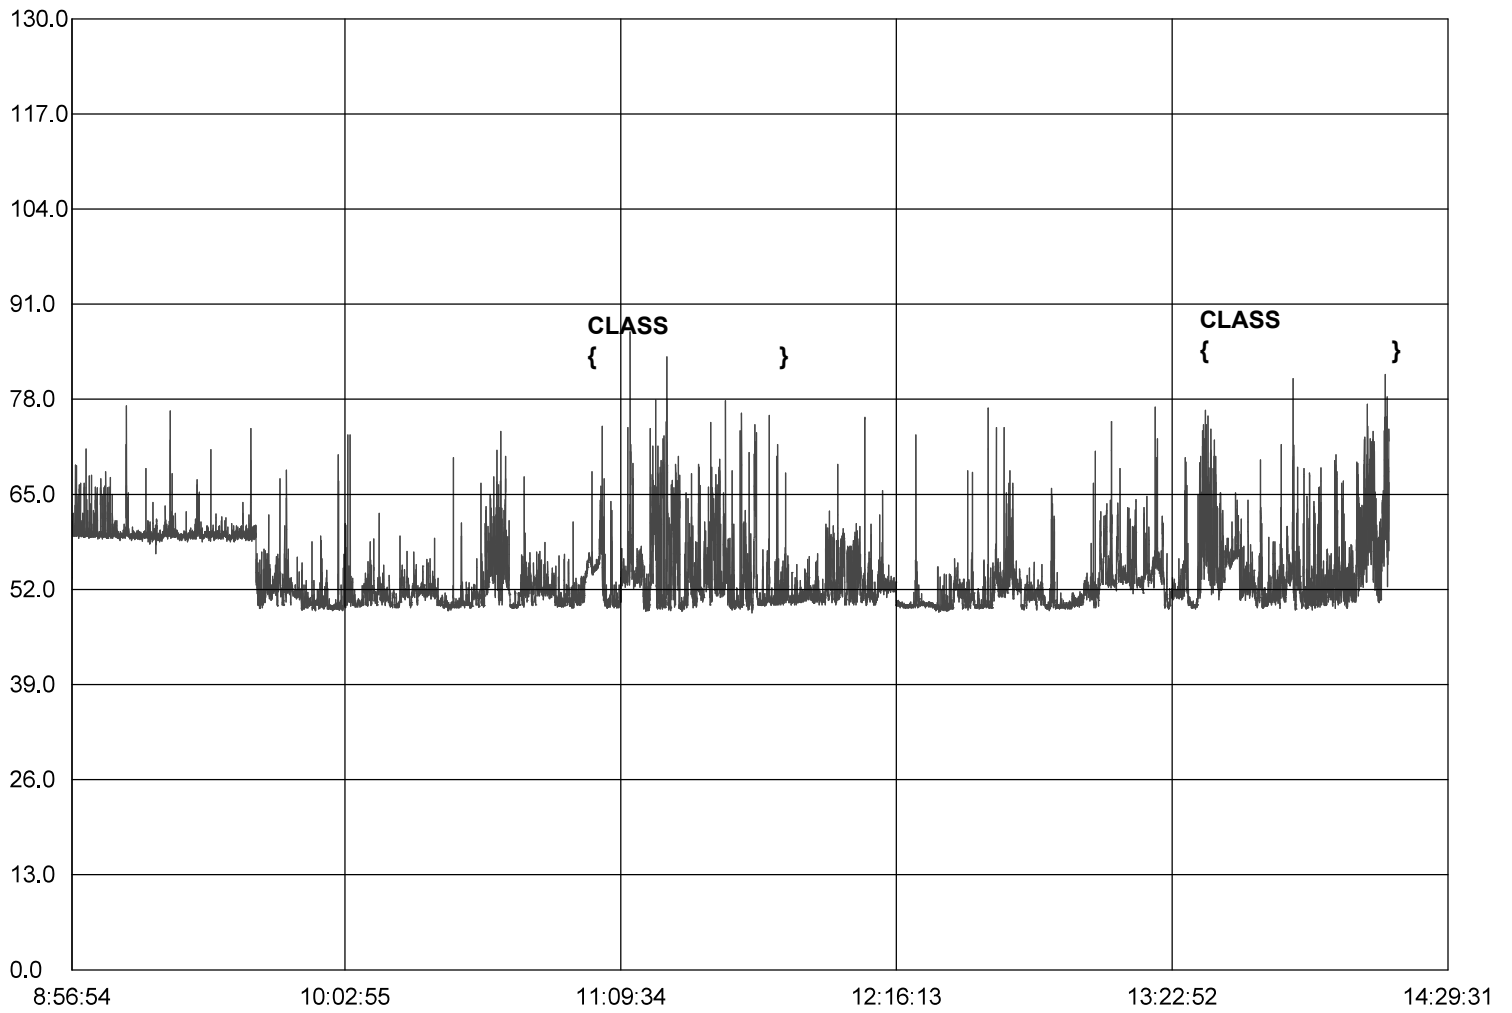
**basement hallway**

Standard Sound Level Meter RealTime Graph  
Time: 2019-9-26 14:26:40

Start Time: 26-09-2019,8:56:54  
Maxnum: 87.20 26-09-2019,11:11:52  
Minnum: 48.80 26-09-2019,11:41:18  
Sample Rate: 1.00  
Average: 53.83

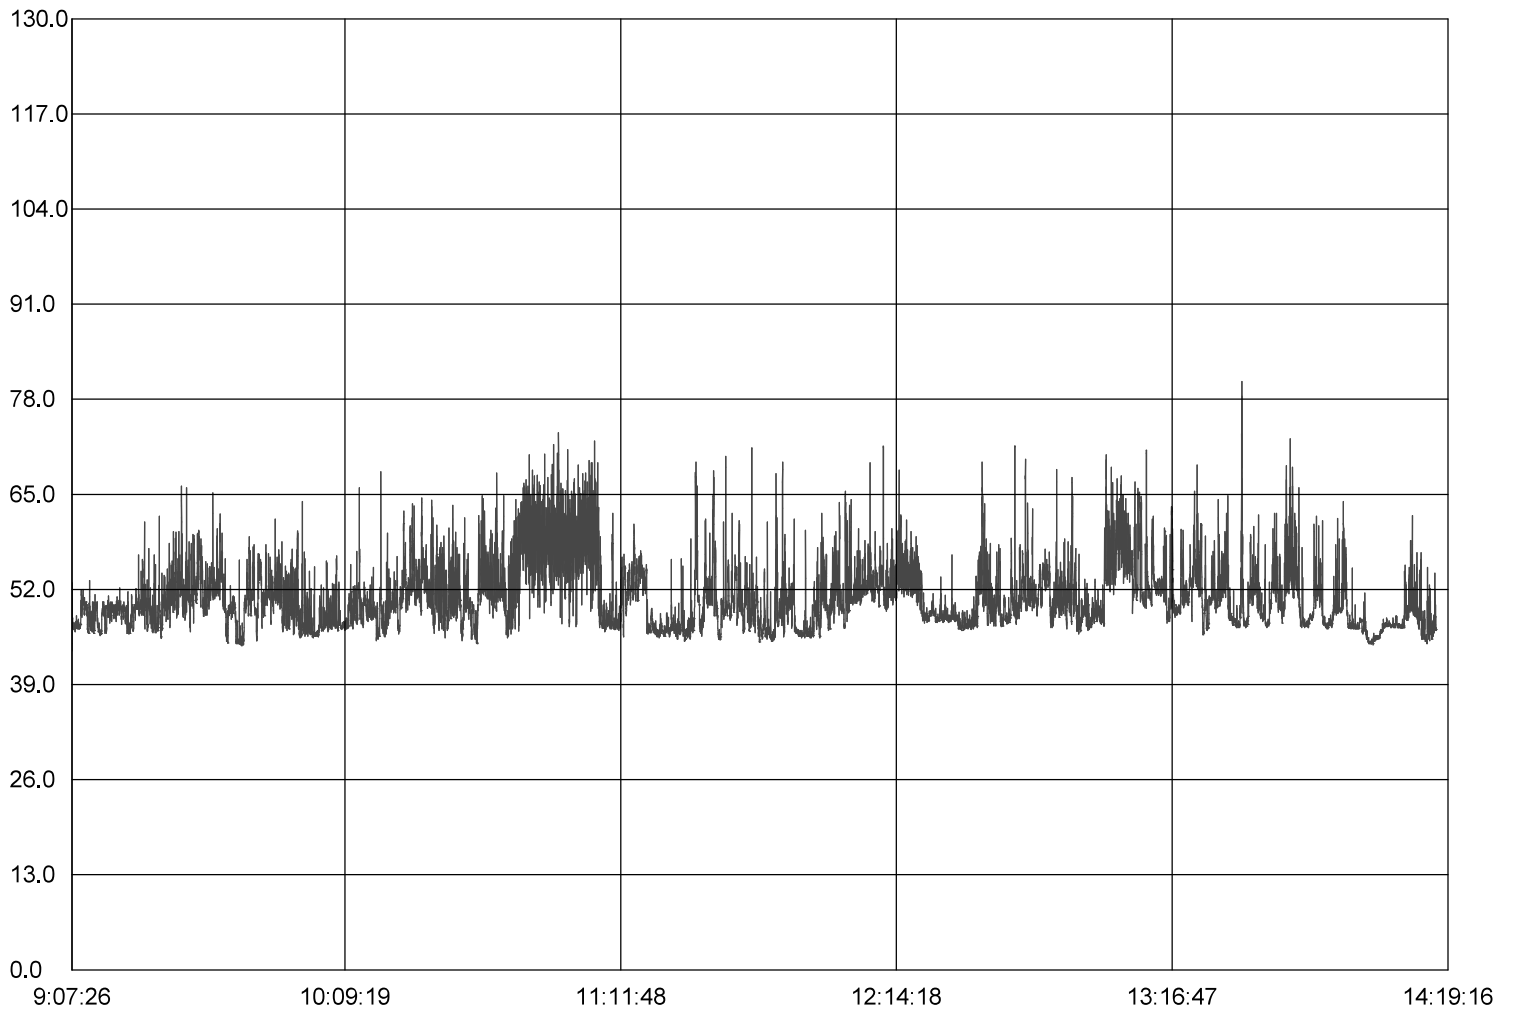
**LIBRARY**

Standard Sound Level Meter RealTime Graph  
Time: 2019-9-26 14:22:42

Start Time: 26-09-2019,9:07:26  
Maxnum: 80.40 26-09-2019,13:32:35  
Minnum: 43.60 26-09-2019,9:07:26  
Sample Rate: 1.00  
Average: 50.88
