Project: GREENACRES ELEMENTARY SCHOOL			Date: 01.28.2020							
Address: 41 HUNTINGTON AVENUE, SCARSDALE NY			NY	Job ID / MU #:						
					Weather: CLOUDY					
Inspection '	Type: N(DISE AND	DUST M	ONITOR	Contract	or:				
Present At S	27	0AM	2001111	01(11011	Sub-Con	Sub-Contractor:				
General Are		011111			CM/Designer:					
Specific Loc	ation: N	ORTHER	N AND SO	DUTHERN	BASE	EMENT,	1ST FL, 2N	ND FL		
Last Inspection:					Building Code Section:					
Reviewed	Drawing	s:			***					
Approved	Submitta	ıls								
прргочец	Other:									
Deficiency:					Resoluti	on:		-37		
Request For	r Informat	tion:			l.					
Non-Confor	mance Re	port:								
RFI#:	Issued	RFI#:	Answered	NCR # :	Issued	NCR # :[Resolved	NCR # : Open		
Observation	ns/Notes:									
Noise caused by ongoing construction in the perimeter of the school was monitored using a sound level meter. Readings were taken in the basement hallway next to the work performed today.

INSPECTION REPORT

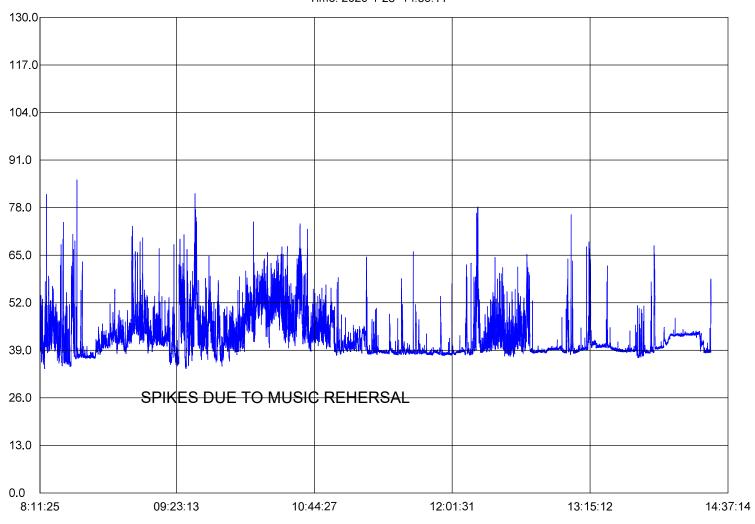
Standard Sound Level Meter RealTime Graph Time: 2020-1-28 14:53:11

Start Time: 28-01-2020,8:11:25

Maxnum: 81.40 28-01-2020,10:52:10 Minnum: 33.20 28-01-2020,9:05:12

Sample Rate: 1.00 Average: 49.57 basement hallway

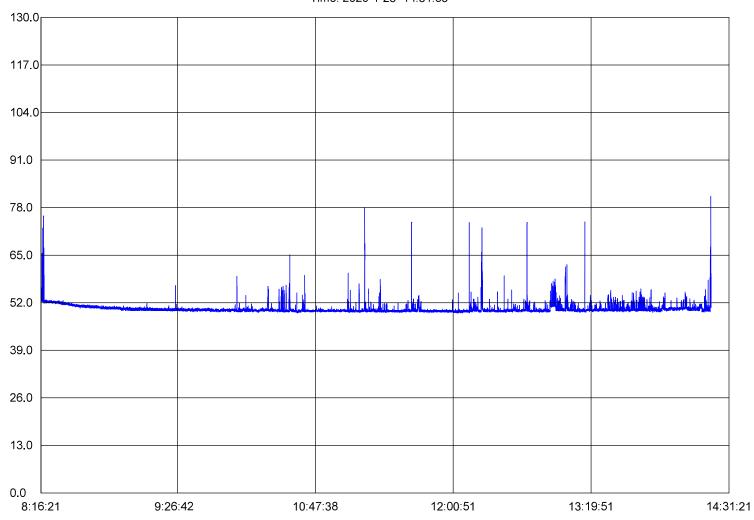
Standard Sound Level Meter RealTime Graph Time: 2020-1-28 14:51:33

Start Time: 28-01-2020,8:16:21

Maxnum: 83.40 28-01-2020,15:11:45 Minnum: 45.80 28-01-2020,13:11:22

Sample Rate: 1.00 Average: 53.40
