INSPECTION REPORT

Project: GREENACRES ELEMENTARY SCHOOL						Ι	Date: 01/29/2020				
Address: 41 HUNTINGTON AVENUE, SCARS					SDALE	NY J	‡ :				
Client: PARK EAST CONSTRUCTION							Weather: SUNNY				
Inspection Type: NOISE AND DUST MONITOR Contractor:											
Present At Site:					Sub-Contractor:						
General Area:						CM/Designer:					
	Specific Location: NORTHERN AND SOUTHERN SIDE BASEMENT, 1ST FL, 2ND FL										
Last Inspection:						Building Code Section:					
Drawings:											
Reviewed	Submittals										
Approved	Other:	Other:									
Deficiency:						Resolution:					
Deficiency.											
Para Lafe											
Request For Information:											
Non-Conformance Report:											
RFI # : Issued RFI # : Answered NCR # : Issued NCR # : Resolved NCR # : Open Observations/Notes:											
observation	is/notes:										
Noise ca	used by	ongoing	construction	on in the p	erimete	r of the sch	nool was r	nonitored using

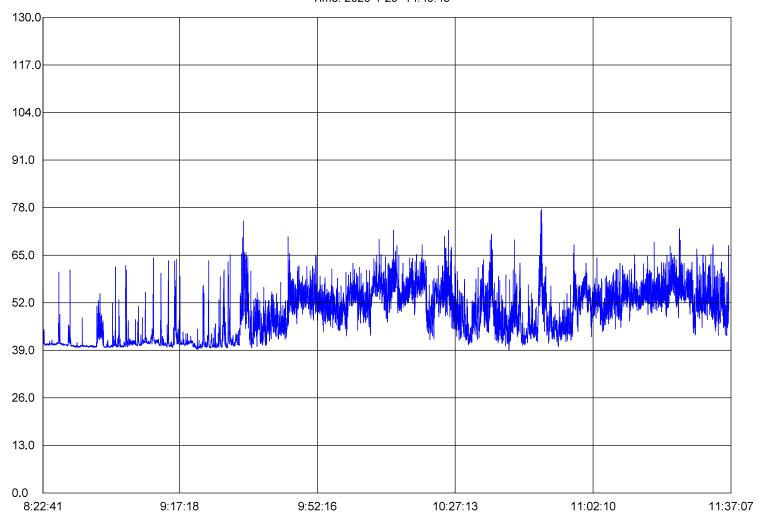
Standard Sound Level Meter RealTime Graph Time: 2020-1-29 14:40:45

Start Time: 29-01-2020,8:22:41

Maxnum: 77.50 29-01-2020,10:49:08 Minnum: 39.00 29-01-2020,10:40:51

Sample Rate: 1.00 Average: 48.69 BASEMENT HALLWAY

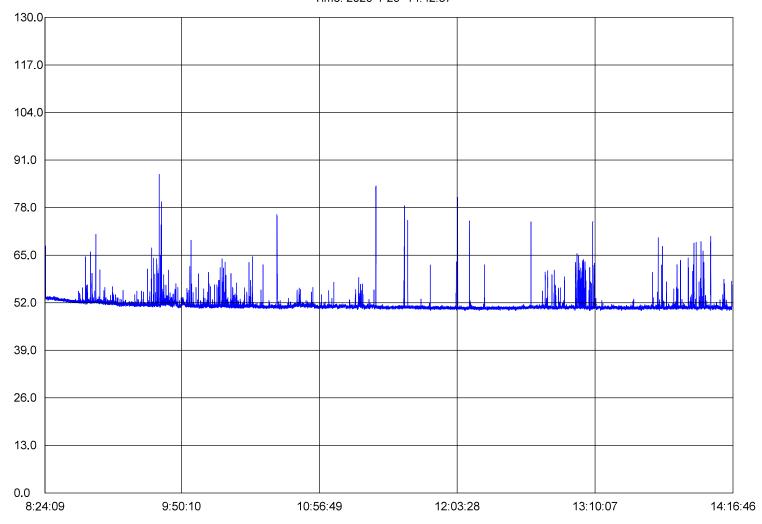
Standard Sound Level Meter RealTime Graph Time: 2020-1-29 14:42:37

Start Time:
 29-01-2020,8:24:09

Maxnum:
 87.10
 29-01-2020,9:39:25

Minnum:
 49.90
 29-01-2020,11:50:32

Sample Rate: 1.00 Average: 51.26 2nd floor storage
