INSPECTION REPORT

Project: GREENACRES ELEMENTARY SCHOOL							Date: 01/30/2020					
Address: 41 HUNTINGTON AVENUE, SCARS						ENY	Job ID / MU #	# :				
Client: PARK EAST CONSTRUCTION					7111	SUNNY						
					Contract	or.						
Present At S	Site N	JISE ANI	D DUST M	ONITOR	Sub-Contractor:							
General Are					CM/Designer:							
						li						
Specific Location: N AND S BASEMENT, 1ST FL Last Inspection:				1, 151 FL	Building Code Section:

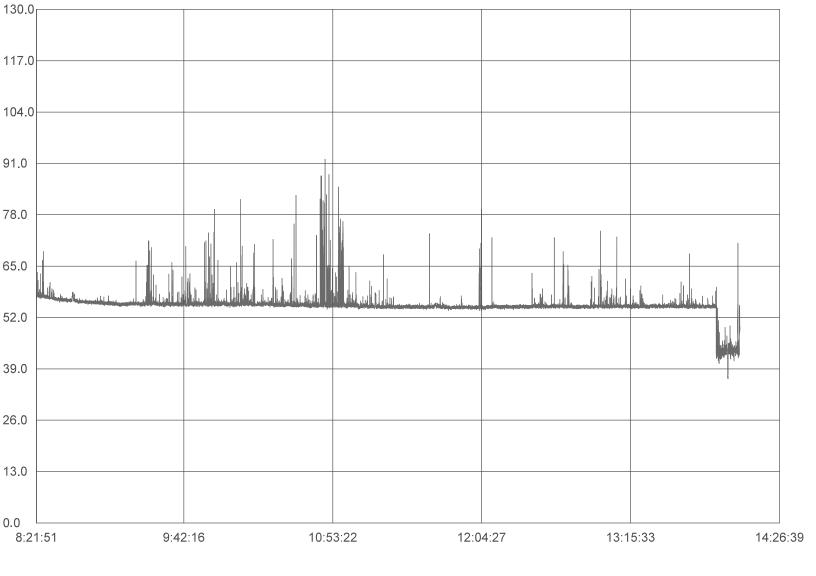
Start Time: 30-01-2020,8:21:51

Maxnum: 92.10 30-01-2020,10:49:40 Minnum: 36.60 30-01-2020,14:01:57

Sample Rate: 1.00 Average: 54.95 2nd floor storage

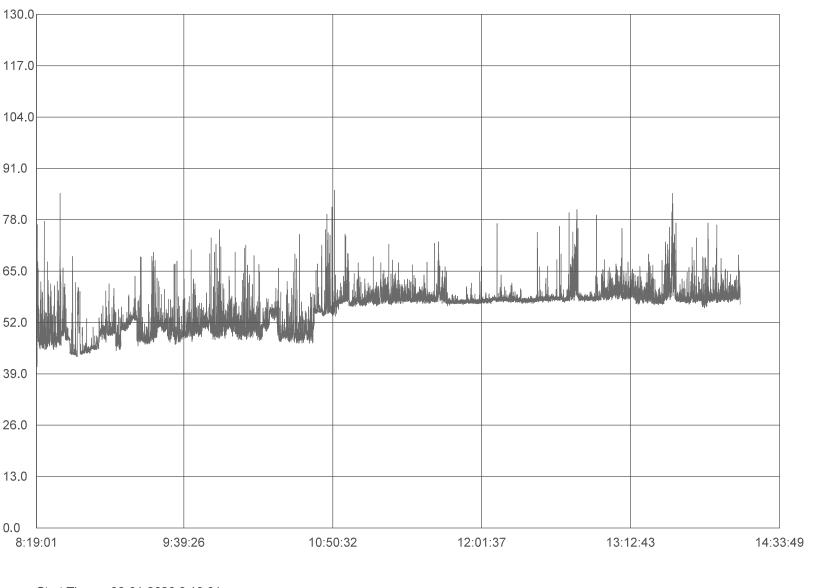
Start Time: 30-01-2020,8:19:01

Maxnum: 85.50 30-01-2020,10:51:16 Minnum: 40.80 30-01-2020,8:29:17

Sample Rate: 1.00 Average: 55.21
