**MUNICIPAL**  
 TESTING LABORATORY, INC.

## INSPECTION REPORT

| Project: <b>Greenacres School</b> | Date: <b>10/02/19</b> |

| Inspection Type: <b>Noise and Dust Monitoring</b> | Contractor: <b>Park East</b> |

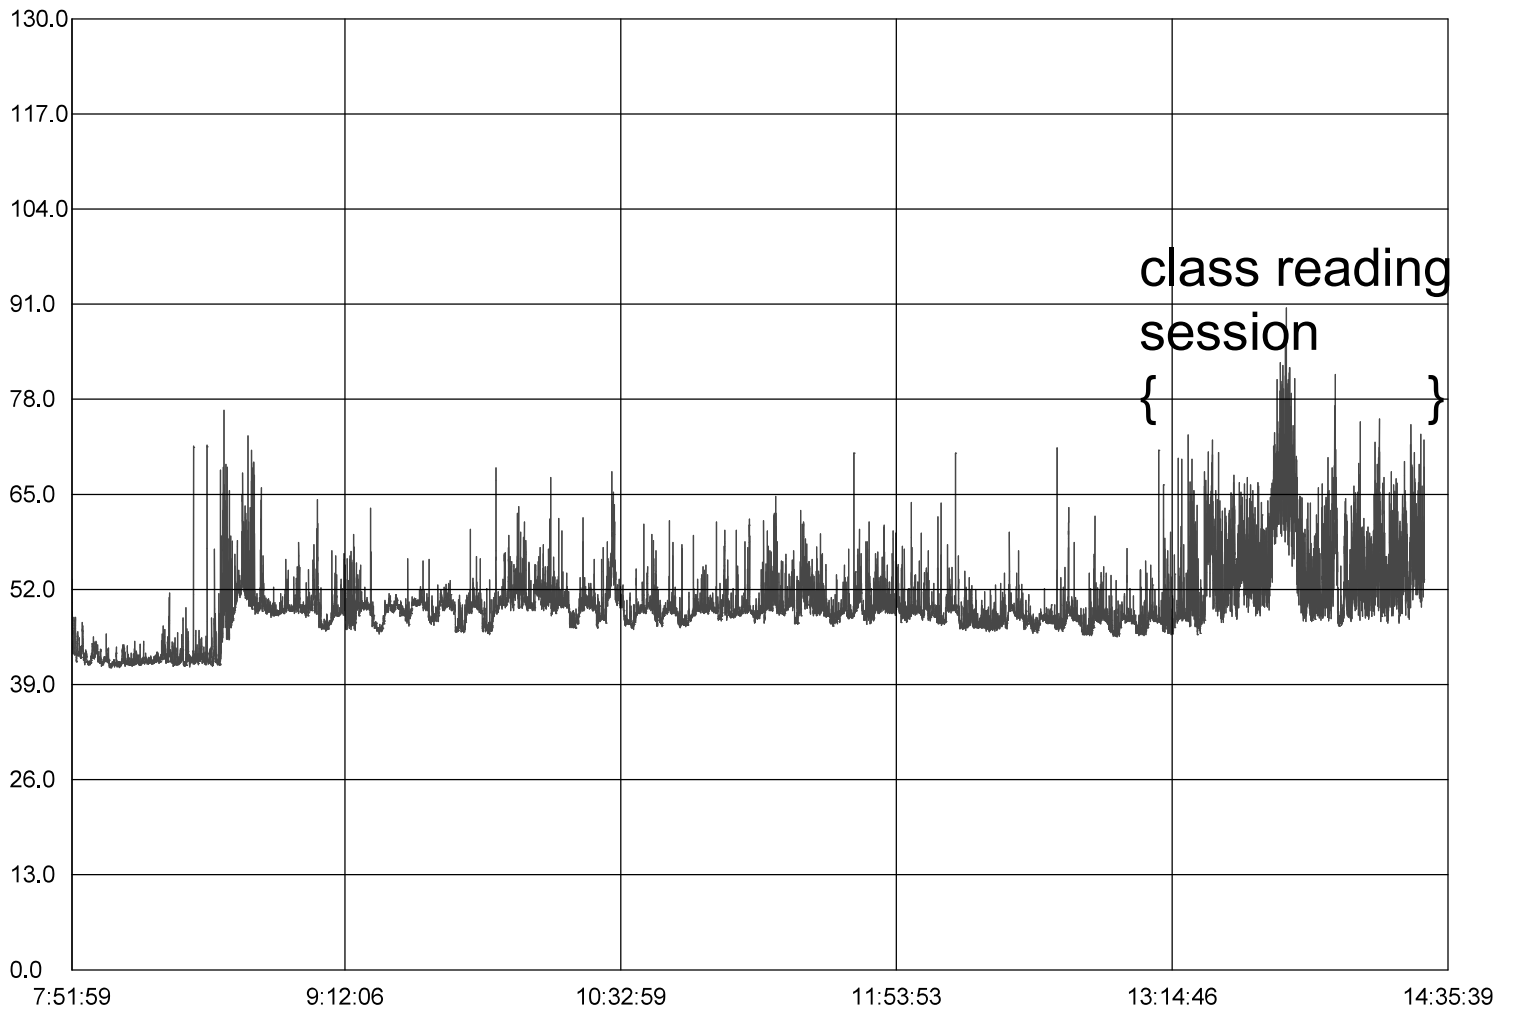
Library

Standard Sound Level Meter RealTime Graph  
Time: 2019-10-2 14:42:39

Start Time: 02-10-2019,7:51:59  
Maxnum: 90.50 02-10-2019,13:48:18  
Minnum: 41.30 02-10-2019,8:03:02  
Sample Rate: 1.00  
Average: 49.81

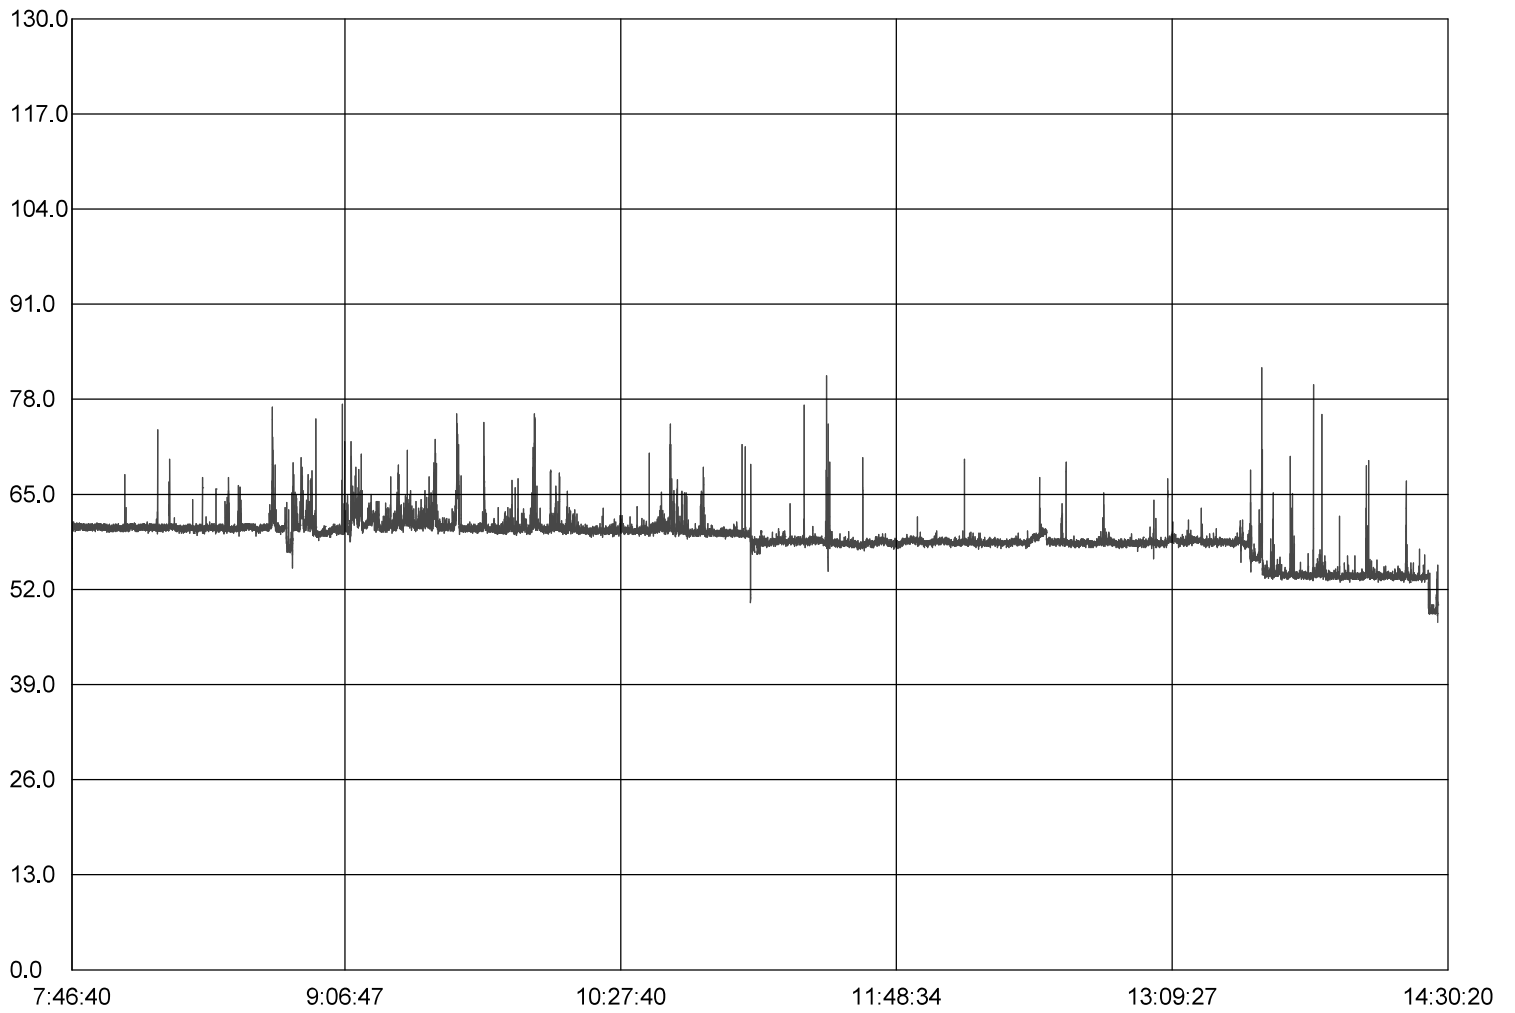
basement hallway

Standard Sound Level Meter RealTime Graph  
Time: 2019-10-2 14:36:11

Start Time: 02-10-2019,7:46:40  
Maxnum: 82.30 02-10-2019,13:35:46  
Minnum: 47.50 02-10-2019,14:27:26  
Sample Rate: 1.00  
Average: 58.96
